AUTOMOBILE APPRAISAL REPORT

VEHICLE DAMAGE INSPECTION REPORT

Handling Insurer:	MSIG Insurance (Singapore) Pte. Ltd.	Policy No:	A27246252QMY
Claimant Vehicle No :	SKB2763C	Insured Vehicle No :	SJB4960Z
Date of Loss:	27/09/2017	Nature of Claim:	TP
			Claim No: 531348

Reg No:	SKB2763C		
Make & Model:	BMW 523i, 2.5 AT ABS D/AB 2WD 4DR GAS/D NAV (A)	Engine No:	08647737N52B25AF
Reg. Date:	13/05/2011 (Man. Year: 2011)	Chassis No:	WBAFP32050C866082
Colour:	Silver	Odometer:	311280 km
Engine Capacity:	2497 cc		
Market Value/New Car Price:	N/A		
Sum Insured (S\$):	Market Value/New Car Price

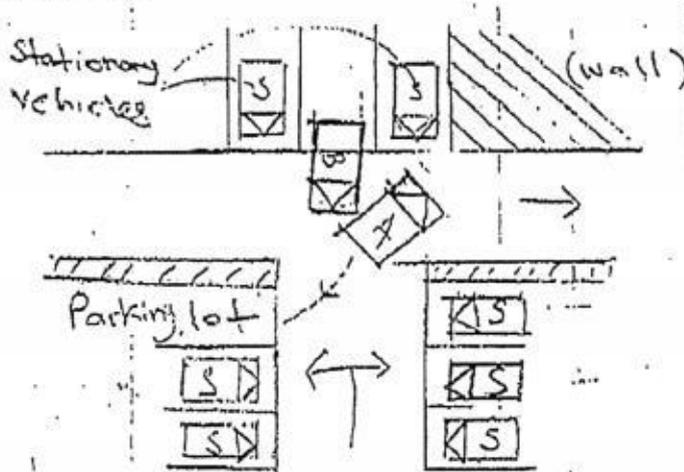
SKETCH PLAN

A: SKB 2763C
 B: SJB 4960Z
 S: Stationary Vehicles

On 27/09/17 at about 1930 hours, I was driving in White Sands basement carpark searching for a parking lot. I found a carpark lot, positioned my car and started to reverse into the carpark lot. Suddenly, I felt an impact on the left of my vehicle. Vehicle B, came out of his parking lot and collided into the left of my vehicle.
