Date : 28-11-2017

1. Policy Particulars :- THIRD PARTY CLAIM

4. Description of Damages

VEHICLE DAMAGE INSPECTION REPORT

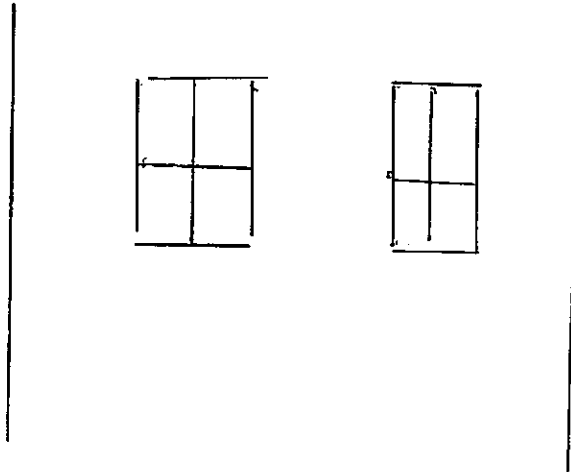
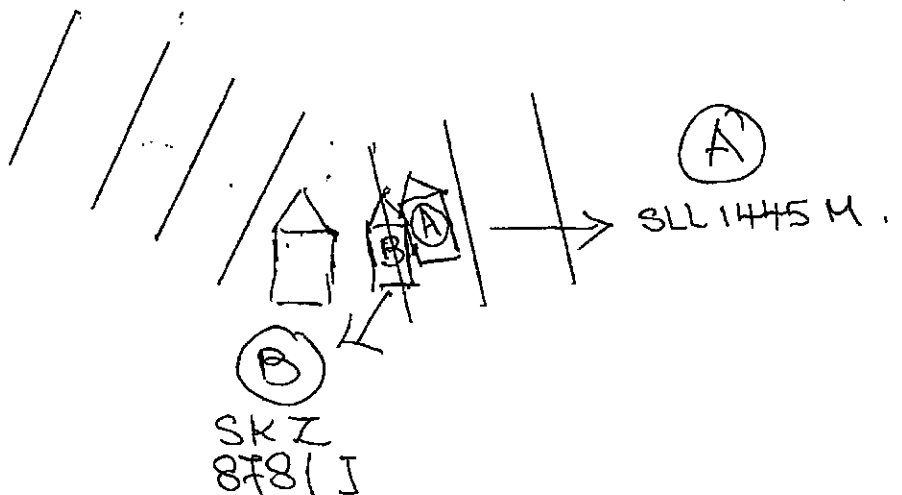
Sketch Plan #2 Pg. 1

I WAS DRIVING AT JB SECOND LINK COMING BACK TO SINGAPORE. APPROACHING THE PASSPORT CHECKING, I WAS DRIVING WITHIN MY LANE. A CAR(SKZ8781J) FROM THE LEFT, SUDDENLY CUT INTO MY LANE AND HIT ONTO THE LEFT SIDE OF MY CAR. ATTENDED BY AINI

J.B
second link
was
