VEHICLE DAMAGE INSPECTION REPORT

Our File No: CS/MSG17022642/T1RBE2

Handling Insurer: MSIG Insurance (Singapore) Pte. Ltd. Policy No: MSD/VPCP/17-000961-00
 Claimant Vehicle No: GQ154S Insured Vehicle No: SJE7642G
 Date of Loss: 23/11/2017 Nature of Claim: TP Claim No: MSCN/17-001847

Reg No: **GQ154S**
 Make & Model: MITSUBISHI CANTER, 3.0 D FEA01BR2SDEB (CBU) (M) Engine No: 4P10C21890
 Reg. Date: 28/07/2016 (Man. Year: 2016) Chassis No: FEA01BA20250
 Colour: White Odometer: 24990 km
 Engine Capacity: 2998 cc
 Market Value/New Car Price: N/A
 Sum Insured (S\$): **Market Value/New Car Price**

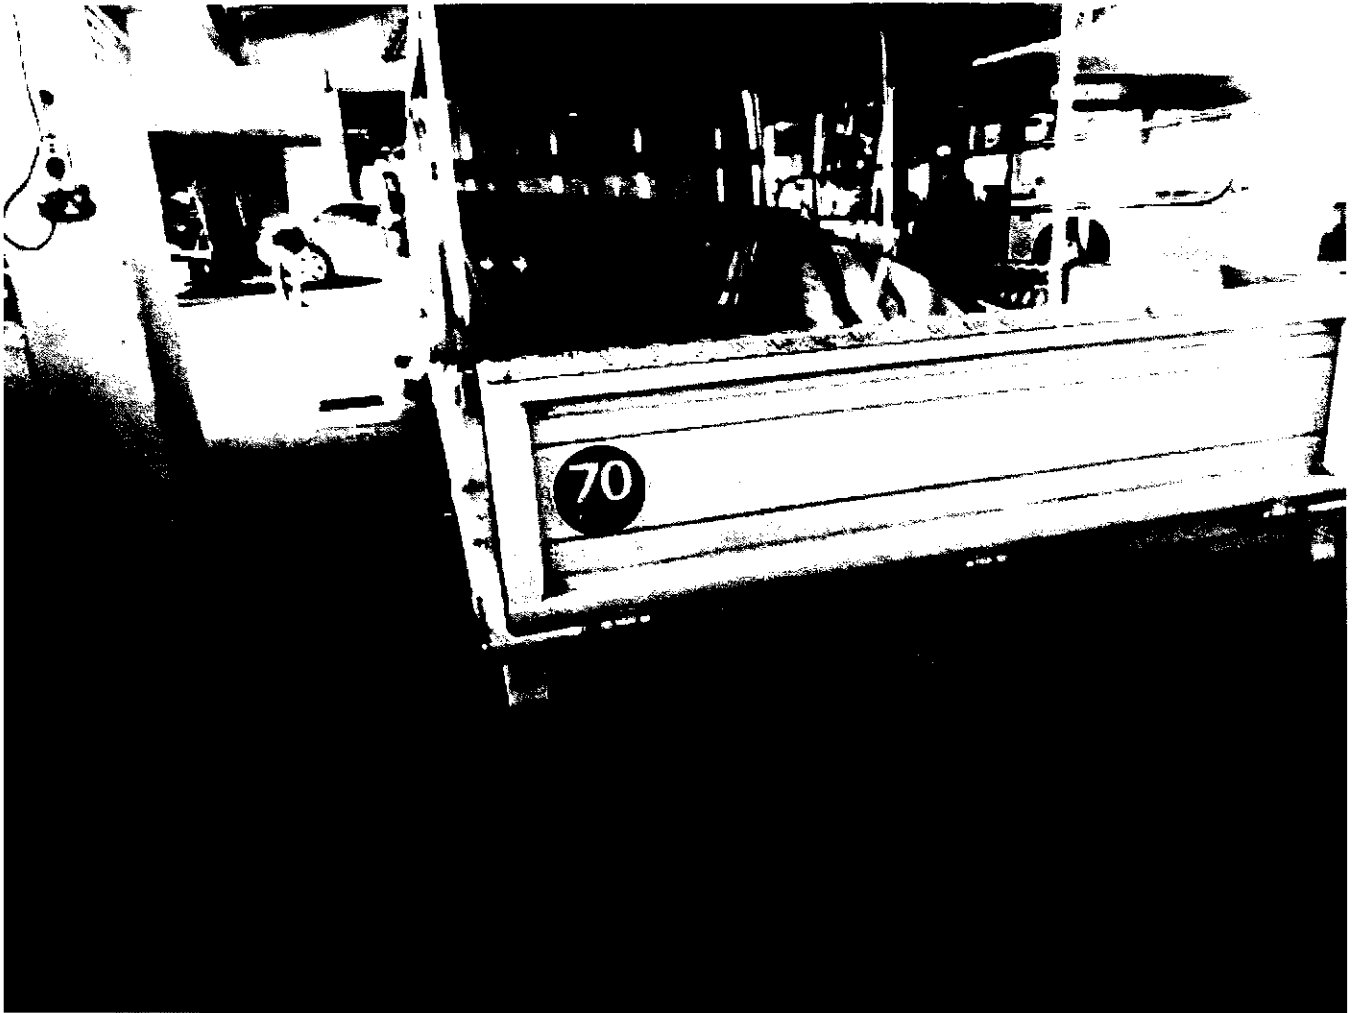
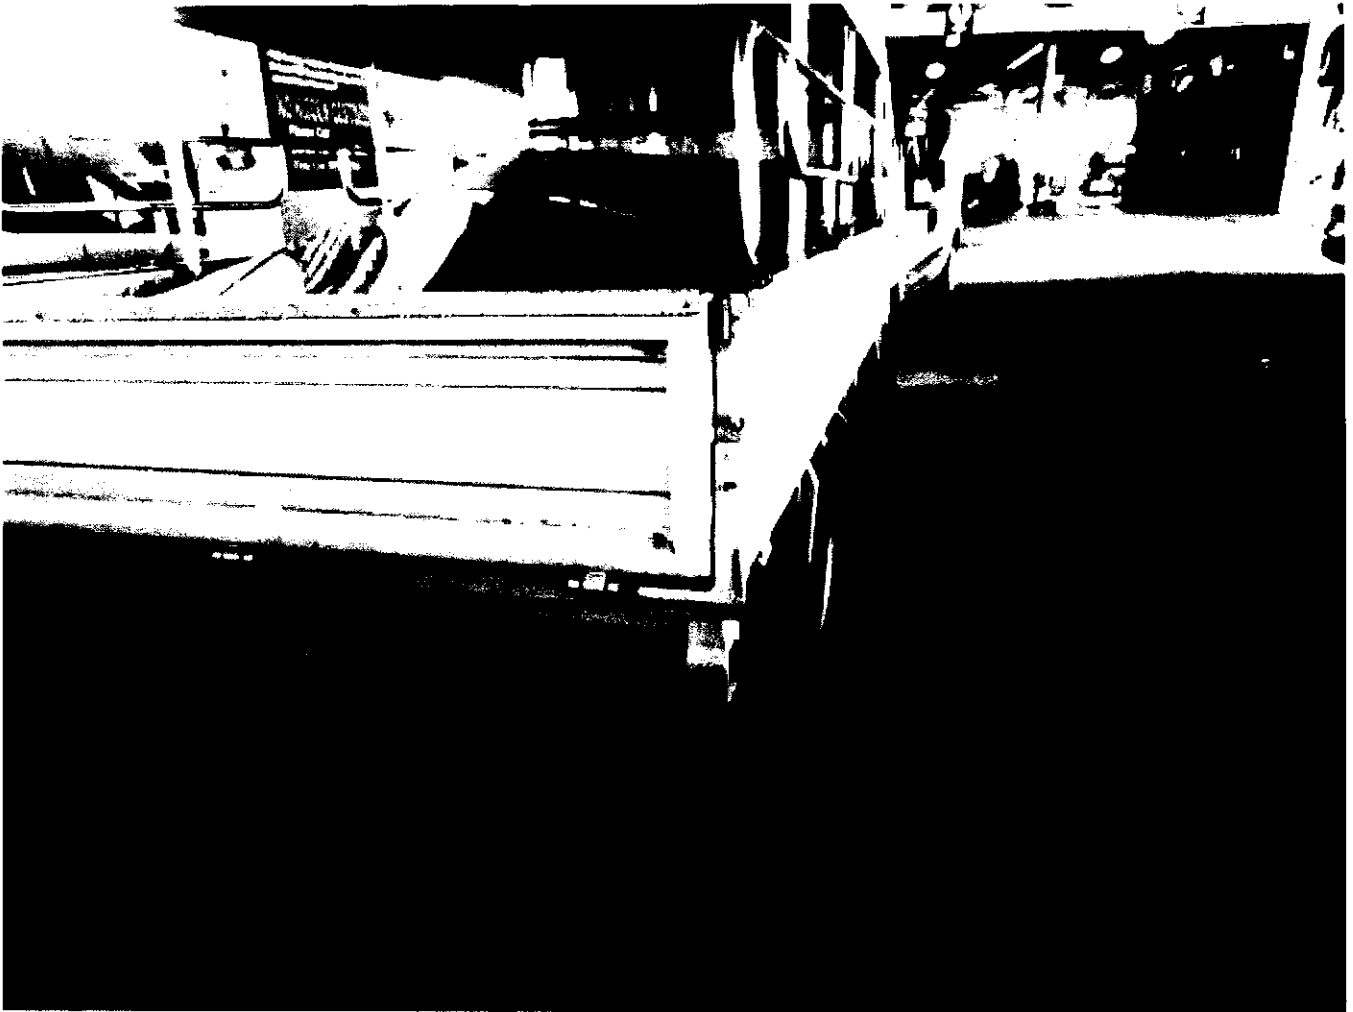
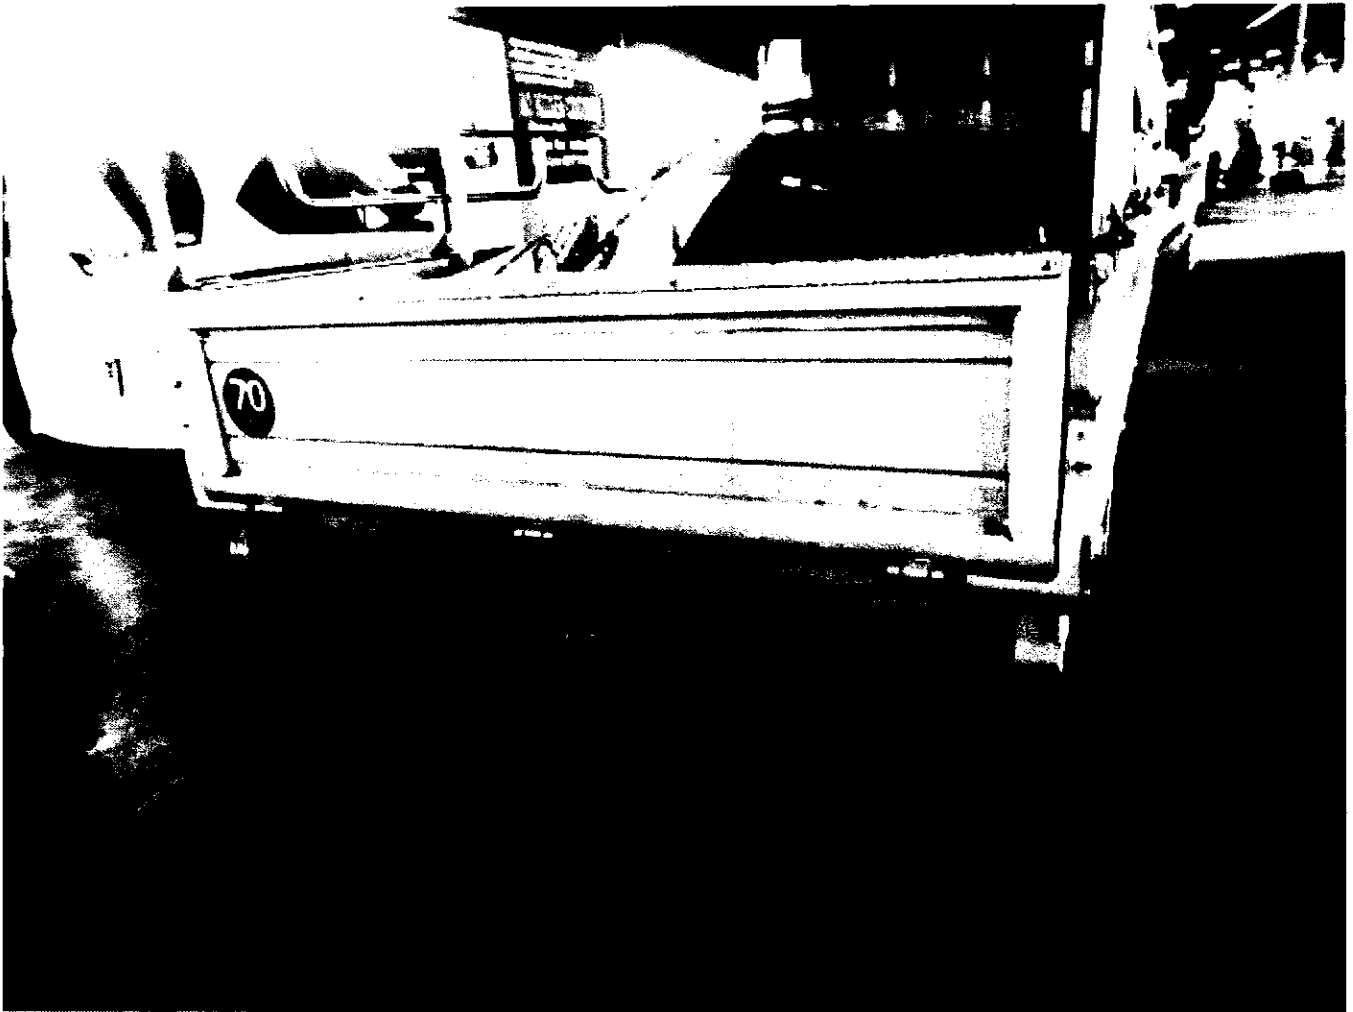
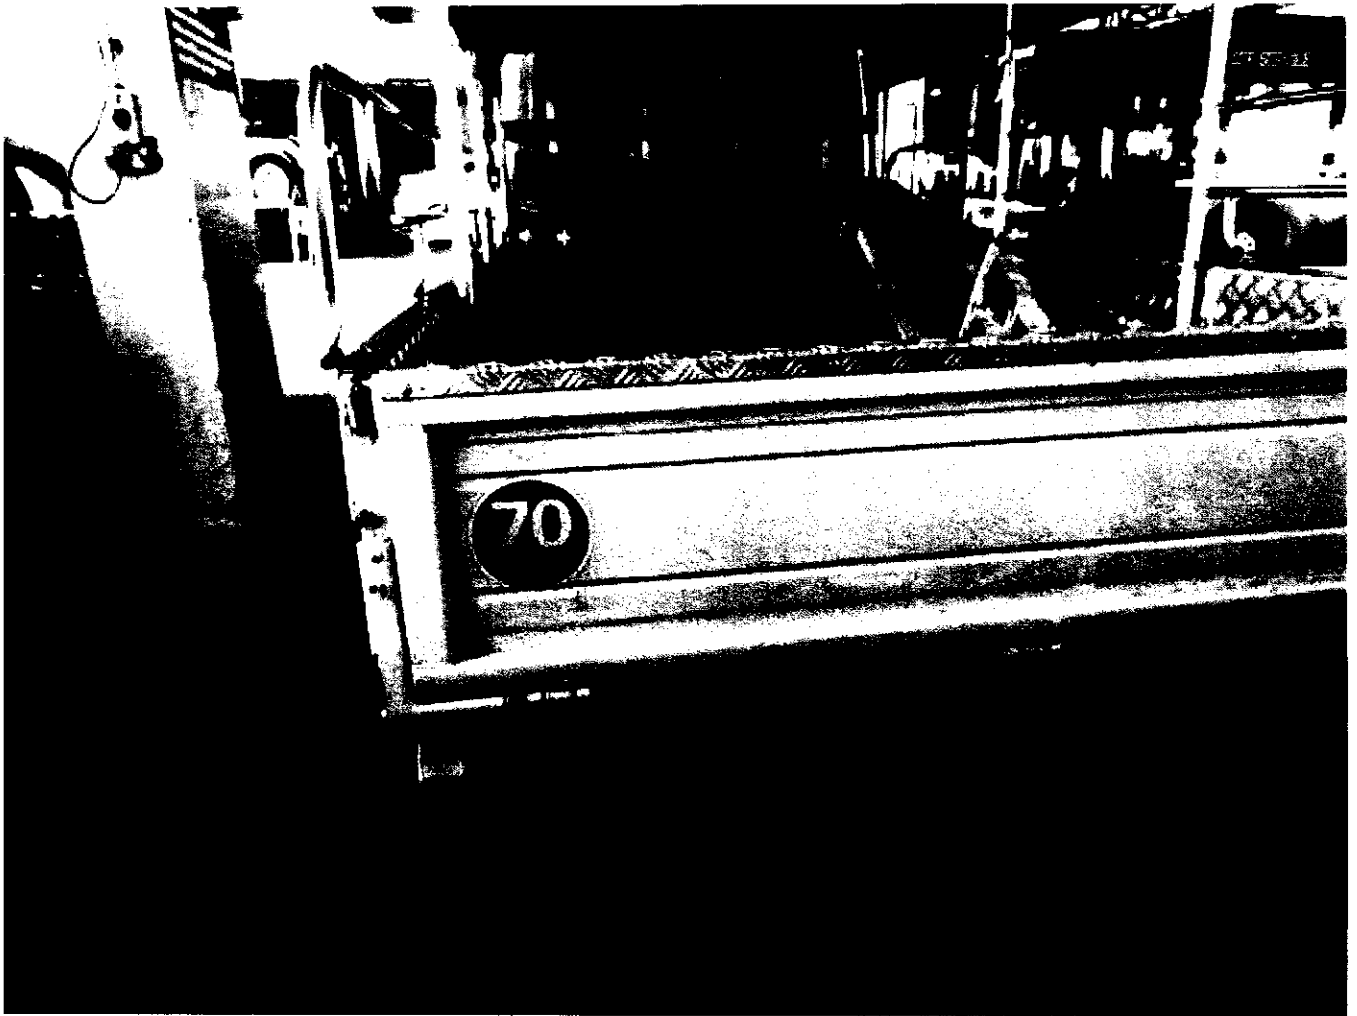
The U/C / Chassis frame / Body Structure affected due to collision.

I STOPPED MY VEHICLE AT THE JUNCTION OF WOODLANDS ROAD ON THE RIGHT LANE, A VEHICLE CAME FROM BEHIND AND HIT ONTO THE REAR PORTION OF MY VEHICLE. ATTENDED BY : SUSAN

Accident Photo
