ASSIGNMENT

VEHICLE DAMAGE INSPECTION REPORT

Our File No: CC3/TMI17022660/K1VBN2

Handling Insurer:	Tokio Marine Insurance Singapore Ltd	Policy No:	MB010047
Claimant Vehicle No :	SHC1328M	Insured Vehicle No :	PZ822T
Date of Loss:	25/11/2017	Nature of Claim:	TP
		Claim No:	M1706010

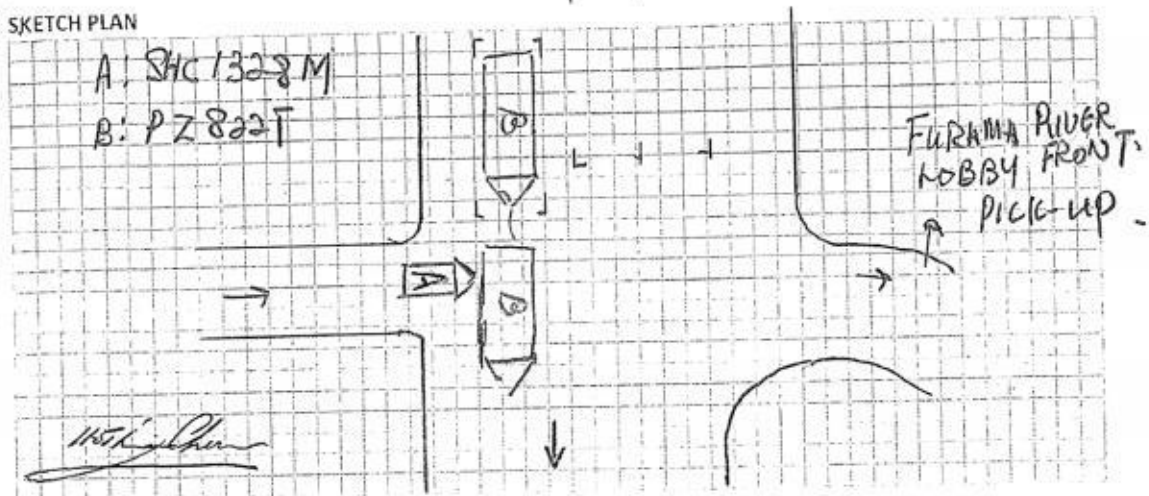
SKETCH PLAN

Suddenly a parked bus PZ822T on my left drive out from the parking lot. As a result of this, the right hand side rear of the bus hit and grazed the front left portion towards the front right of my taxi thus damaging them in the process.
