1. Policy Particulars :- THIRD PARTY CLAIM

THE VEHICLE SUSTAINED DAMAGES AT THE N/S BODY. DAMAGES SEE DETAILS.
--

ADJUSTMENT ON REPAIR COST FOR VEHICLE NO. SHB 4016Z

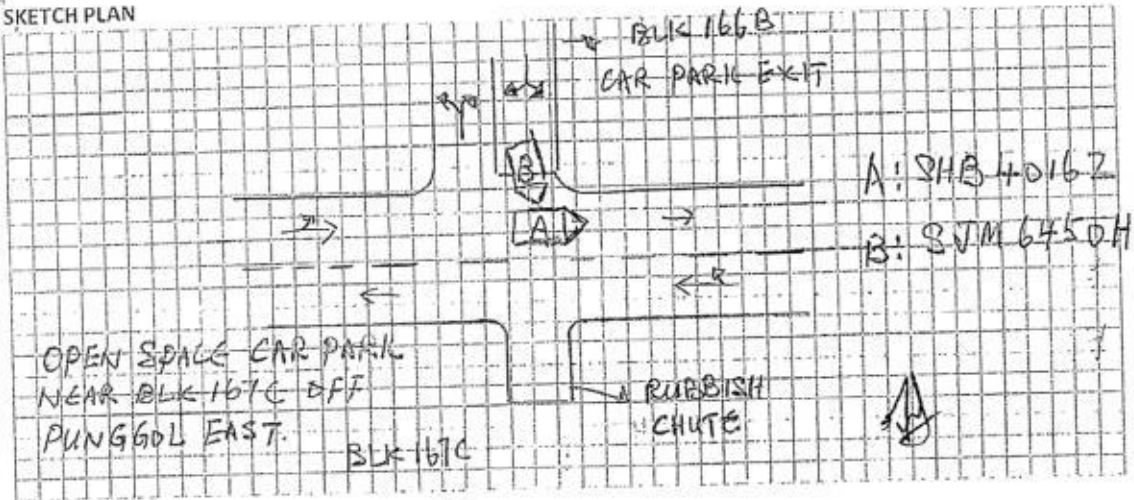
SKETCH PLAN

On 30 Nov 2017 at about 20:10 hrs I was slowly driving straight along Blk 167C open space car park driveway heading towards the main exit leading to Punggol East.

As I was about to drive pass Blk 166B car park exit suddenly I felt an impact coming from the left hand side mid-section of my taxi followed by a jerk. Shortly after I stopped my taxi and stepped out to check.

Found that a car SJM6450H had driven out from the exit and hit my taxi. In the process the front of the car hit and grazed the left hand side front door towards the left hand side rear including the left hand side rear wheel of my taxi thus damaging them.

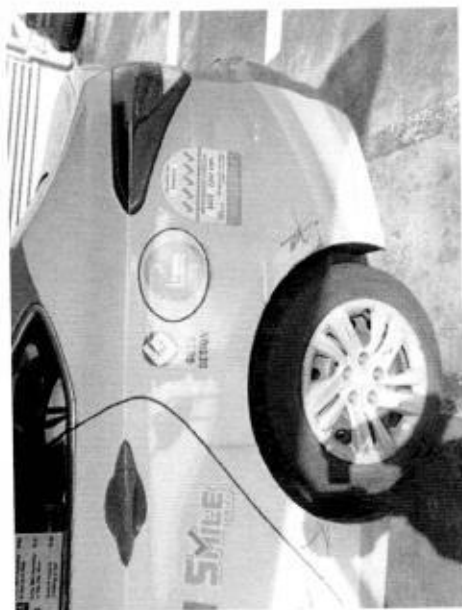
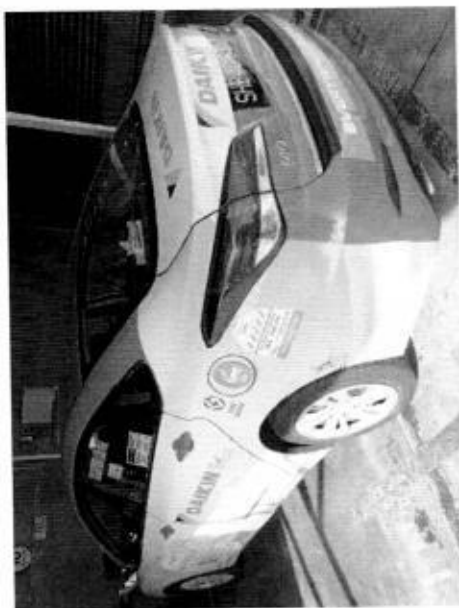
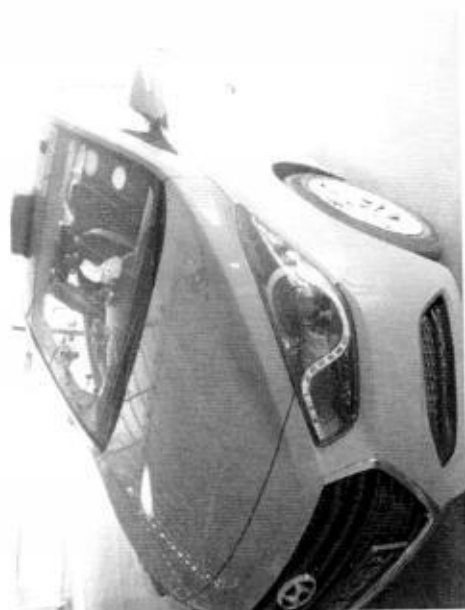
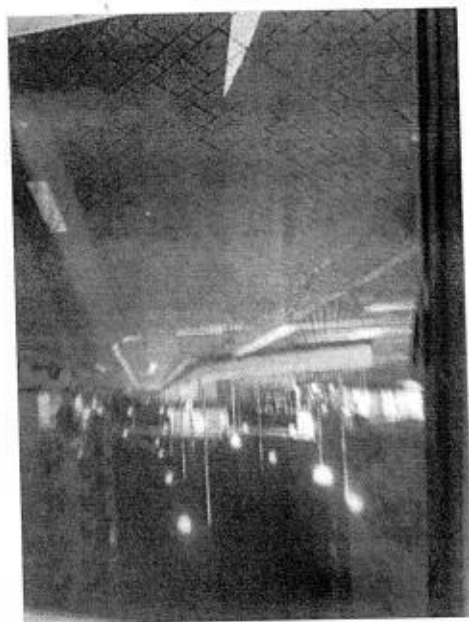
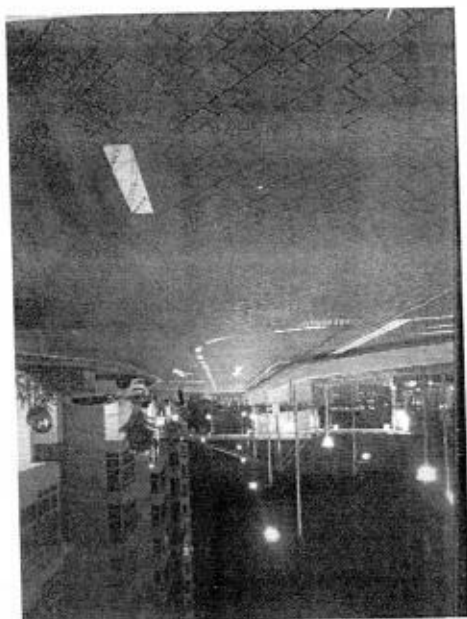
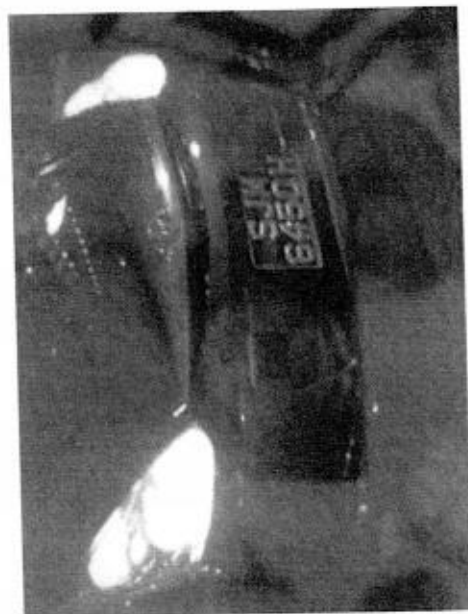
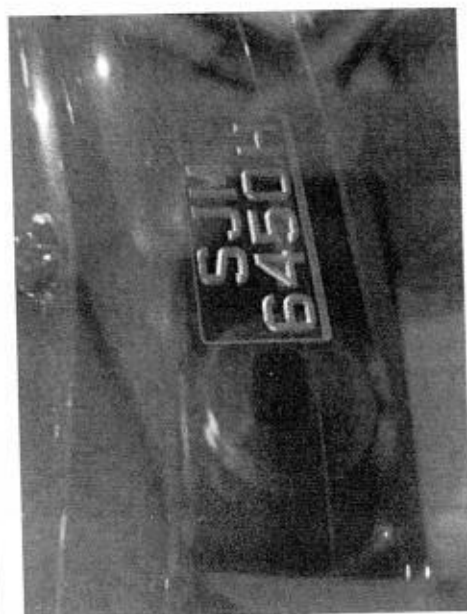
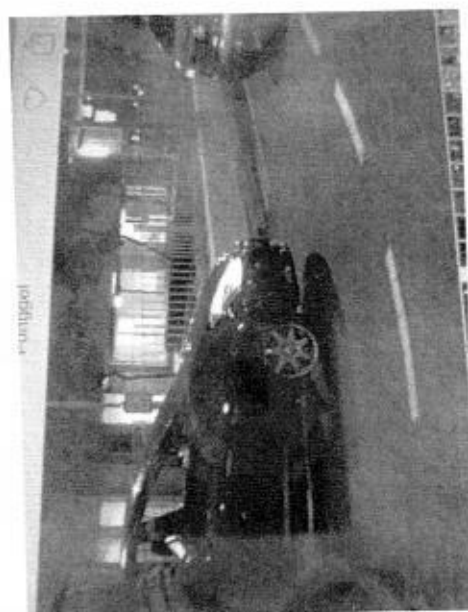
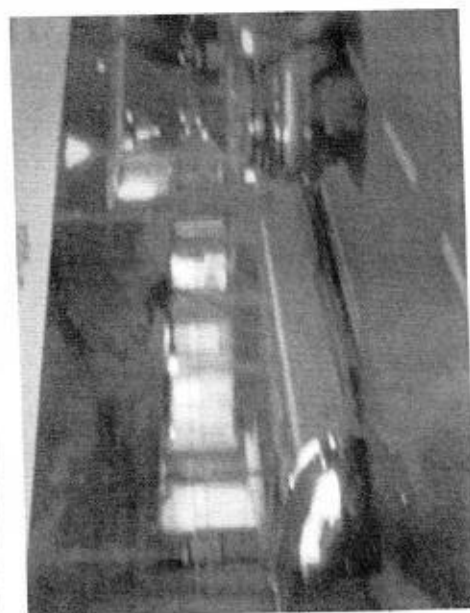
Remark: The veh had commenced its
repair at the time of inspection.

Qty	Parts Description/ Labour	Type	Unit Price	Amount
	Rear Door (LH) <i>X repair</i>			\$ 1,351.10
	Front Door (LH) <i>dent</i>			\$ 1,403.05
	Rear Wheel Hup-Cap (LH) <i>hinged</i>			\$ 150.70
	SUB TOTAL			\$ 2,904.85
	LESS 20%			\$ 580.97
	DISCOUNTED TOTAL			\$ 2,323.88
	Rear Bumper Advertisement Logo <i>X</i>			\$ 50.00
	Rear Bumper Rubber Mat <i>X</i>			\$ 50.00
	Rear Fender Advertisement Logo (LH/RH) <i>4H</i>		100.00	\$ 200.00
	Rear Door Comfortdelgro & Apps Sticker (LH) <i>✓</i>			\$ 80.00
	Front Door Coloured Comfort Logo (LH) <i>✓</i>			\$ 75.00
	Front Door Advertisement Logo (LH) <i>✓</i>			\$ 100.00
				\$ 555.00
	Labour Charge			
	Panel Beating- Repair Fender			\$ 800.00 <i>400 PB</i>
	Spray Painting Charge			\$ 800.00 <i>360 SP</i>
	Wiring Charge			\$ 50.00 <i>X PB</i>
	Tuff Kote			\$ 50.00 <i>20 SP</i>
	Towing Fees			\$ 50.00 <i>X</i>
	Remove/Refix Reverse Sensor			\$ 120.00 <i>X PB</i>
	Transfer of Door			\$ 240.00 <i>50 PB</i>
