National Assessment Centre Services

NTUC INCOME INSURANCE CO-OPERATIVE LTD Ref: NS/INC17022997/K1qb			
73 BRAS BASAH ROAD		 	
#05-01 NTUC TRADE UNION HOUSESINGAPORE 189556			
		Date: 05-12-2017	
Code: INC4

4. Description of Damages			
THE VEHICLE SUSTAINED DAMAGES AT THE N/S FRONT PORTION. DAMAGES SEE DETAILS.			
5. General Information			
Accident Date	04/12/2017	Inspection Date	04/12/2017
Survey held at	COMFORTDELGRO ENGINEERING PTE LTD 59 LOYANG DRIVE SINGAPORE 508969		
5a. Remarks			
A)THE INSPECTION WAS CONDUCTED ON A"WITHOUT PREJUDICE" BASIS. B)IN ACCORDANCE TO YOUR INSTRUCTIONS, WE HAVE NOT AUTHORISED REPAIRS.			
5b. Estimate Days of Repair			
ESTIMATED NORMAL PERIOD FOR REPAIR:		2 Working Days

ADJUSTMENT ON REPAIR COST FOR VEHICLE NO. SHA 2392E

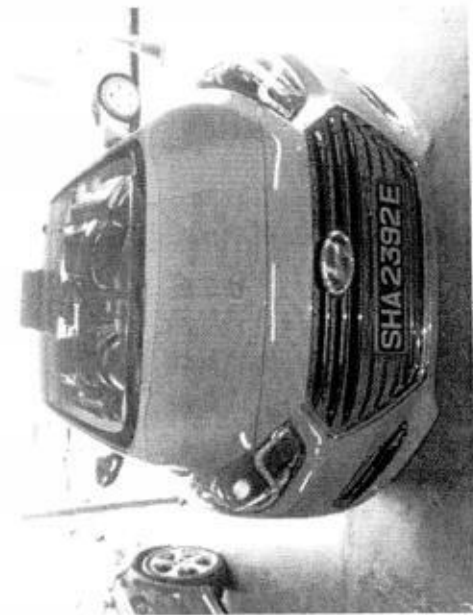
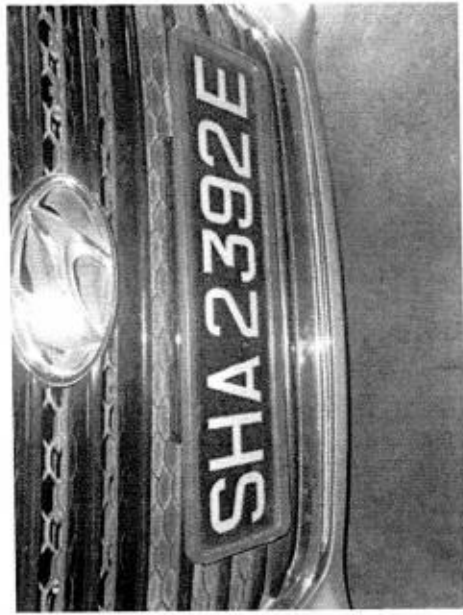
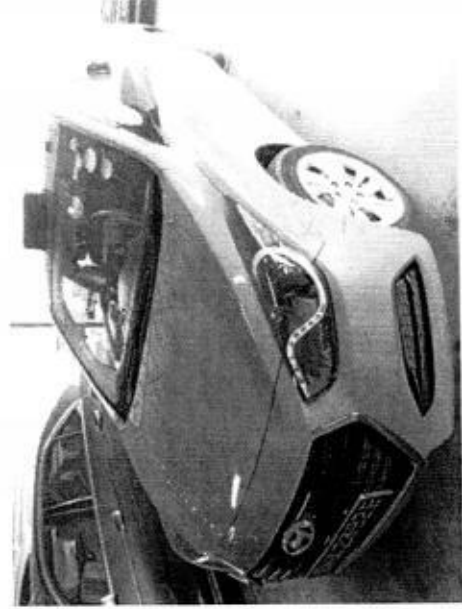
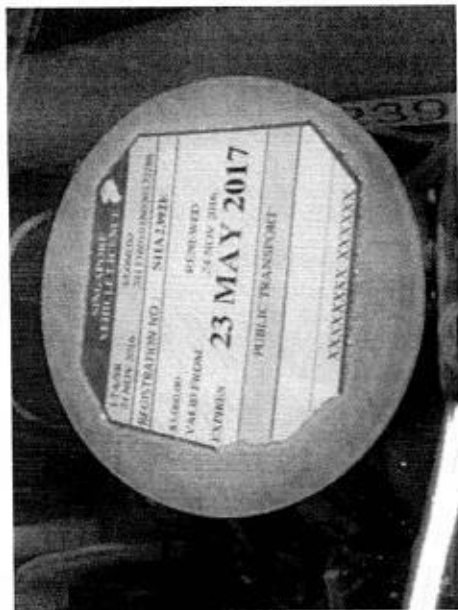
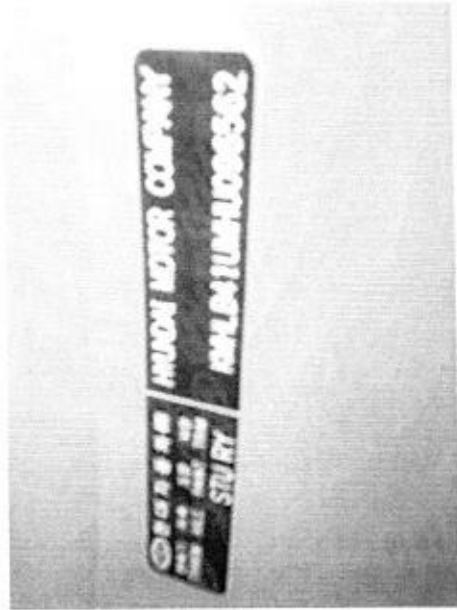
Qty	Description of Parts	Condition	Estimate By Workshop (\$)	Our Adjusted (\$)
REPLACEMENT OF PARTS				
1	FRONT BUMPER	TO REPAIR	1,052.20	-
10	FRONT BUMPER CLIPS @\$2.20	NOT NECESSARY	22.00	-
1	FRONT FENDER - LH	TO REPAIR	619.00	-
1	FRONT FENDER SHIELD - LH	SERVICEABLE	169.80	-
1	FRONT WHEEL COVER - LH	GRAZED	150.70	150.70
	LESS 20% DISCOUNT		-402.74	-30.14
			1,610.96	120.56
LABOUR				
	THATCHAM STANDARD REPAIR TIME ON BODY WORKS.		570.00	200.00
	THATCHAM TTS STANDARD SPRAY PAINTING COST AND LABOUR.		450.00	360.00
			1,020.00	560.00
GRAND TOTAL			2,630.96	680.56
RECOMMENDED COST OF REPAIRS (CONFIRMED)				680.56
