1. Policy Particulars :- THIRD PARTY CLAIM

THE VEHICLE SUSTAINED DAMAGES AT THE O/S REAR PORTION. DAMAGES SEE DETAILS.
--

ADJUSTMENT ON REPAIR COST FOR VEHICLE NO. SHC 3029M

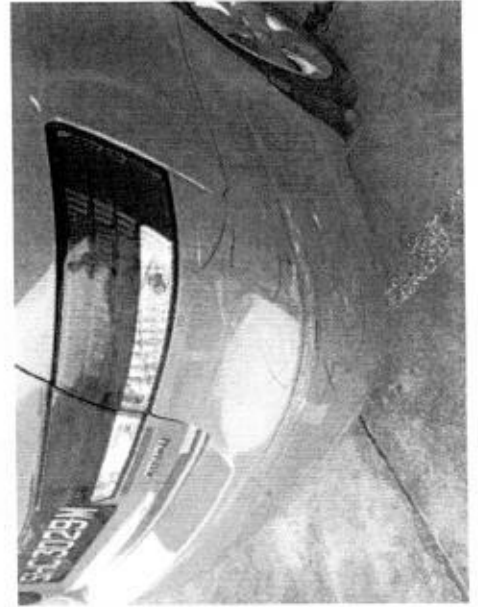
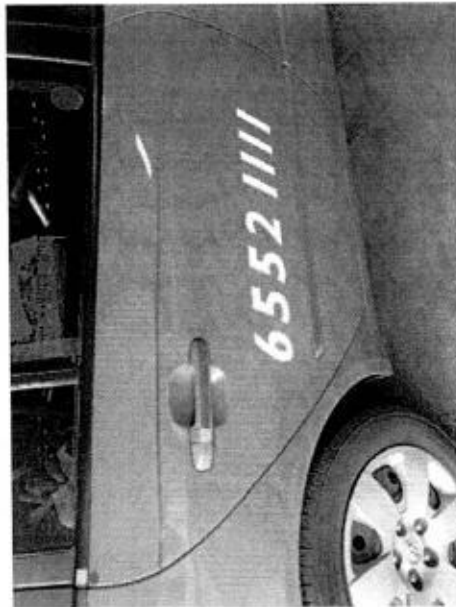
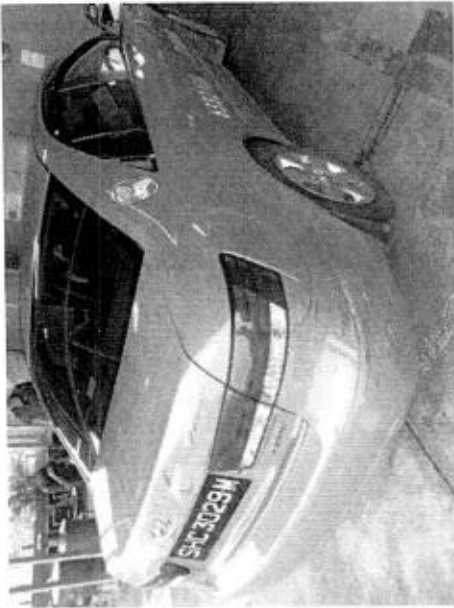
Remark: The veh had commenced its
repair at the time of inspection.

Qty	Description of Parts	Condition	Estimate By Workshop (\$)	Our Adjusted (\$)
<u>REPLACEMENT OF PARTS</u>				
1	REAR BUMPER	TO REPAIR	578.40	-
10	REAR BUMPER CLIP	NOT NECESSARY	22.00	-
1	REAR BUMPER PROTECTOR (RH)	CUT	38.00	38.00
	LESS 20% DISCOUNT		-127.68	-7.60
			510.72	30.40
<u>LABOUR</u>				
	THATCHAM STANDARD REPAIR TIME ON BODY WORKS.		550.00	200.00
	THATCHAM TTS STANDARD SPRAY PAINTING COST AND LABOUR.		200.00	180.00
			750.00	380.00
GRAND TOTAL			1,260.72	410.40
RECOMMENDED COST OF LUMP SUM REPAIRS (TO ITS PRE-ACCIDENT CONDITION) (CONFIRMED)				350.00
