REF: NS/2NC17023005 /Kltbn2

## 1. Policy Particulars :- THIRD PARTY CLAIM

THE VEHICLE SUSTAINED DAMAGES AT THE REAR PORTION. DAMAGES SEE DETAILS.
--

### ADJUSTMENT ON REPAIR COST FOR VEHICLE NO. SHC 8041T

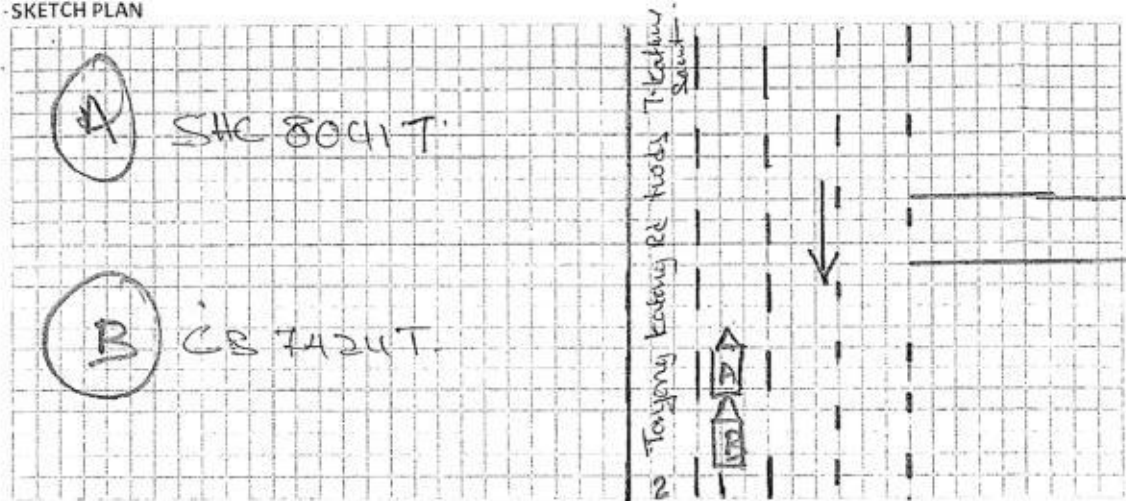
## SKETCH PLAN

ON, 2 Dec 2017 @ 1800 hrs. I

veh A was driving along Tanjong katong rd

twds T-katay South. I veh A was on 1<sup>st</sup> lane.

vehicle. When slow down I veh A also

slow down and stop. Suddenly veh B from

behind hit veh A from behind. at the point of
