1. Policy Particulars :- THIRD PARTY CLAIM

THE VEHICLE SUSTAINED DAMAGES AT THE REAR PORTION.
DAMAGES SEE DETAILS.

ADJUSTMENT ON REPAIR COST FOR VEHICLE NO. SHC 7881S

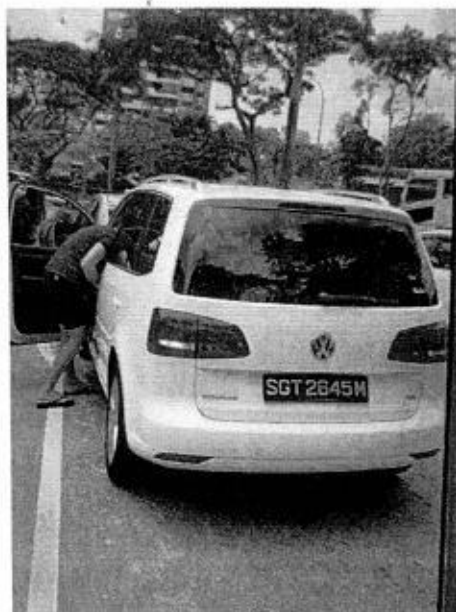
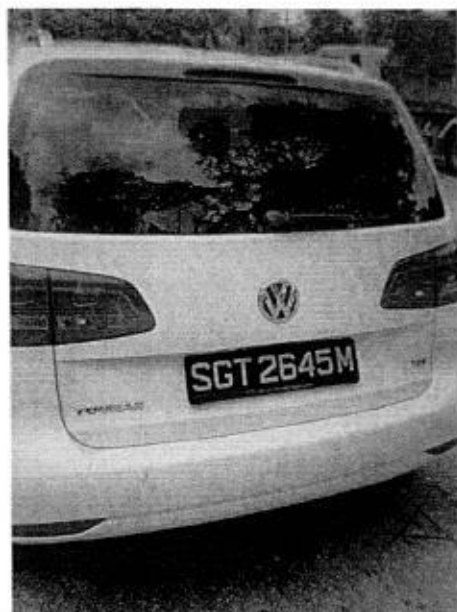
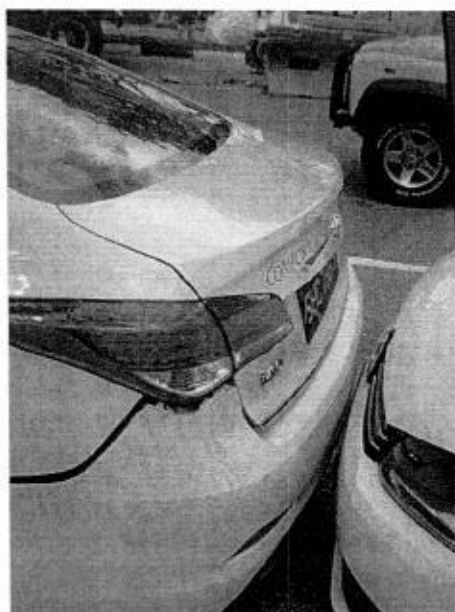
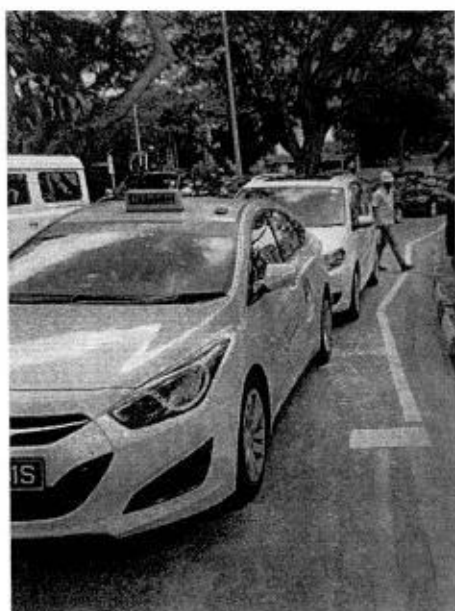
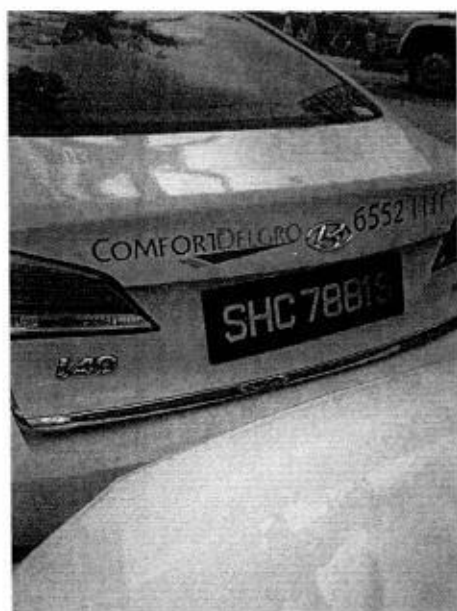
Qty	Description of Parts	Condition	Estimate By Workshop (\$)	Our Adjusted (\$)
REPLACEMENT OF PARTS				
1	REAR BUMPER	DEFORMED	603.60	603.60
1	REAR BUMPER REINFORCEMENT	SERVICEABLE	504.35	-
2	REAR BUMPER REINFORCEMENT BRACKET (LH/RH) @\$180.00	SERVICEABLE	360.00	-
1	REAR BUMPER SIDE BRACKET	SERVICEABLE	49.00	-
10	REAR BUMPER CLIPS	NECESSARY	22.00	22.00
1	REAR BUMPER SPONGE	SERVICEABLE	143.40	-
1	REAR BUMPER UNDER COVER	SERVICEABLE	225.00	-
	LESS 20% DISCOUNT		-381.47	-125.12
			1,525.88	500.48
SPECIAL NETT ITEMS				
1	REAR BUMPER REVERSE SENSOR (SN)	SERVICEABLE	135.70	-
			135.70	-
LABOUR				
	THATCHAM STANDARD REPAIR TIME ON BODY WORKS.		550.00	220.00
	THATCHAM TTS STANDARD SPRAY PAINTING COST AND LABOUR.		200.00	180.00
			750.00	400.00
GRAND TOTAL			2,411.58	900.48
RECOMMENDED COST OF LUMP SUM REPAIRS (TO ITS PRE-ACCIDENT CONDITION) (CONFIRMED)				700.00

ESTIMATED NORMAL PERIOD FOR REPAIR:	2 Working Days
-------------------------------------	----------------
