AUTOMOBILE ASSESSMENT REPORT

Assessment of Vehicle No : PC 2009H
Date of Accident : 27/6/2016
Date of Inspection : 21/7/2016

VEHICLE DAMAGE INSPECTION REPORT

Handling Insurer:	Tokio Marine Insurance Singapore Ltd	Policy No:	MY006079
Claimant Vehicle No :	PC2009H	Insured Vehicle No :	SJU2932T
Date of Loss:	27/06/2016	Nature of Claim:	TP
		Claim No:	M1602866

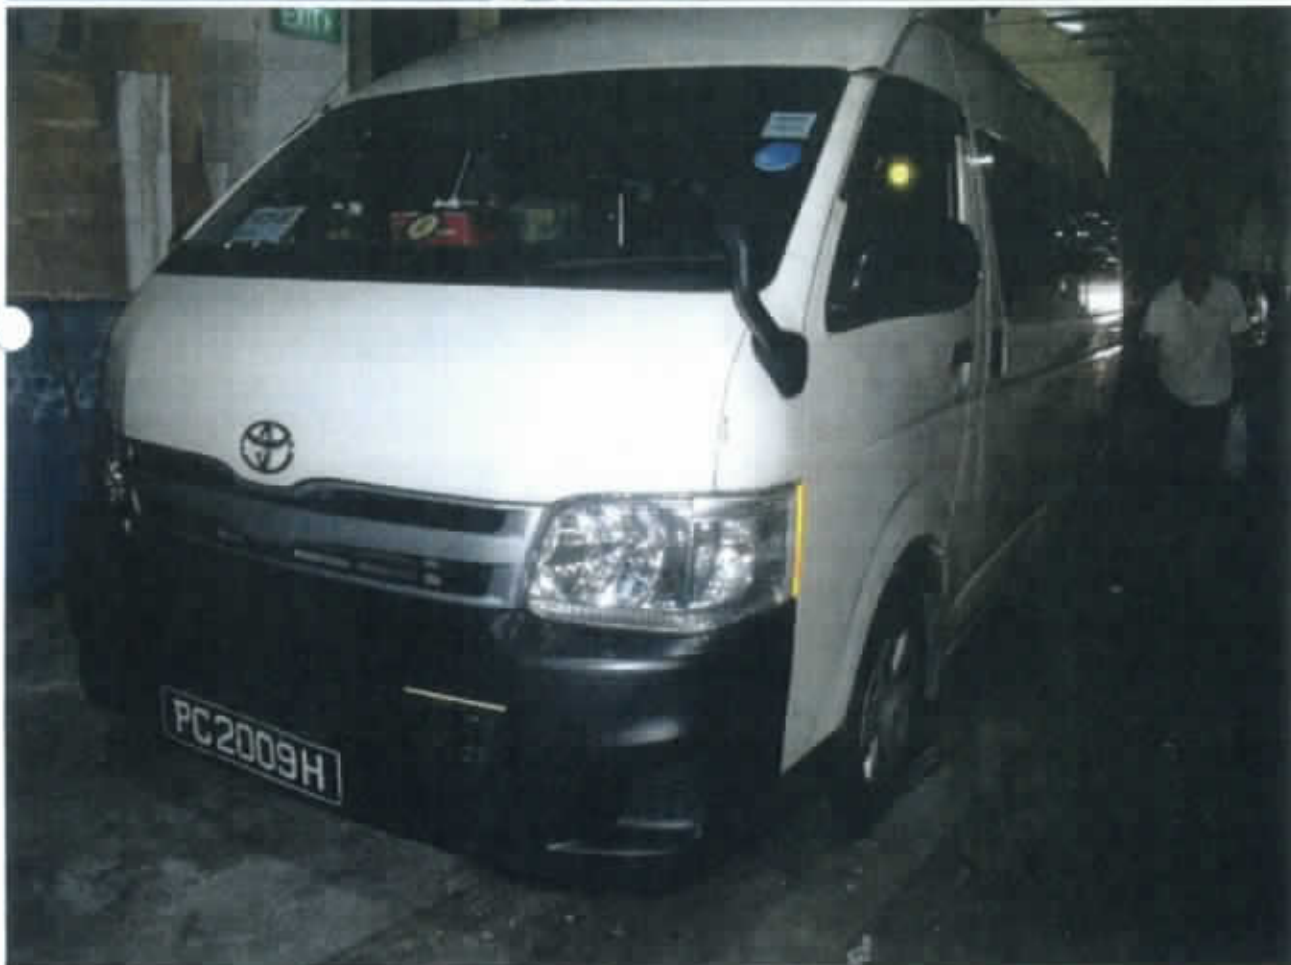
2/7: 2 LHF
GEN VIEW

At the time of inspection observed that this vehicle had sustained damages to the Left side front to rear portion

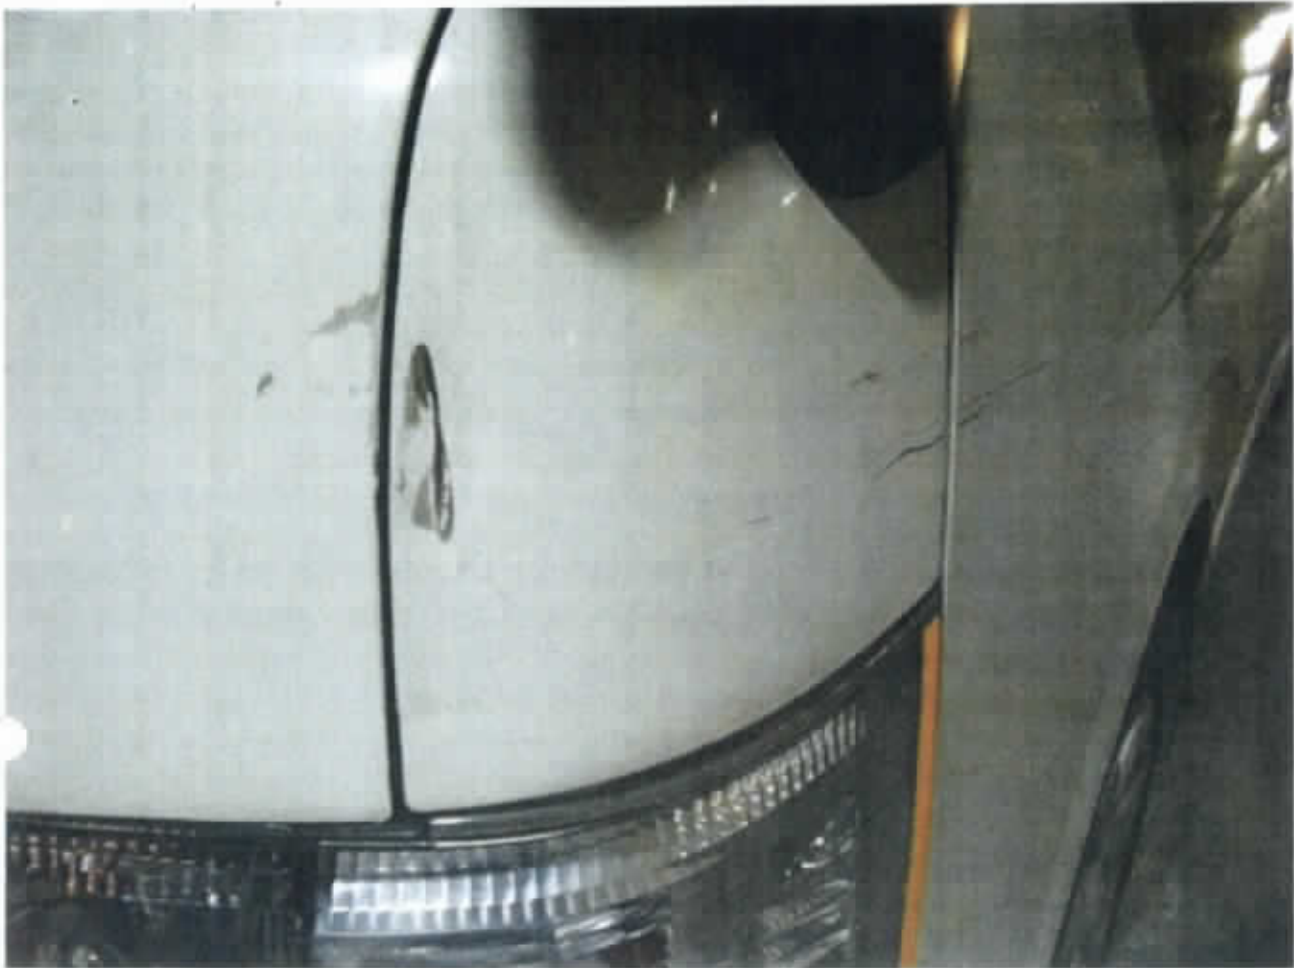
3/7: 3 LHF
CORNER
PANEL/FRT
PANEL

No.	Qty	Part No.	Particulars	Condition	Repairer's	Amount
1	1		*LHF CORNER PANEL	Dented	428.00 FL	*428.00 FL
2	1		*LH HEADLAMP	Grazed	742.00 FL	*742.00 FL
3	1		*LHF VIEW MIRROR ASSY	Grazed	654.00 FL	*654.00 FL
4	1		*LHF DOOR	To repair	0.00 FL	*- FL
5	1		*LHF SHOCK ABSORBER	Not affected	425.90 FL	*- FL
6	1		*LHF KNUCKLE ARM	Not affected	588.00 FL	*- FL
7	1		*LHF WHEEL HUB WITH BEARING	Not affected	549.70 FL	*- FL
8	1		*LHF LOWER ARM	Not affected	673.60 FL	*- FL
9	1		*LHF LOWER BALL JOINT	Not affected	215.80 FL	*- FL
10	1		*LH SLIDING DOOR	Not related	1,680.00 FL	*- FL
11	1		*LH SLIDING DOOR TRIM BOARD	Not related	0.00 FL	*- FL
12	1		*LH SLIDING DOOR TRIM BOARD CLIPS	Not related	25.60 FL	*- FL
13	1		*LH SLIDING DOOR FRONT SENSOR STRIP	Not related	1,055.10 FL	*- FL
14	1		*LH SLIDING DOOR REAR LOCK	Not related	0.00 FL	*- FL
15	1		*LH SLIDING DOOR SLIDE LOCK	Not related	226.60 FL	*- FL
16	1		*LH SLIDING DOOR SLIDE LOCK MOTOR	Not related	673.60 FL	*- FL
