1. Policy Particulars :- THIRD PARTY CLAIM

TP Claims against NTUC Income: Follow-Through Survey

THE VEHICLE SUSTAINED DAMAGES AT THE REAR PORTION. DAMAGES SEE DETAILS.
--

ADJUSTMENT ON REPAIR COST FOR VEHICLE NO. SHC 1351U

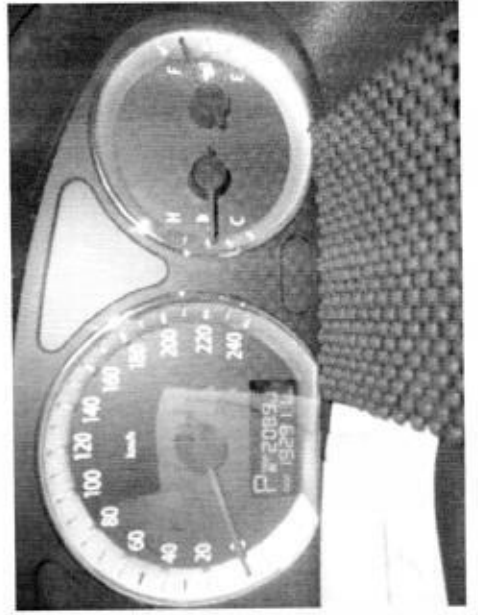
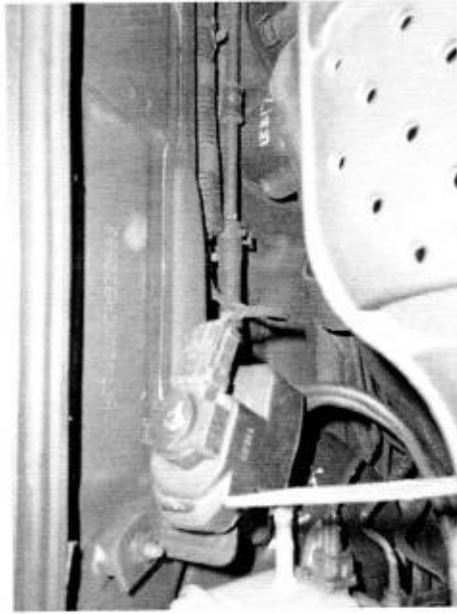
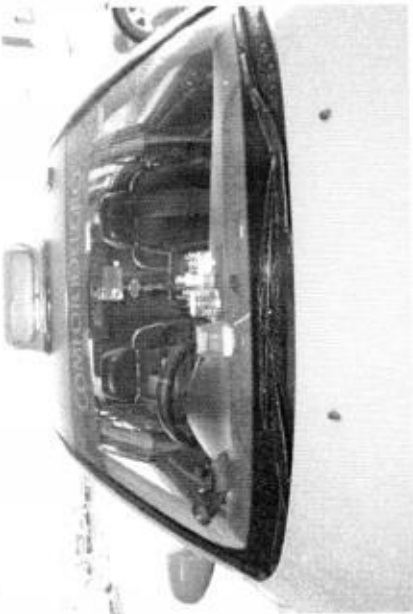
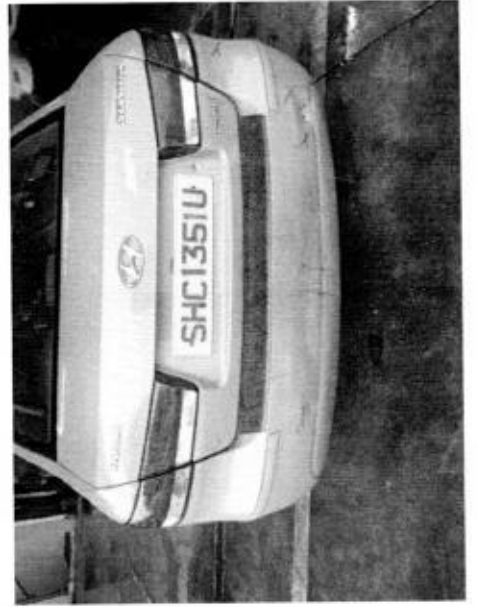
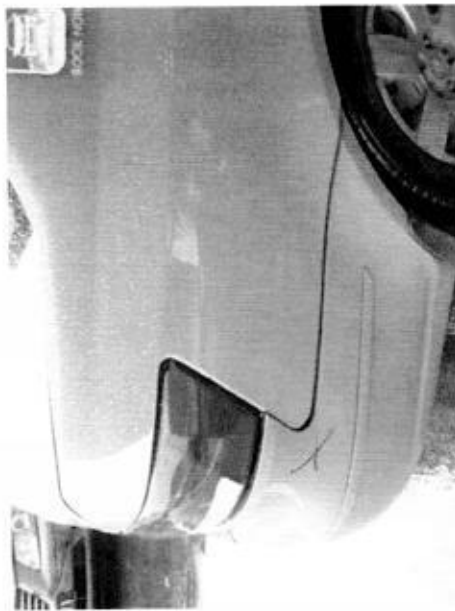
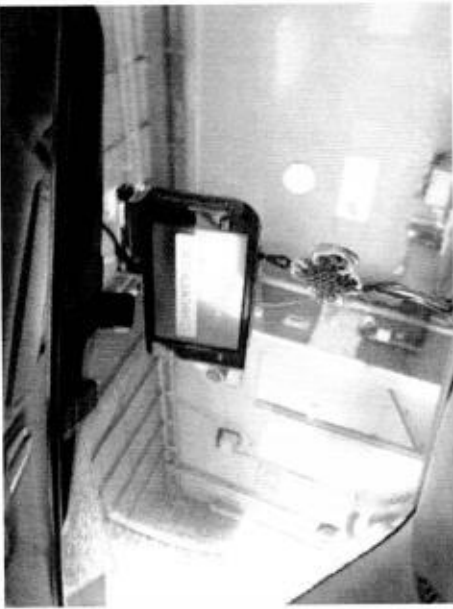
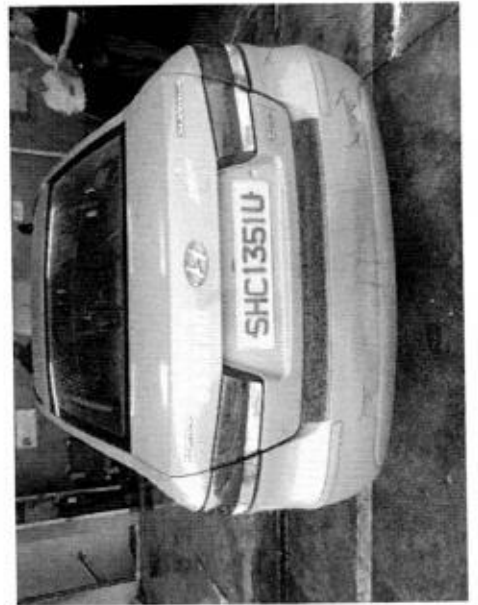
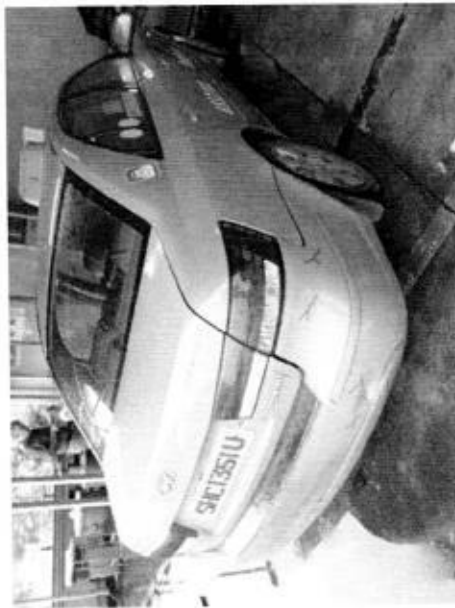
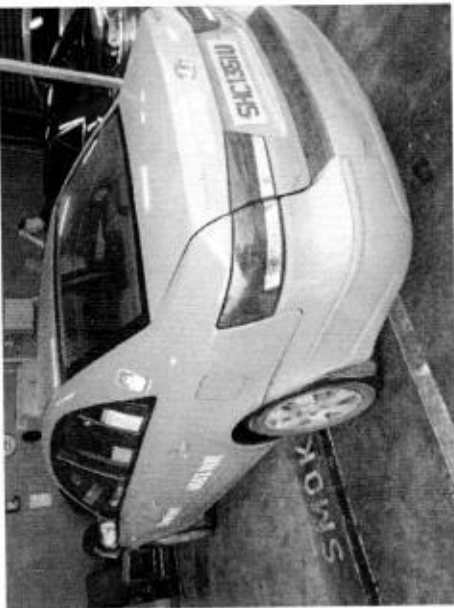
Veh No: SHC 13514 Yr Regn: 5 Apr 2012
 Type: M.Car / M.Cycle / Bus / Van / Lorry / ☒ Taxi / Prime Mover /
 Truck / Trailer or
 Make: Hyundai Santa
 Colour: Blue A/C: ☒ Ins: ☒ Std / NI / NA
 Sp. Reading: 192911 T/Radio: ☒ Ins: ☒ Std / NI / NA
 Eng/No: _____
 C/No: KMHETKUMCA822688
 Gen. Cond: Good / ☒ Poor / Burnt
 Steering: Inord / ☒ Jammed / Leaked / Burnt or
 Brake: Inord / ☒ Jammed / Leaked / Burnt or
 Modi: Nil / S/Rim / STOA/Rim or
 Tyre Size: F: 215/60 R16
 R: _____
 BS / DUN / EXNOVA / GY / FS / LIZA / MIC / OHTSU / PIR / SUMI /
 TOYO / YOKO or Westlake
 Front: _____ Rear: _____
 R/Bal: 7 mm R/Bal: 7 mm
 L/Bal: 7 mm L/Bal: 7 mm
 D.O.A: 3/12/17 D.O.I: 5/12/17
 Survey held at: CDE (17/12/17)
 Des. of Damages: Fnt / Rear / O/S / N/S / U/C / Rooftop or
 Rear
 The U/C / Chassis frame / Body Structure affected due to collision.

Qty	Description of Parts	Condition	Estimate By Workshop (\$)	Our Adjusted (\$)
<u>REPLACEMENT OF PARTS</u>				
1	BOOT LID	TO REPAIR	1,349.50	-
1	BOOT LID RUBBER	SERVICEABLE	110.90	-
1	BOOT LID LOCK UPPER	SERVICEABLE	132.10	-
1	BOOT LID LOCK LOWER	SERVICEABLE	30.30	-
1	BOOT LID SONATA PLATE	NECESSARY	43.60	43.60
1	BOOT LID HYUNDAI PLATE	NECESSARY	24.20	24.20
1	BOOT LID "H" EMBLEM	NECESSARY	26.10	26.10
1	BOOT LID CRDI PLATE	NECESSARY	22.70	22.70
1	REAR BUMPER	DEFORMED	578.40	578.40
1	REAR BUMPER REINFORCEMENT	SERVICEABLE	483.30	-
10	REAR BUMPER CLIP	NECESSARY	22.00	22.00
1	REAR BUMPER SPONGE	SERVICEABLE	137.40	-
1	REAR BUMPER UNDER COVER	SERVICEABLE	185.80	-
	LESS 20% DISCOUNT		-629.26	-143.40
			2,517.04	573.60
<u>SPECIAL NETT ITEMS</u>				
1	BOOT LID COMFORT LOGO & TEL NO STICKER (SN)	NECESSARY	30.00	30.00

30.00	30.00
<u>LABOUR</u>				
	THATCHAM STANDARD REPAIR TIME ON BODY WORKS.		560.00	200.00
	THATCHAM TTS STANDARD SPRAY PAINTING COST AND LABOUR.		400.00	360.00

-		-	-
	-		-	-
	-		-	-
			960.00	560.00
GRAND TOTAL			3,507.04	1,163.60
RECOMMENDED COST OF LUMP SUM REPAIRS (TO ITS PRE-ACCIDENT CONDITION) (CONFIRMED)				900.00
