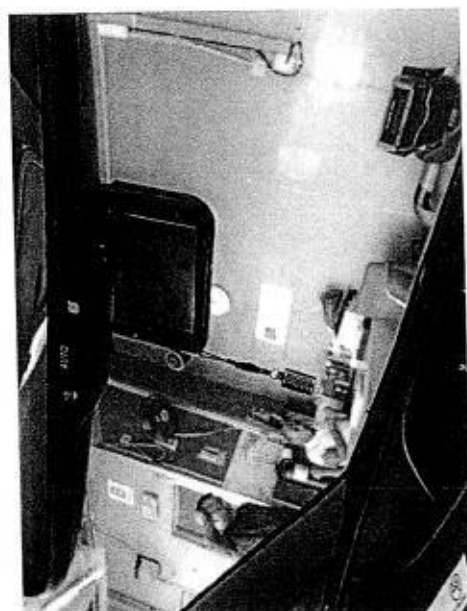
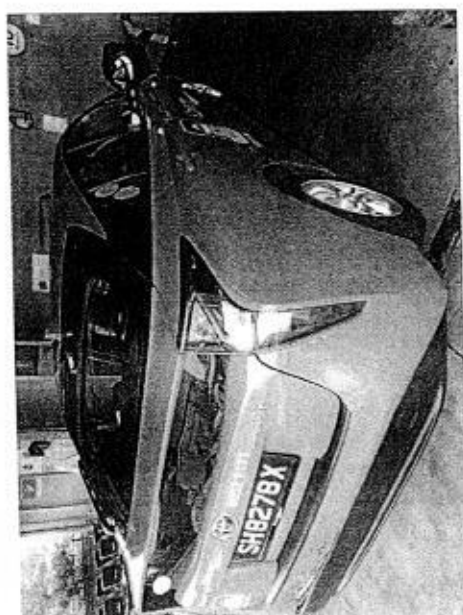
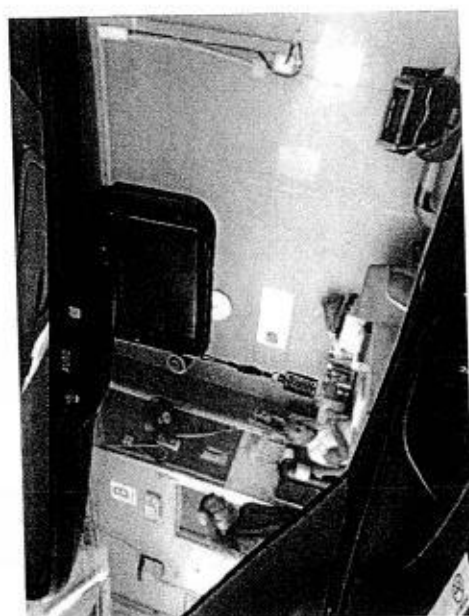
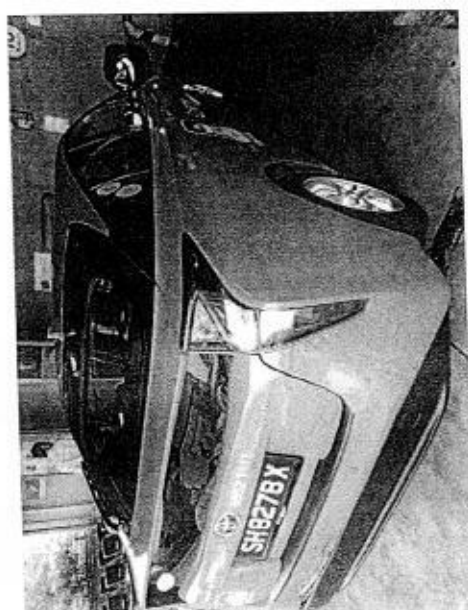
THE VEHICLE SUSTAINED DAMAGES AT THE REAR N/S PORTION. DAMAGES SEE DETAILS.
--

Qty	Description of Parts	Condition	Estimate By Workshop (\$)	Our Adjusted (\$)
<b>REPLACEMENT OF PARTS</b>				
1	REAR BUMPER	DEFORMED	458.60	458.60
1	REAR BUMPER RE-INFORCEMENT	SERVICEABLE	318.80	-
1	REAR BUMPER UNDER COVER	DEFORMED	552.60	552.60
1	REAR BUMPER SIDE RETAINER	SERVICEABLE	112.70	-
1	REAR BUMPER SPONGE	NOT NECESSARY	143.40	-
1	REAR BUMPER UNDER SIDE COVER (LH)	TO REPAIR	232.00	-
10	REAR BUMPER CLIPS	NECESSARY	22.00	22.00
	LESS 25% DISCOUNT		-460.02	-258.30
			1,380.08	774.90
<b>SPECIAL NETT ITEMS</b>				
1	REAR BUMPER REVERSE SENSOR (SN)	SHORTED	135.70	135.70
1	REAR BUMPER RUBBER MAT (SN)	NECESSARY	50.00	50.00

185.70	185.70
<b>LABOUR</b>				
	THATCHAM STANDARD REPAIR TIME ON BODY WORKS.		520.00	220.00
	THATCHAM TTS STANDARD SPRAY PAINTING COST AND LABOUR.		200.00	180.00

720.00	400.00
<b>GRAND TOTAL</b>			<b>2,285.78</b>	<b>1,360.60</b>
<b>RECOMMENDED COST OF REPAIRS (CONFIRMED)</b>				<b>1,360.60</b>
