## 1. Policy Particulars :- THIRD PARTY CLAIM

## 4. Description of Damages

| THE VEHICLE SUSTAINED DAMAGES AT THE REAR PORTION.<br>DAMAGES SEE DETAILS. |

## ADJUSTMENT ON REPAIR COST FOR VEHICLE NO. SLM 6885M

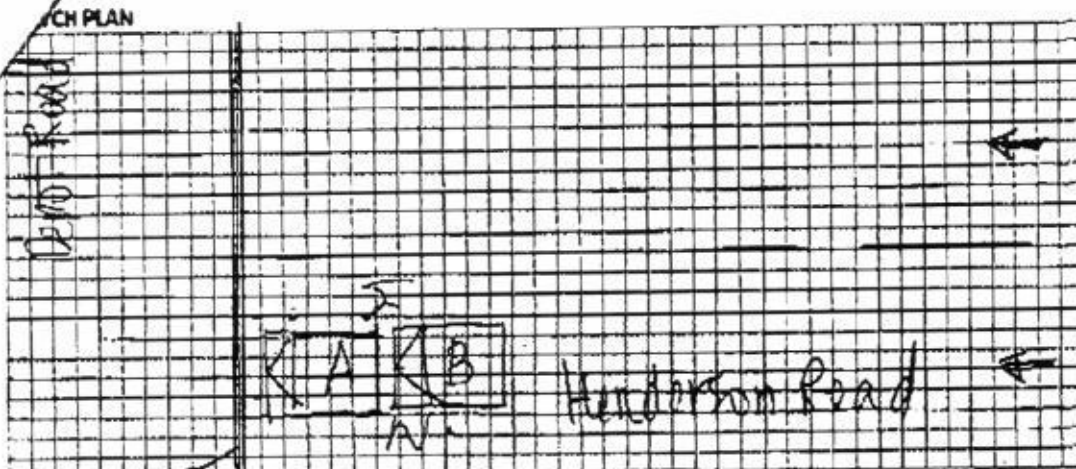
## Sketch Plan #2

On 05/12/17 at about 8:55am, I was driving  
 on Henderson Road on the left lane. My vehicle was stationary. <sup>traffic light was red so</sup>  
 Suddenly vehicle B which was behind me started to  
 move and hit the rear of my vehicle A.
