NTU	C INCOME INSUR	ANCE CO-OPERATIVE LTD	Ref:	NS/INC1702324	19/K1vb
		O JINION HOUSESINGAPORE	Date:	07-12-2017 INC4	
1.		Policy Particulars	:- THIR	PARTY CLAIM	
	Insured Veh.	FBJ 730A	Veh. Ir	spected	SHB 4355U
	Policy No.	5076279658-01	Cover	age (\$)	0.00
	Claim No.		Exces	s (\$)	0.00
	Assign From		Assig	n Date	06/12/2017

TP Claims against NTUC Income: Follow-Through Survey

VEHICLE NO: SHB 4355U

ADJUSTMENT ON REPAIR COST FOR VEHICLE NO. SHB 4355U

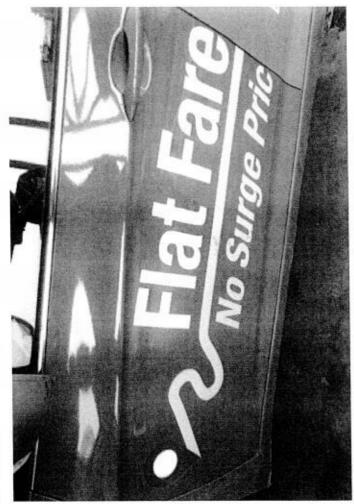
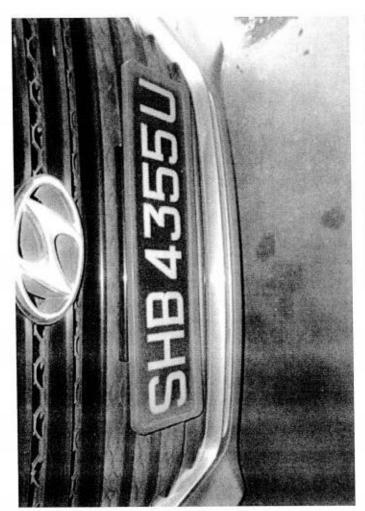
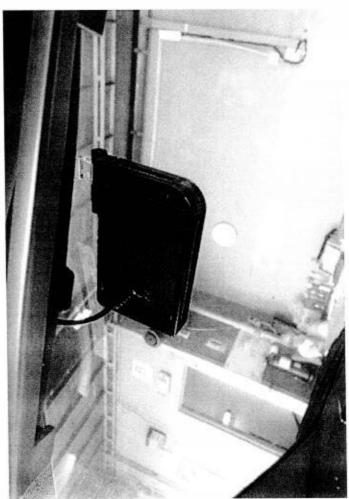
Description of Parts	Condition	Estimate By Workshop (\$)	Our Adjusted (\$)
REPLACEMENT OF PARTS		1.3.7	(*/
FRONT DOOR MIRROR (LH)	BROKEN	980.50	980.50
LESS 20% DISCOUNT		-196.10	-196.10

784.40	784.40
SPECIAL NETT ITEMS			
FRONT DOOR COLOURED COMFORT LOGO (LH)(SN)	NOT NECESSARY	75.00	72
FROTN DOOR ADVERTISEMENT LOGO (LH)(SN)	NOT NECESSARY	100.00

175.00	7.
LABOUR			
THATCHAM STANDARD REPAIR TIME ON BODY WORKS.		300.00	120.00
THATCHAM TTS STANDARD SPRAY PAINTING COST AND LABOUR.		300.00	50.00
		600.00	170.00
GRAND TOTAL		1,559.40	954.40
	REPLACEMENT OF PARTS FRONT DOOR MIRROR (LH) LESS 20% DISCOUNT SPECIAL NETT ITEMS FRONT DOOR COLOURED COMFORT LOGO (LH)(SN) FROTN DOOR ADVERTISEMENT LOGO (LH)(SN) LABOUR THATCHAM STANDARD REPAIR TIME ON BODY WORKS. THATCHAM ITS STANDARD SPRAY PAINTING COST AND LABOUR.	REPLACEMENT OF PARTS FRONT DOOR MIRROR (LH) LESS 20% DISCOUNT SPECIAL NETT ITEMS FRONT DOOR COLOURED COMFORT LOGO (LH)(SN) FROTN DOOR ADVERTISEMENT LOGO (LH)(SN) LABOUR THATCHAM STANDARD REPAIR TIME ON BODY WORKS. THATCHAM ITS STANDARD SPRAY PAINTING COST AND LABOUR.	REPLACEMENT OF PARTS FRONT DOOR MIRROR (LH) LESS 20% DISCOUNT SPECIAL NETT ITEMS FRONT DOOR COLOURED COMFORT LOGO (LH)(SN) FROTN DOOR ADVERTISEMENT LOGO (LH)(SN) NOT NECESSARY 100.00 175.00 LABOUR THATCHAM STANDARD REPAIR TIME ON BODY WORKS. THATCHAM TTS STANDARD SPRAY PAINTING COST AND LABOUR. 600.00
