NTUC INCOME INSURANCE CO-OPERATIVE LTD Ref: NS/INC17023251/K1vb

### 1. Policy Particulars :- THIRD PARTY CLAIM

**ADJUSTMENT ON REPAIR COST FOR VEHICLE NO. SHC 3205X**

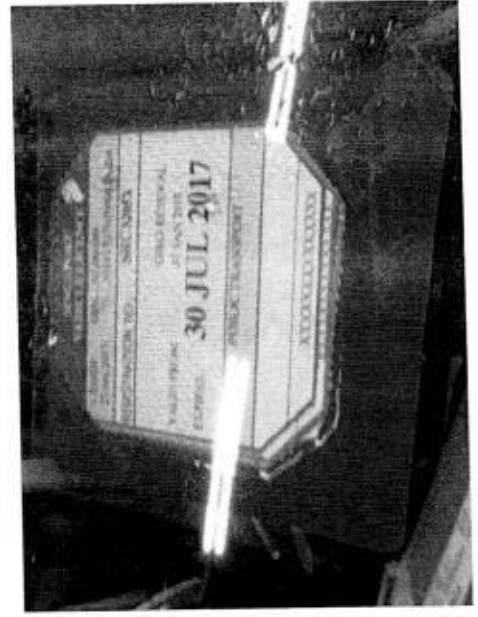
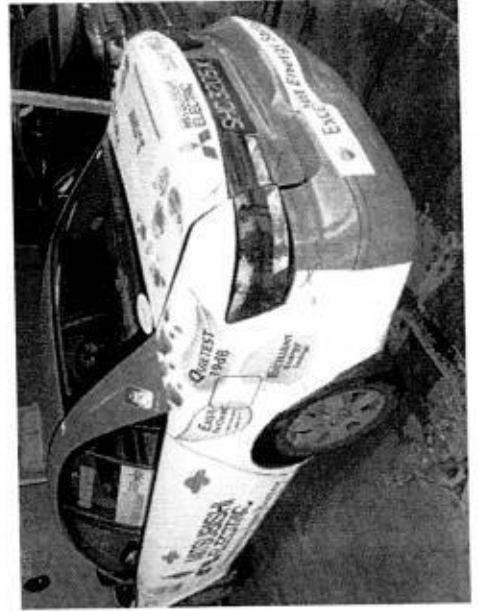
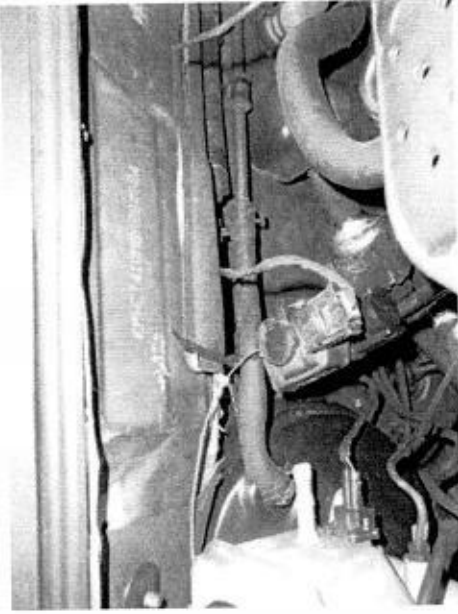
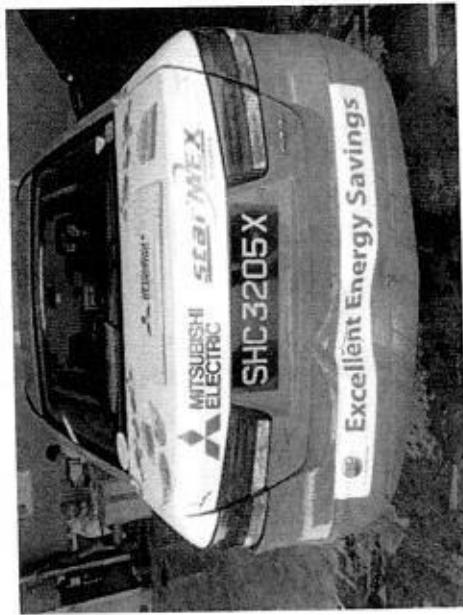
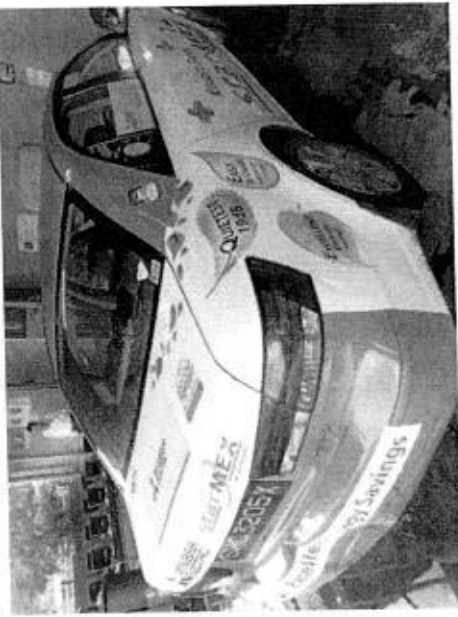
THE VEHICLE SUSTAINED DAMAGES AT THE REAR PORTION.

DAMAGES SEE DETAILS.

Qty	Description of Parts	Condition	Estimate By Workshop (\$)	Our Adjusted (\$)
<b><u>REPLACEMENT OF PARTS</u></b>				
1	BOOT LID	DENTED	1,349.50	1,349.50
1	BOOT LID RUBBER	SERVICEABLE	110.90	-
1	BOOT LID LOCK UPPER	CRACKED	132.10	132.10
1	BOOT LID LOCK LOWER	SERVICEABLE	30.30	-
1	BOOT LID SONATA PLATE	NECESSARY	43.60	43.60
1	BOOT LID HYUNDAI PLATE	NECESSARY	24.20	24.20
1	BOOT LID "H" EMBLEM	NECESSARY	26.10	26.10
1	BOOT LID CRDI PLATE	NECESSARY	22.70	22.70
1	REAR BUMPER	DEFORMED	578.40	578.40
1	REAR BUMPER REINFORCEMENT	CRACKED	483.30	483.30
10	REAR BUMPER CLIP	NECESSARY	22.00	22.00
1	REAR BUMPER SPONGE	TORN	137.40	137.40
1	REAR BUMPER UNDER COVER	SERVICEABLE	185.80	-
2	REAR BUMPER PROTECTOR (LH/RH) @\$38.00	TO REPAIR	76.00	-
1	REAR PANEL	TO REPAIR	391.80	-
1	REAR PANEL GARNISH	SERVICEABLE	95.80	-
	LESS 20% DISCOUNT		-741.98	-563.86
			2,967.92	2,255.44
<b><u>SPECIAL NETT ITEMS</u></b>				
1	BOOT LID COMFORT LOGO & TEL NO STICKER (SN)	NECESSARY	30.00	30.00

GRAND TOTAL		5,053.62	3,651.14
RECOMMENDED COST OF LUMP SUM REPAIRS (TO ITS PRE-ACCIDENT CONDITION) (CONFIRMED)			2,900.00
