1. Policy Particulars :- THIRD PARTY CLAIM

SINGAPORE ACCIDENT STATEMENT

SMRT Accident Vehicle Repair Estimates

ADJUSTMENT ON REPAIR COST FOR VEHICLE NO. SMB 3141S

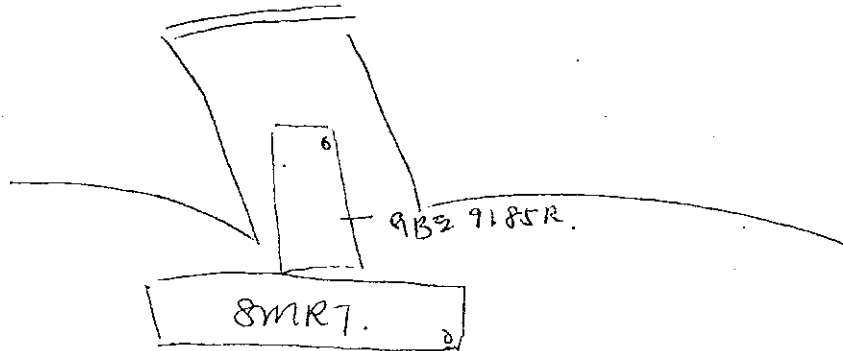
SKETCH PLAN

Bus while traveling along Kallang Bahru rd before bus stop(Bs:60039) opp Blk 66, a lorry (GBE9185R) that had turn left and stopped at the SP PowerGrip building entrance suddenly reversing his vehicle and side-swiped the left body of the bus. For the alleged accident nobody was injured.
