REF: NS/CNC17023386/Klvb n2

Insured Veh.	SJL 8592Z	Veh. Inspected	SHB 4898U
Policy No.	5067588920-02	Coverage (\$)	0.00
Claim No.	MT/0972754-002	Excess (\$)	0.00
Assign From		Assign Date	08/12/2017

THE VEHICLE SUSTAINED DAMAGES AT THE N/S BODY. DAMAGES SEE DETAILS.
--

ADJUSTMENT ON REPAIR COST FOR VEHICLE NO. SHB 4898U

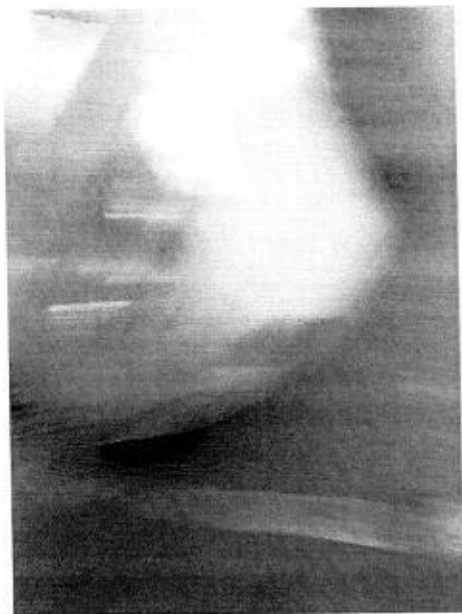
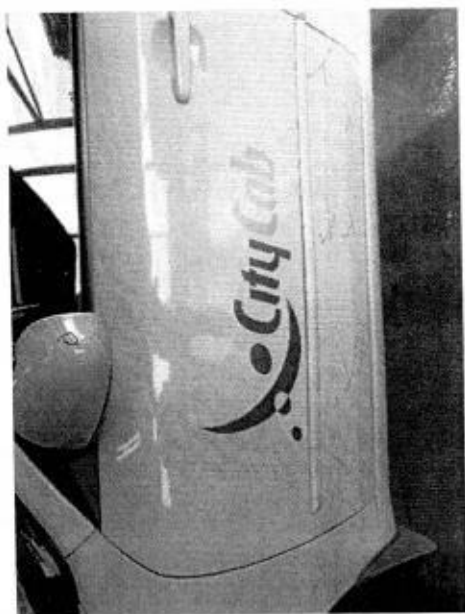
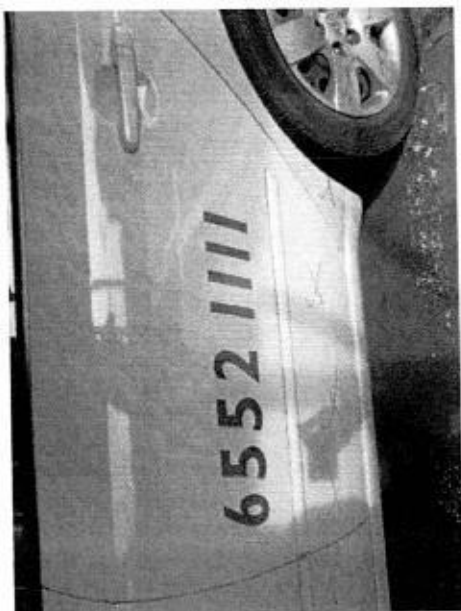
Qty	Description of Parts	Condition	Estimate By Workshop (\$)	Our Adjusted (\$)
REPLACEMENT OF PARTS				
1	FRONT BUMPER COVER	DEFORMED	538.80	538.80
1	FRONT DOOR PROTECTOR (LH)	TO REPAIR	78.25	-
1	FRONT WHEEL RIM (LH)	BENT	284.70	284.70
2	FRT & REAR WHEEL HUB CAP @\$150.70	GRAZED	301.40	301.40
2	LH FRONT & REAR DOOR (NPA)	TO REPAIR	-	-
2	LH FRONT & REAR FENDER (NPA)	TO REPAIR	-	-
1	REAR BUMPER (NPA)	TO REPAIR	-	-
	LESS 20% DISCOUNT		-240.63	-224.98

292.00	188.50
LABOUR				
	THATCHAM STANDARD REPAIR TIME ON BODY WORKS.		720.00	400.00
	THATCHAM TTS STANDARD SPRAY PAINTING COST AND LABOUR.		1,200.00	1,080.00
			1,920.00	1,480.00
GRAND TOTAL			3,174.52	2,568.42
RECOMMENDED COST OF LUMP SUM REPAIRS (TO ITS PRE-ACCIDENT CONDITION) (CONFIRMED)				2,050.00
