Preliminary Advice

Vehicle No	: SGG9672G	Accident Date	: 07/12/2017
Make	: HONDA CIVIC	Policy No.	: DMPCSN3043821606
Assignment Date	: 11/12/2017	Excess	: S\$0.00
Date of Inspection	: 12/12/2017	Est. Duration of Repair	: 5.00
Inspection At	: CAR CITY AUTO CENTRE PTE LTD (HQ) BLK 9006 #01-198, TAMPINES STREET 93 SINGAPORE 528840

The vehicle sustained impact / damages o/s portion and parts claimed are consistent to the accident.

VEHICLE DAMAGE INSPECTION REPORT

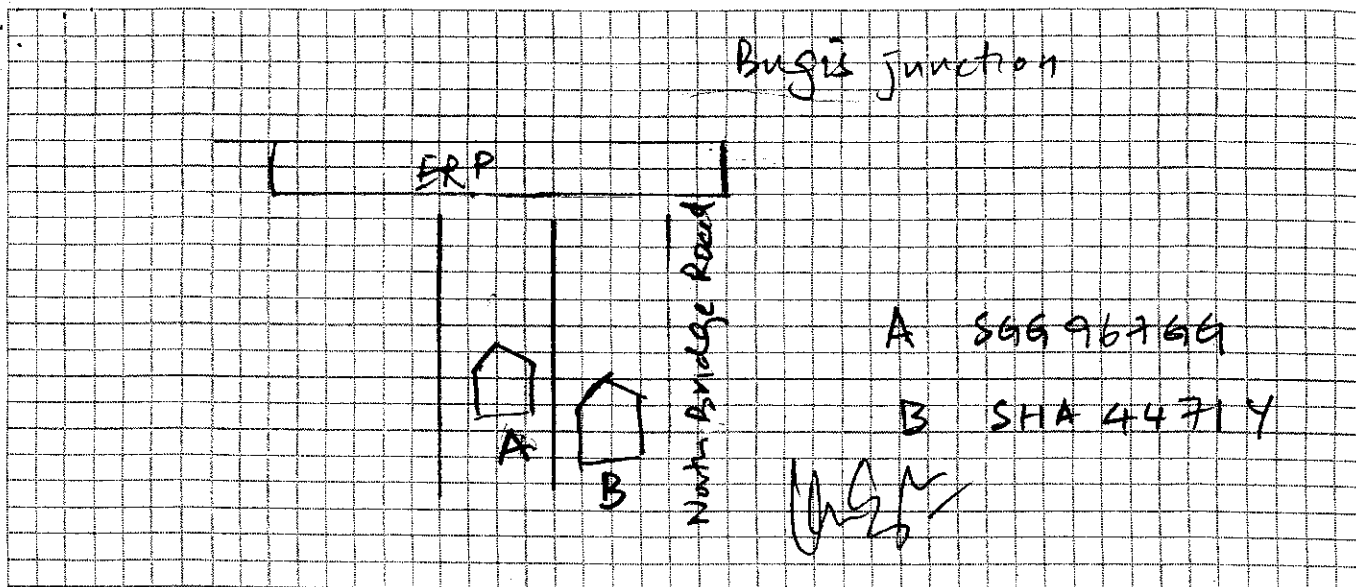
SKETCH PLAN

On 7 Dec about 6:30 pm I was driving along North Bridge Road towards Bugis junction. When I ~~was~~ filter right, car B ~~came~~ was driving on my right side and the ~~two~~ car A hit car B. As a result, right side mirror of car A and bumper was scratched. For car B, left side mirror was affected plus some minor scratches at the left front.
