NTUC INCOME INSURANCE CO-OPERATIVE LTD Ref: NS/INC17023509/K1qbs2

1. Policy Particulars :- THIRD PARTY CLAIM

Insured Veh.	SJV 6367T	Veh. Inspected	SH 6306L
Policy No.	5068883728-03	Coverage (\$)	0.00
Claim No.	MT/0972998-002	Excess (\$)	0.00
Assign From		Assign Date	11/12/2017

ADJUSTMENT ON REPAIR COST FOR VEHICLE NO. SH 6306L

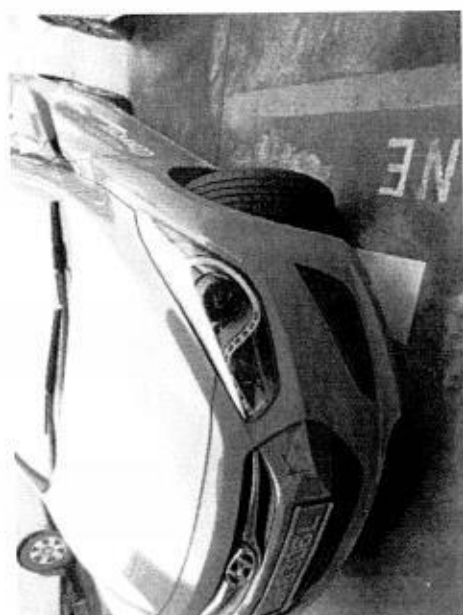
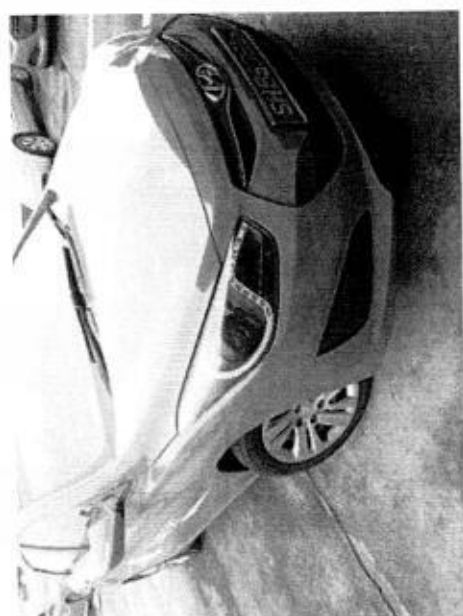
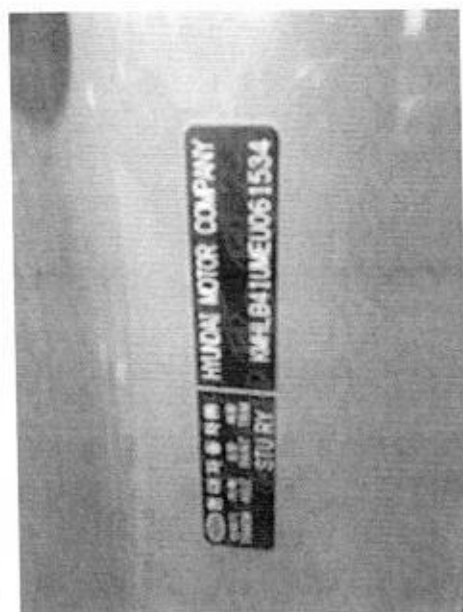
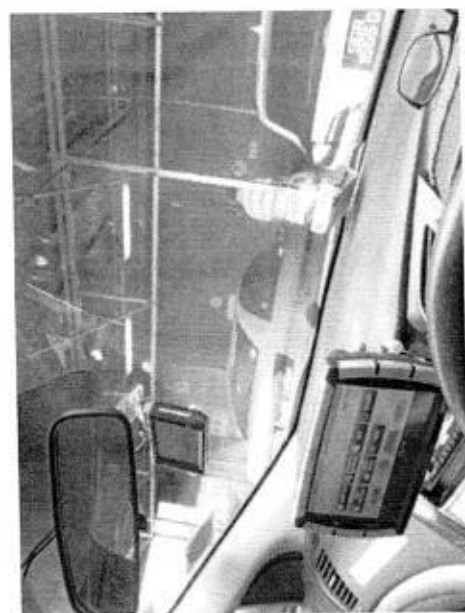
THE VEHICLE SUSTAINED DAMAGES AT THE FRONT PORTION.
DAMAGES SEE DETAILS.

Qty	Description of Parts	Condition	Estimate By Workshop (\$)	Our Adjusted (\$)
<u>REPLACEMENT OF PARTS</u>				
1	RADIATOR GRILLE	SERVICEABLE	294.35	-
1	RADIATOR GRILLE H EMBLEM	SERVICEABLE	113.65	-
1	FRONT BUMPER COVER	TO REPAIR	562.30	-
1	FRONT BUMPER SPONGE	SERVICEABLE	142.20	-
1	FRONT BUMPER REINFORCEMENT	SERVICEABLE	526.10	-
1	FRONT BUMPER CENTRE GRILLE	SERVICEABLE	176.90	-
2	FRONT BUMPER BRACKET TOP (LH/RH) @\$22.40	SERVICEABLE	44.80	-
2	FRONT BUMPER RETAINER MOUNTING @\$9.20	SERVICEABLE	18.40	-
	LESS 20% DISCOUNT		-375.74	-
			1,502.96	-
<u>SPECIAL NETT ITEMS</u>				
1	FRONT NUMBER PLATE (SN)	GRAZED	25.00	25.00
1	FRONT NO PLATE TRIM COVER (SN)	SERVICEABLE	30.00	-

55.00	25.00
<u>LABOUR</u>				
	THATCHAM STANDARD REPAIR TIME ON BODY WORKS.		550.00	-
	THATCHAM TTS STANDARD SPRAY PAINTING COST AND LABOUR.		200.00	200.00

750.00	200.00
GRAND TOTAL			2,307.96	225.00
RECOMMENDED COST OF REPAIRS (CONFIRMED)				225.00
