CS/CT117023553/KH022

GT 3720Y

Claim : Third Party Claim
Veh. No : GT 3720 Y
Model : NISSAN NV 200
Insured Ins: NTUC INS

VEHICLE DAMAGE INSPECTION REPORT**Our File No:** CS/CT117023553/KTBE2**Date:** 07/03/2018**REFERENCE**

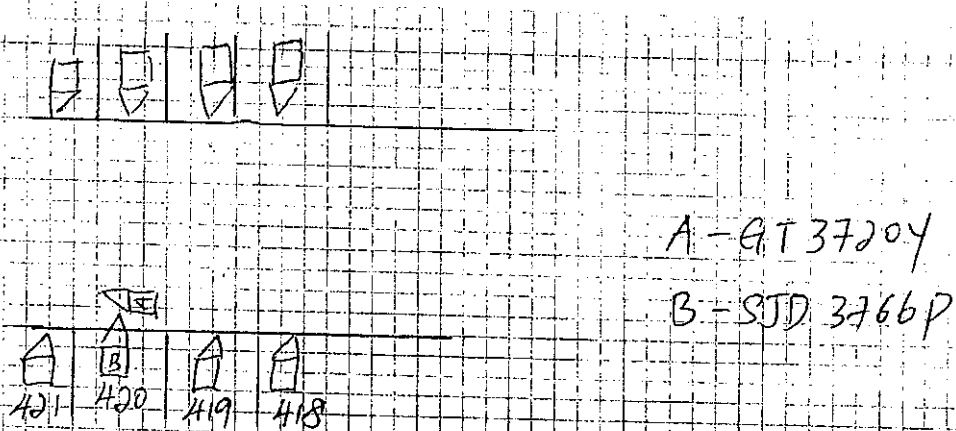
SKETCH PLAN

I WAS driving straight, suddenly SJD 3766P come
420
out from parking lot and never check his right and
the left of
hit onto my vehicle GT 37204.
