A member of COMFORTDELGRO

NTUC INCOME INSURANCE CO-OPERATIVE LTD Ref: NS/INC17023615/K1qbn2

1. Policy Particulars :- THIRD PARTY CLAIM

ADJUSTMENT ON REPAIR COST FOR VEHICLE NO. SHC 1446E

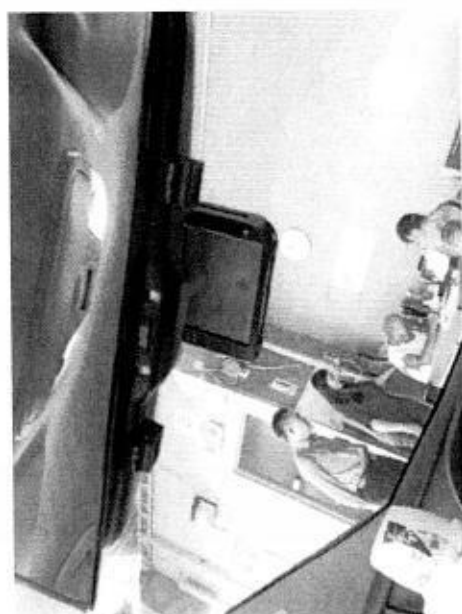
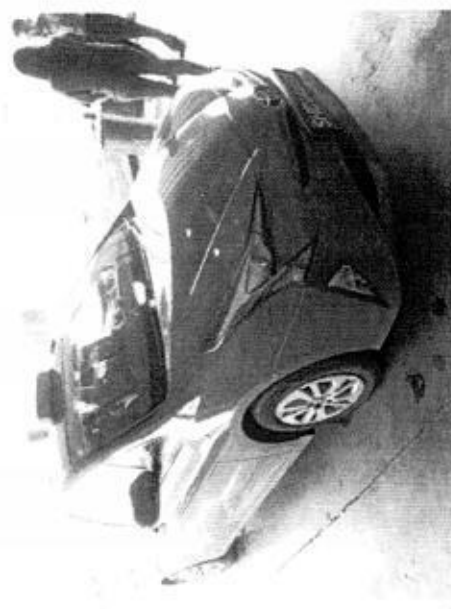
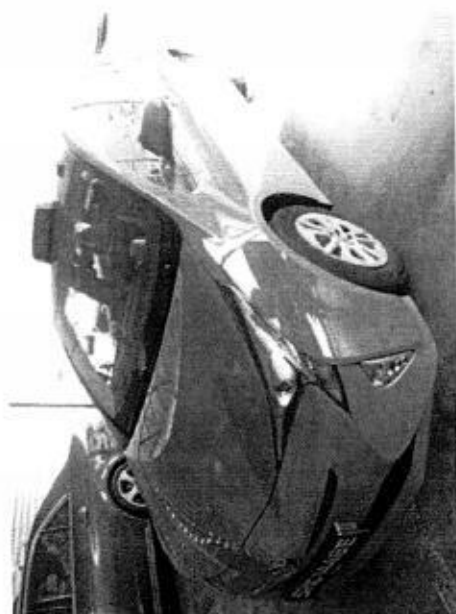
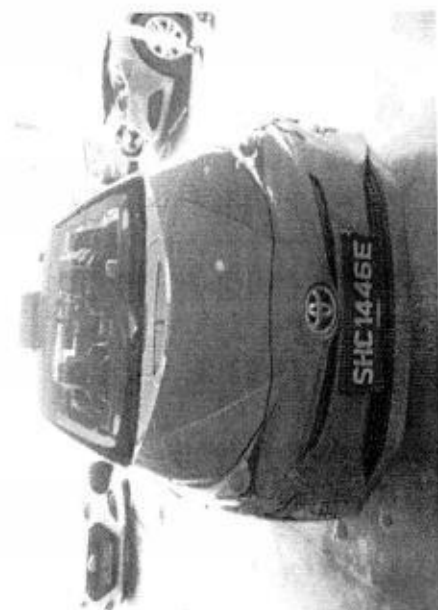
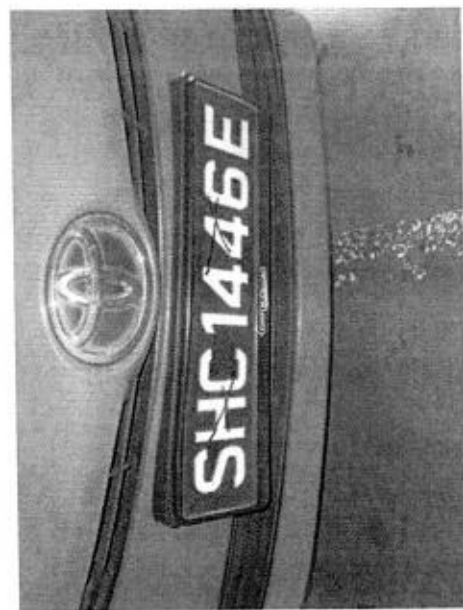
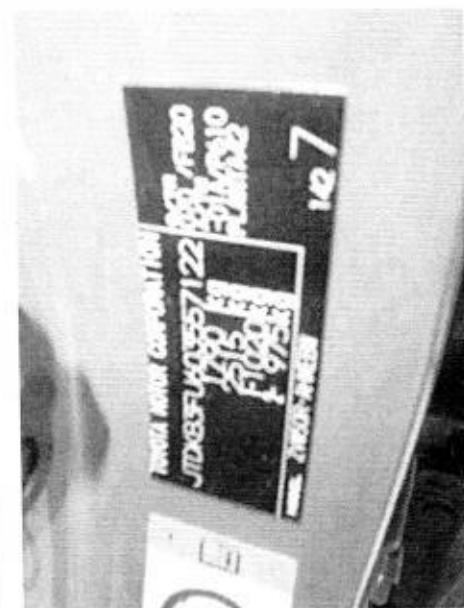
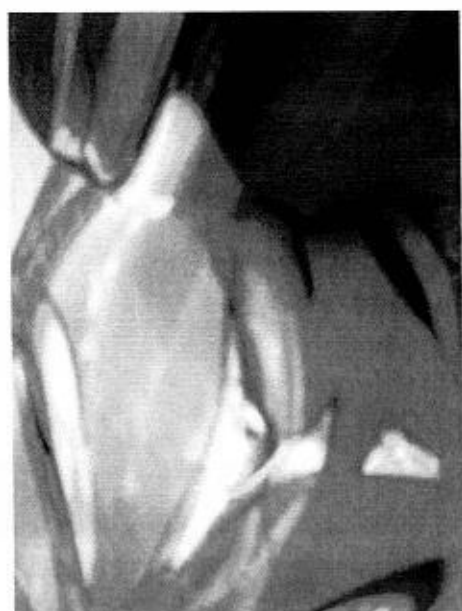
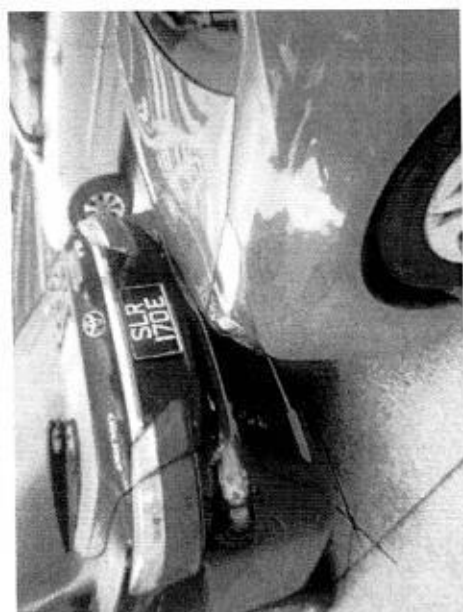
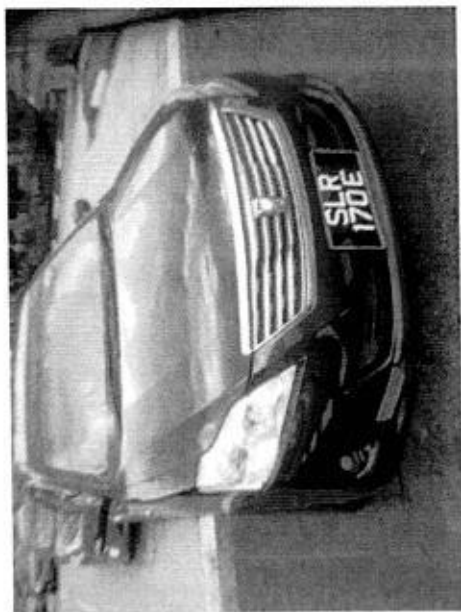
THE VEHICLE SUSTAINED DAMAGES AT THE FRONT PORTION. DAMAGES SEE DETAILS.

Qty	Description of Parts	Condition	Estimate By Workshop (\$)	Our Adjusted (\$)
<u>REPLACEMENT OF PARTS</u>				
1	FRONT BUMPER COVER	TO REPAIR	490.50	-
	LESS 20% DISCOUNT		-98.10	-
	LESS 25% DISCOUNT		-	-
			392.40	-
1	FRONT NO PLATE GARNISH	CRACKED	99.00	99.00
	LESS 25% DISCOUNT		-	-24.75
			99.00	74.25
<u>SPECIAL NETT ITEMS</u>				
1	FRT NUMBER PLATE (SN)	DENTED	25.00	25.00
1	LICENSE PLATE TRIM COVER (SN)	SERVICEABLE	30.00	-
1	FRONT BUMPER LOGO (SN)	NOT NECESSARY	87.10	-
			142.10	25.00
<u>LABOUR</u>				
	THATCHAM STANDARD REPAIR TIME ON BODY WORKS.		400.00	200.00
	THATCHAM TTS STANDARD SPRAY PAINTING COST AND LABOUR.		200.00	180.00
			600.00	380.00
GRAND TOTAL			1,233.50	479.25

RECOMMENDED COST OF REPAIRS (CONFIRMED)			479.25
--	--	--	---------------
