## National Assessment Centre Services

Insured Veh.	SKU 8437E	Veh. Inspected	SHC 3019S
Policy No.	5092414844	Coverage (\$)	0.00
Claim No.	MT/0973342-002	Excess (\$)	0.00
Assign From		Assign Date	13/12/2017

### 4. Description of Damages

**ADJUSTMENT ON REPAIR COST FOR VEHICLE NO. SHC 3019S**

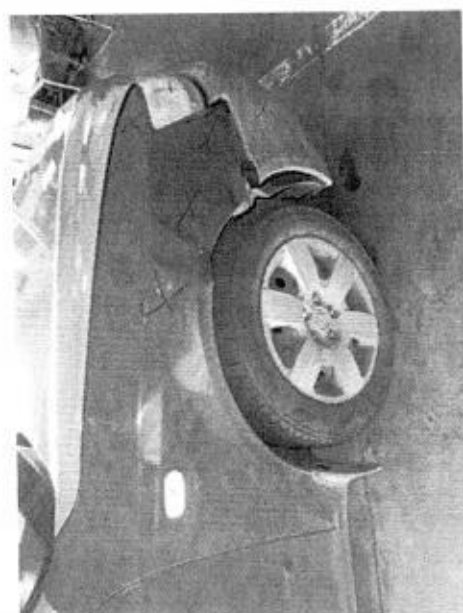
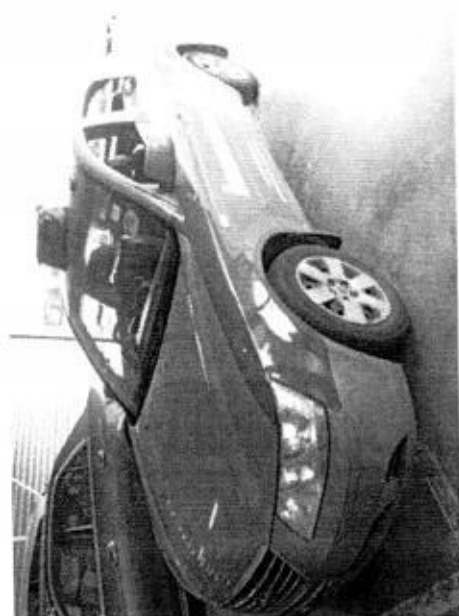
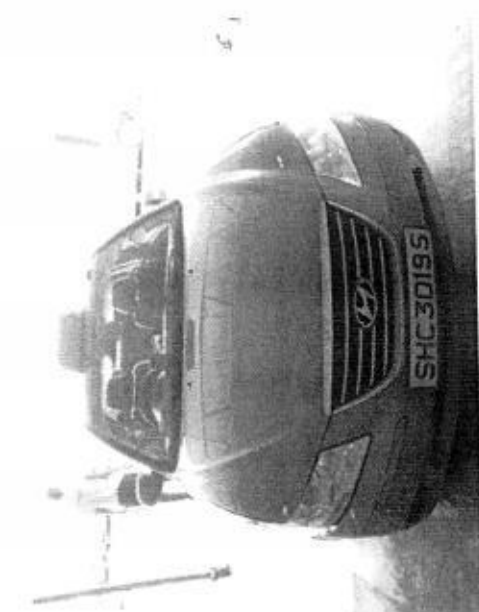
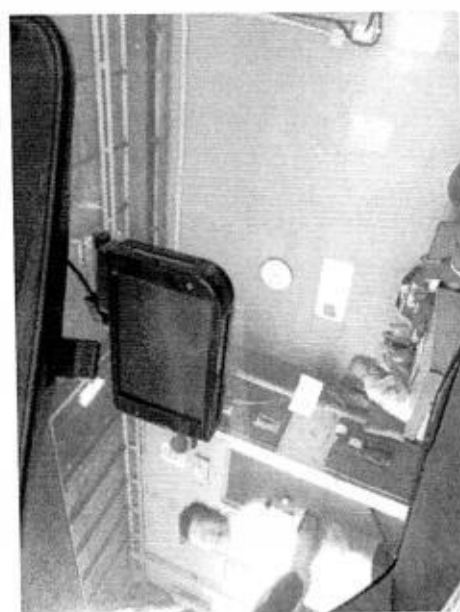
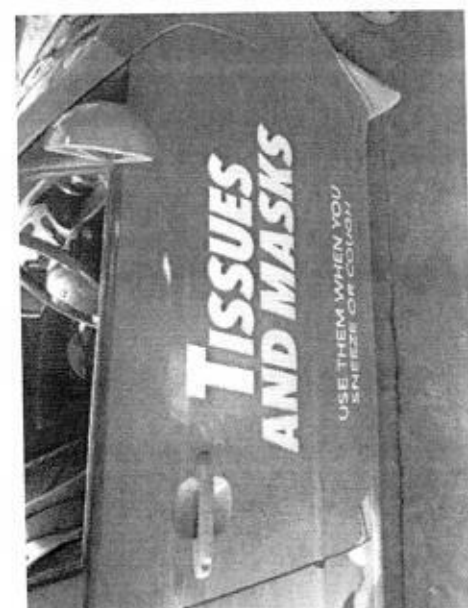
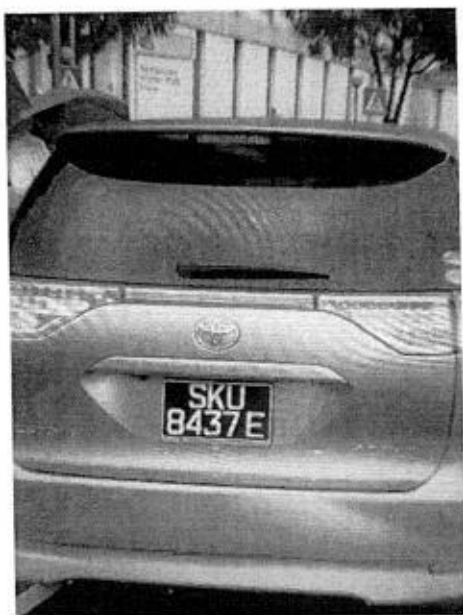
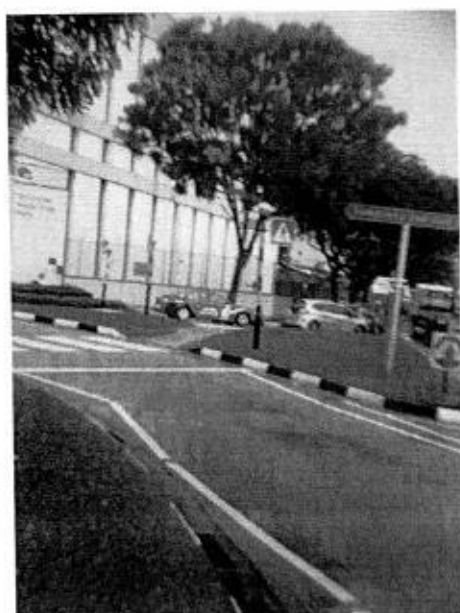
THE VEHICLE SUSTAINED DAMAGES AT THE O/S FRONT PORTION. DAMAGES SEE DETAILS.
---

Qty	Description of Parts	Condition	Estimate By Workshop (\$)	Our Adjusted (\$)
<b>REPLACEMENT OF PARTS</b>				
1	FRONT BUMPER COVER	DEFORMED	538.80	538.80
1	FRONT BUMPER PROTECTOR (RH)	CUT	29.20	29.20
1	FRONT BUMPER BRACKET (RH)	SERVICEABLE	20.10	-
1	HEADLAMP SUPPORT PANEL ASSY	SERVICEABLE	1,023.00	-
1	HEADLAMP (RH)	GRAZED	797.90	797.90
1	FRONT FENDER (RH)	DENTED	593.00	593.00
1	FRONT FENDER SHIELD (RH)	TORN	86.00	86.00
	LESS 20% DISCOUNT		-617.60	-408.98
			2,470.40	1,635.92
<b>SPECIAL NETT ITEMS</b>				
1	FRONT FENDER ADVERTISEMENT LOGO (RH)(SN)	NECESSARY	100.00	100.00

100.00	100.00
<b>LABOUR</b>				
	THATCHAM STANDARD REPAIR TIME ON BODY WORKS.		1,050.00	420.00
	THATCHAM TTS STANDARD SPRAY PAINTING COST AND LABOUR.		450.00	380.00
	TOWING CHARGE.		50.00	-
			1,550.00	800.00
<b>GRAND TOTAL</b>			<b>4,120.40</b>	<b>2,535.92</b>
<b>RECOMMENDED COST OF LUMP SUM REPAIRS (TO ITS PRE-ACCIDENT CONDITION) (CONFIRMED)</b>				<b>2,050.00</b>
