## 1. Policy Particulars :- THIRD PARTY CLAIM

**4. Description of Damages**

| THE VEHICLE SUSTAINED DAMAGES AT THE N/S BODY.<br>DAMAGES SEE DETAILS. |

**ADJUSTMENT ON REPAIR COST FOR VEHICLE NO. SHC 1195D**

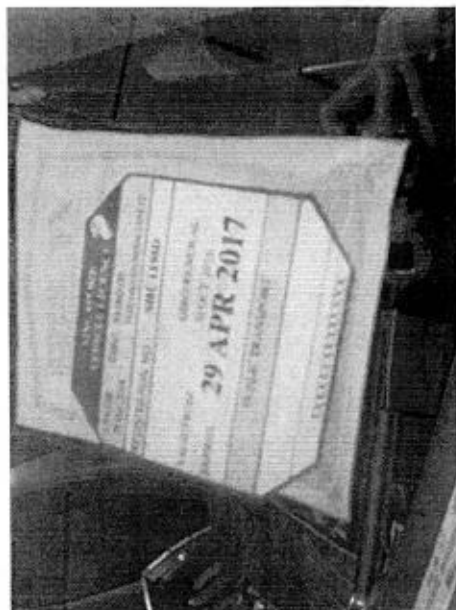
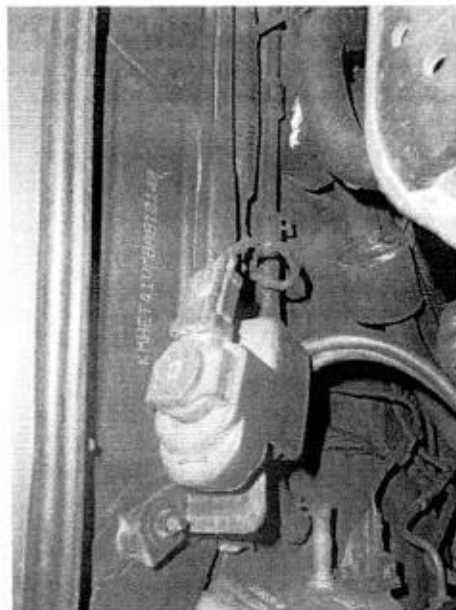
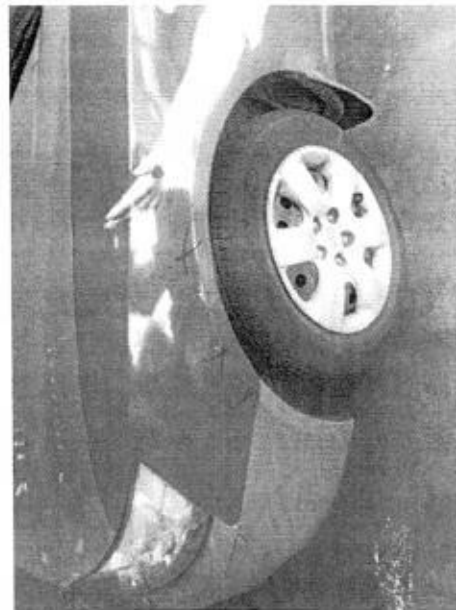
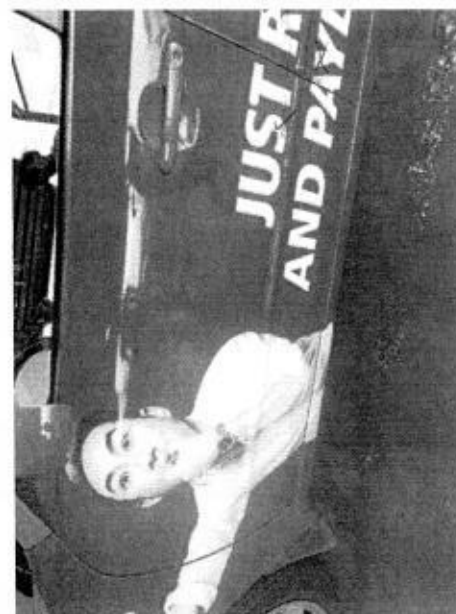
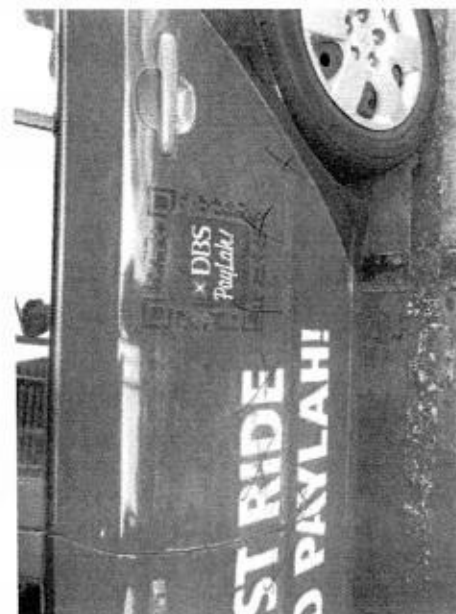
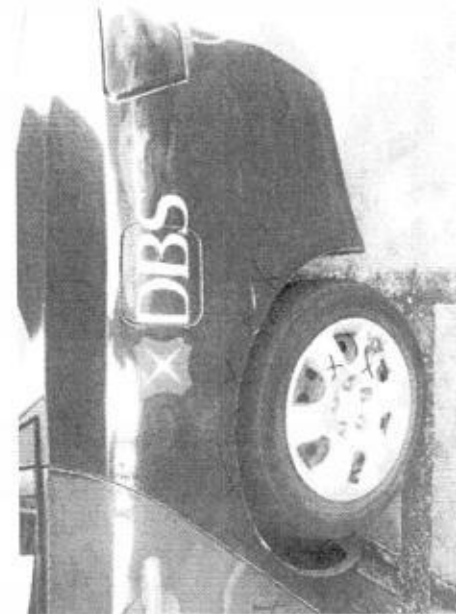
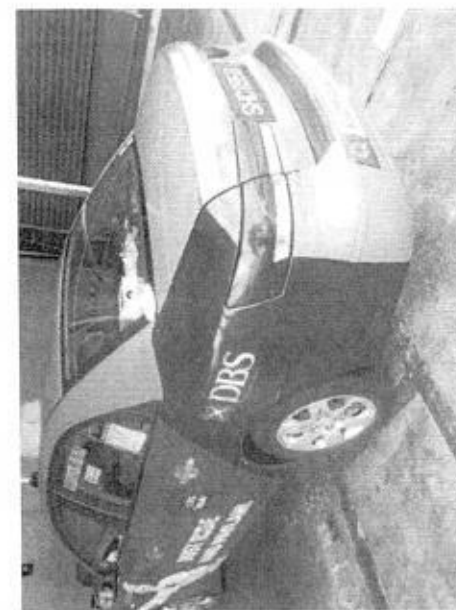
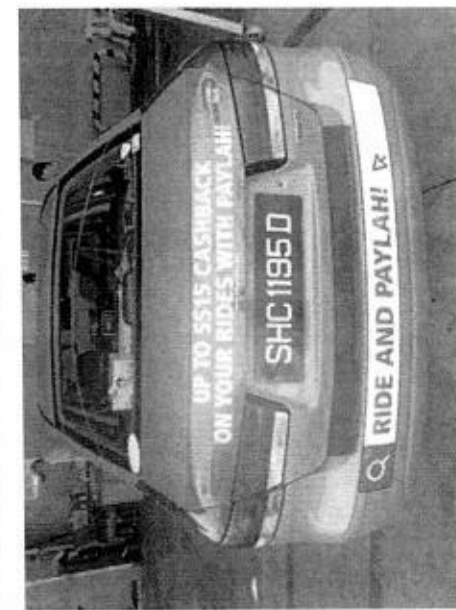
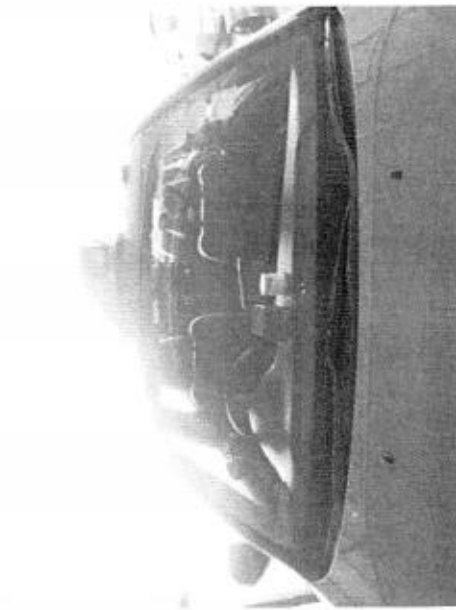
**n/s Body**  
 The U/C / Chassis frame / Body Structure affected due to collision.

| Qty | Description of Parts | Condition | Estimate By Workshop (\$) | Our Adjusted (\$) |
|---|---|---|---|---|
| 1 | REAR WHEEL HUB CAP (LH) | GRAZED | 145.00 | 145.00 |
| 1 | FRONT FENDER (NPA) | TO REPAIR | - | - |
| 1 | FRONT DOOR (NPA) | TO REPAIR | - | - |
| 1 | REAR DOOR (NPA) | TO REPAIR | - | - |
| <b>RECOMMENDED COST OF LUMP SUM REPAIRS (TO ITS PRE-ACCIDENT CONDITION) (CONFIRMED)</b> | | | | <b>1,100.00</b> |
