REF: NS/INC17023874 / Srb2

TP Claims against NTUC Income: Follow-Through Survey

NTUC INCOME INSURANCE CO-OPERATIVE LTD Ref: NS/INC17023874/Srbe2				
73 BRAS BASAH ROAD #05-01 NTUC TRADE UNION HOUSESINGAPORE 189556			Date: 16-01-2018	 
			Code: INC4	
<b>1. Policy Particulars :- THIRD PARTY CLAIM</b>				
Insured Veh.	SKC 8591L	Veh. Inspected	SHB 5004B	
Policy No.	5086219651	Coverage (\$)	0.00	
Claim No.	MT/0973642-002	Excess (\$)	0.00	
Assign From		Assign Date	14/12/2017	
<b>2. Vehicle Particulars &amp; Condition</b>				
Make & Model	TOYOTA PRIUS	c.c	1798	
Engine No.	HIDDEN	Year of Reg.	2017	
Chassis No.	JTDKN36U605768770	Colour	MAROON	
Odometer	162683	Steering	IN ORDER	
Brakes	IN ORDER	Modification	NIL	
General	FAIR			
<b>3. Conditions of Tyres</b>				
	Size	Make	Balance	
R/H Front Tyre	195/65 R15	FALKEN	6 mm	
L/H Front Tyre	195/65 R15	FALKEN	6 mm	
R/H Rear Tyre	195/65 R15	FALKEN	6 mm	
L/H Rear Tyre	195/65 R15	FALKEN	6 mm	
<b>4. Description of Damages</b>				
THE VEHICLE SUSTAINED DAMAGES AT THE REAR PORTION. DAMAGES SEE DETAILS.

## ADJUSTMENT ON REPAIR COST FOR VEHICLE NO. SHB 5004B

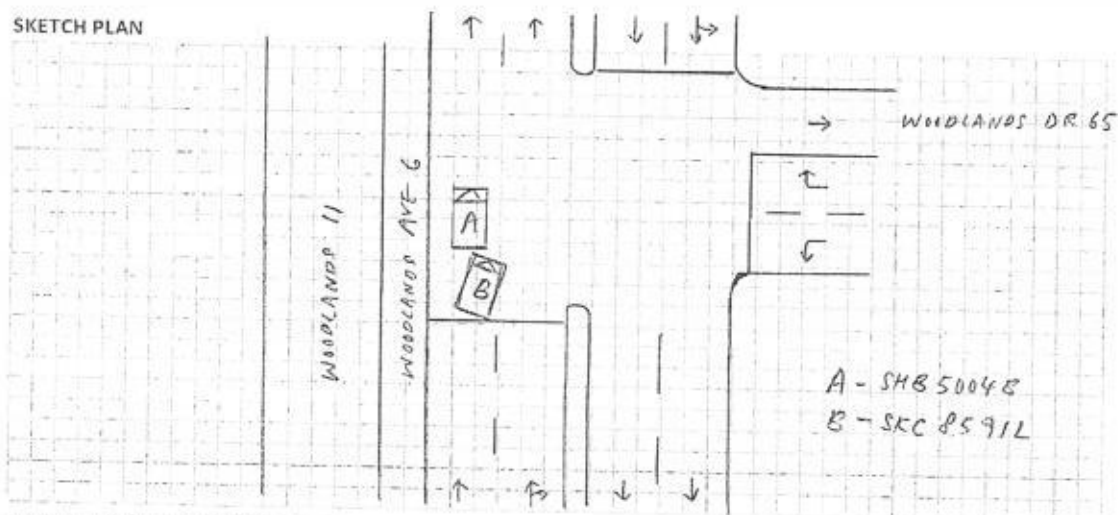
### SKETCH PLAN

I WAS STATIONARY ALONG WOODLANDS AVE 6 DUE TO RED TRAFFIC LIGHT. WHEN THE TRAFFIC LIGHT TURNED GREEN, I STARTED TO MOVE. SUDDENLY THE VEHICLE SKC8591L FROM BEHIND COLLIDED ONTO THE REAR RIGHT PORTION OF MY TAXI.
