4. Description of Damages

REPAIR ESTIMATE*

THE VEHICLE SUSTAINED DAMAGES AT THE REAR PORTION. DAMAGES SEE DETAILS.
--

ADJUSTMENT ON REPAIR COST FOR VEHICLE NO. SHD 6825G

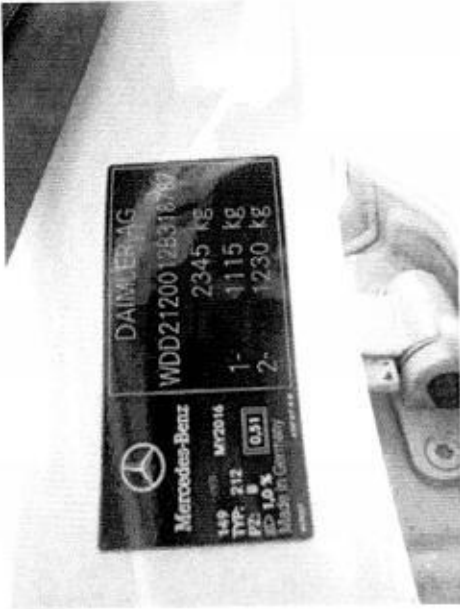
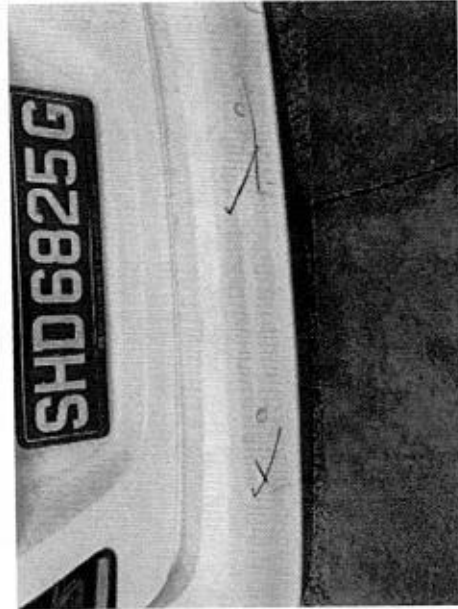
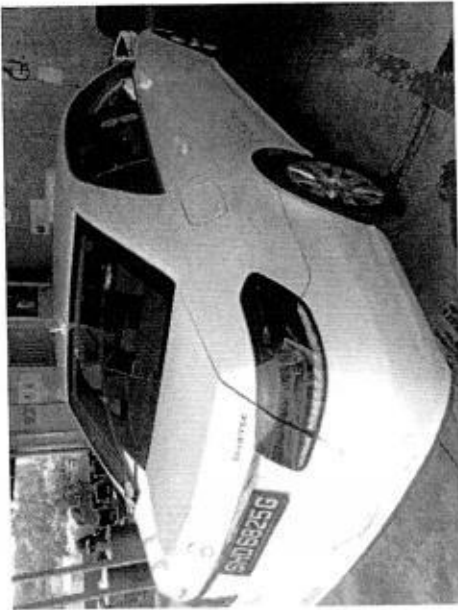
The U/C / Chassis frame / Body Structure affected due to collision.

Qty	Description of Parts	Condition	Estimate By Workshop (\$)	Our Adjusted (\$)
<u>REPLACEMENT OF PARTS</u>				
1	LICENSE PLATE TRIM COVER	SERVICEABLE	96.70	-
1	REAR BUMPER	DEFORMED	1,510.00	1,510.00
1	REAR BUMPER REINFORCEMENT	SERVICEABLE	1,150.00	-
2	REAR BUMPER BRACKET LOWER (LH/RH) @\$135.00	SERVICEABLE	270.00	-
2	REAR BUMPER BRACKET TOP (LH/RH) @\$125.00	SERVICEABLE	250.00	-
2	REAR BUMPER RETAINER MOUNTING (LH/RH) @\$115.00	SERVICEABLE	230.00	-
	LESS 20% DISCOUNT		-701.34	-302.00
			2,805.36	1,208.00
<u>NETT ITEMS</u>				
1	REAR BUMPER SENSOR (N)	SHORTED	388.00	388.00
	LESS 10% DISCOUNT		-	-38.80
			388.00	349.20
<u>LABOUR</u>				
	THATCHAM STANDARD REPAIR TIME ON BODY WORKS.		570.00	220.00
	THATCHAM TTS STANDARD SPRAY PAINTING COST AND LABOUR.		250.00	200.00
			820.00	420.00
GRAND TOTAL			4,013.36	1,977.20
RECOMMENDED COST OF REPAIRS (CONFIRMED)				1,977.20
