1. Policy Particulars :- THIRD PARTY CLAIM

THE VEHICLE SUSTAINED DAMAGES AT THE N/S BODY. DAMAGES SEE DETAILS.
--

ADJUSTMENT ON REPAIR COST FOR VEHICLE NO. SHA 473T

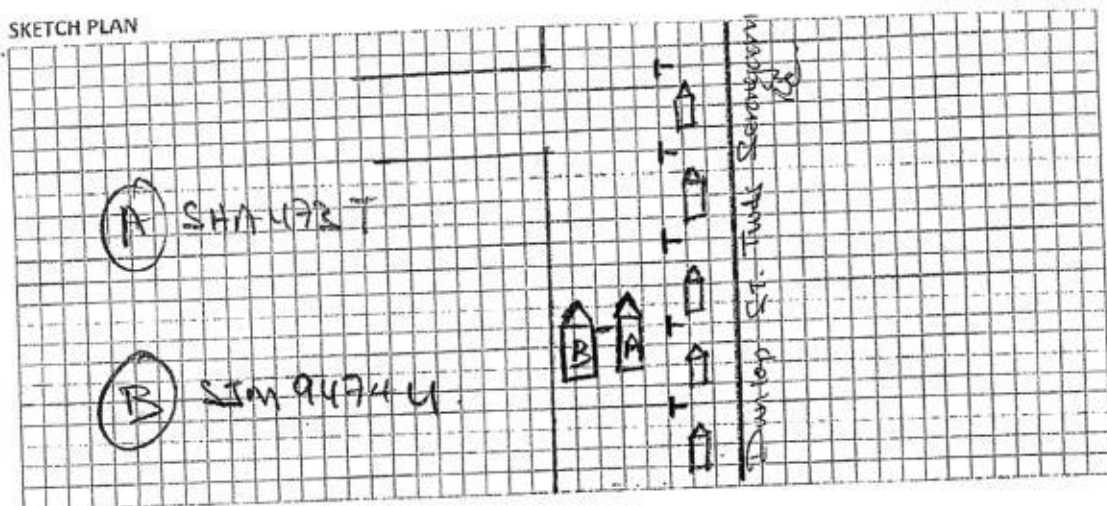
SKETCH PLAN

ON- 15 Dec 2017 @ 1400hr I veh. A
 was driving along Dunlop Rd towards Serangan Rd
 Suddenly veh. B Driver from outside walk towards
 his veh. B and open Right front door without
 looking veh A is coming. Veh. B door hit veh A
 left front door and left front tyre. at the point
 of accident I veh A carry 2 female passengers
 they were ok when I call with them.

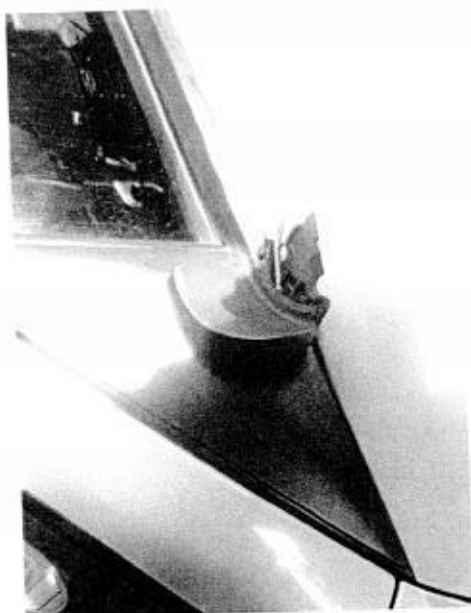
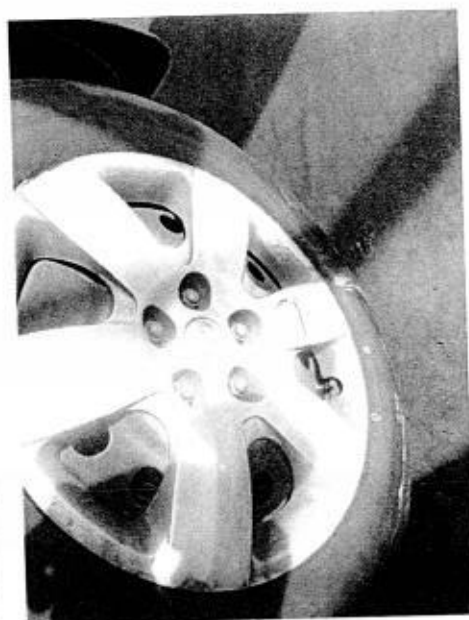
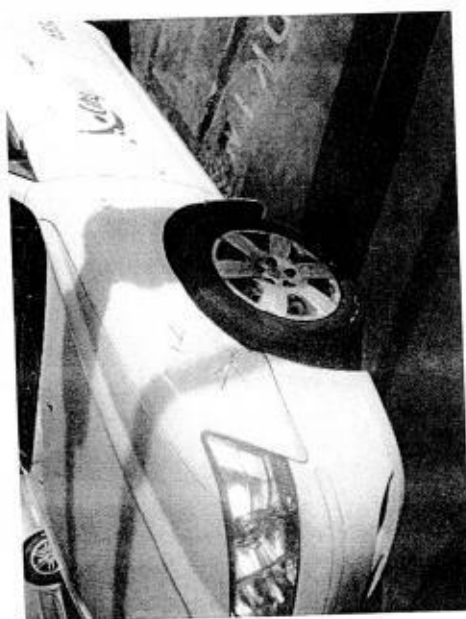
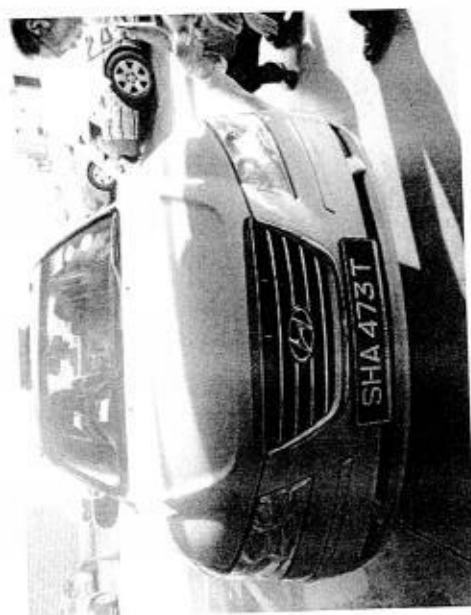
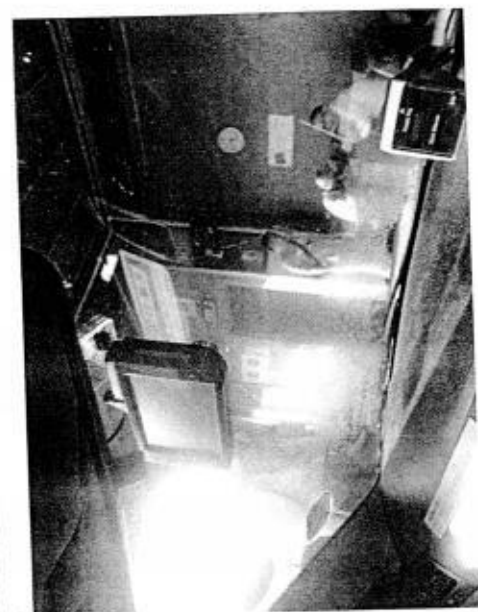
Qty	Description of Parts	Condition	Estimate By Workshop (\$)	Our Adjusted (\$)
<u>REPLACEMENT OF PARTS</u>				
1	FRONT FENDER (LH)	DENTED	593.00	593.00
1	FRONT FENDER SHIELD (LH)	SERVICEABLE	86.00	-
1	FRONT FENDER SIGNAL LAMP (LH)	CRACKED	45.40	45.40
1	FRONT FENDER RETAINER	SERVICEABLE	9.20	-
1	FRONT DOOR OUTER HANDLE (LH)	TO REPAIR	37.00	-
1	FRONT DOOR OUTER MOULDING (LH)	CUT	61.00	61.00
1	FRONT DOOR MIRROR (LH)	BROKEN	545.50	545.50
1	FRONT WHEEL HUB CAP (LH)	GRAZED	145.00	145.00
	LESS 20% DISCOUNT		-304.42	-277.98
			1,217.68	1,111.92
<u>SPECIAL NETT ITEMS</u>				
1	TYRE (50%)(SN)	CUT	207.00	103.50

207.00	103.50
<u>LABOUR</u>				
	THATCHAM STANDARD REPAIR TIME ON BODY WORKS.		730.00	420.00
	THATCHAM TTS STANDARD SPRAY PAINTING COST AND LABOUR.		400.00	250.00
			1,130.00	670.00
GRAND TOTAL			2,554.68	1,885.42
RECOMMENDED COST OF LUMP SUM REPAIRS (TO ITS PRE-ACCIDENT CONDITION) (CONFIRMED)				1,500.00
