## 1. Policy Particulars :- THIRD PARTY CLAIM

THE VEHICLE SUSTAINED DAMAGES AT THE N/S FRONT PORTION. DAMAGES SEE DETAILS.
---

## ADJUSTMENT ON REPAIR COST FOR VEHICLE NO. SH 9111L

Report Ref No. NS/INC17023981/K1tbe2

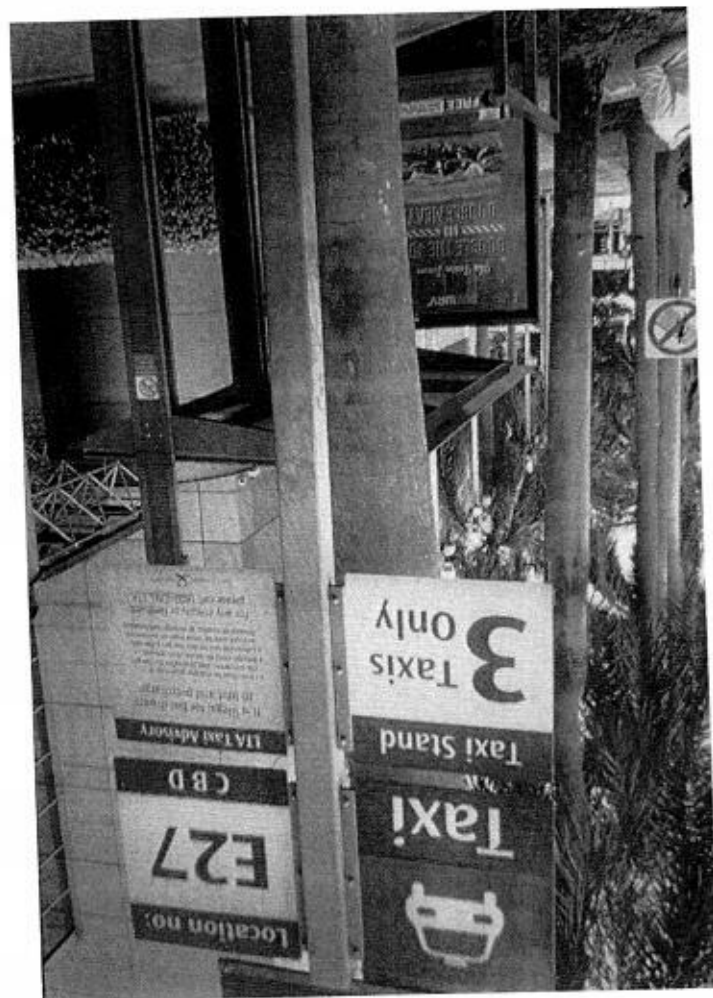
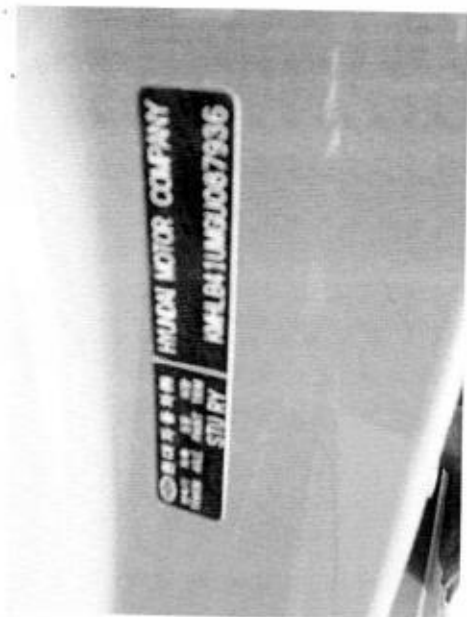
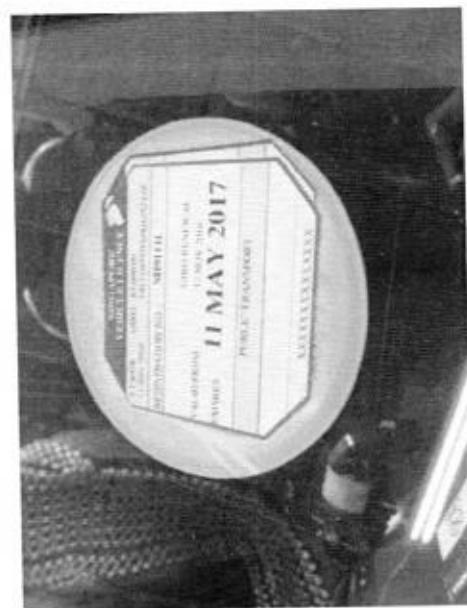
Qty	Description of Parts	Condition	Estimate By Workshop (\$)	Our Adjusted (\$)
<b>REPLACEMENT OF PARTS</b>				
1	FRONT BUMPER COVER	DEFORMED	1,052.20	1,052.20
1	FRONT FENDER (LH)	DENTED	619.00	619.00
1	FRONT FENDER RETAINER	SERVICEABLE	9.20	-
1	FRONT WHEEL HUB CAP (LH)	GRAZED	150.70	150.70
	LESS 20% DISCOUNT		-366.22	-364.38
			1,464.88	1,457.52
<b>SPECIAL NETT ITEMS</b>				
1	FRONT FENDER ADVERTISEMENT LOGO (LH) (SN)	NECESSARY	100.00	100.00
			100.00	100.00
<b>LABOUR</b>				
	THATCHAM STANDARD REPAIR TIME ON BODY WORKS.		520.00	200.00
	THATCHAM TTS STANDARD SPRAY PAINTING COST AND LABOUR.		450.00	380.00
			970.00	580.00
<b>GRAND TOTAL</b>			<b>2,534.88</b>	<b>2,137.52</b>
<b>RECOMMENDED COST OF REPAIRS (CONFIRMED)</b>				<b>2,137.52</b>

0000 L	PANEL BEATING- FRT.	200.00
0001 23-502	SPRAYPAINT ON AFFECTED AREA	360.00
0002 20-00	TUFF COAT ON AFFECTED PARTS.	20.00
0003 20-05	RENEW ADVERTISEMENT STICKER-	100.00
SUB-TOTAL :		680.00
