1. Policy Particulars :- THIRD PARTY CLAIM

THE VEHICLE SUSTAINED DAMAGES AT THE N/S BODY. DAMAGES SEE DETAILS.
--

ADJUSTMENT ON REPAIR COST FOR VEHICLE NO. SHC 3973L

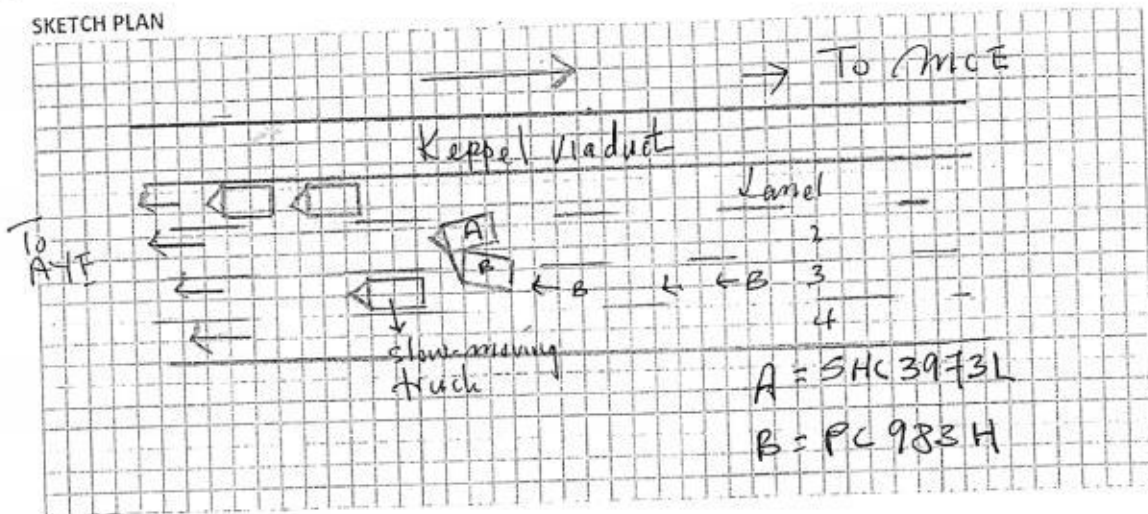
SKETCH PLAN

I travelled on MCE yesterday afternoon (17/12/2017) ferrying a male passenger on the way to Vivocity.

As seen in the video footage, while I moved on the fast lane, vehicle B (PC 983H), a white passenger van, was seen moving on other lane on the left side of the expressway.

As further shown in the video footage, after exiting MCE, I changed from lane 1 to lane 2 on Keppel Viaduct as I was preparing to exit into Keppel Road in the junction ahead. I only veered to this lane after checking it was clear traffic on lane 2 and safe to do so.

However, when I had shifted to this lane, it was vehicle B that hit into the left front of my car after it shifted to the same lane in avoiding a slow-moving truck ahead on lane 3 it was moving alone.

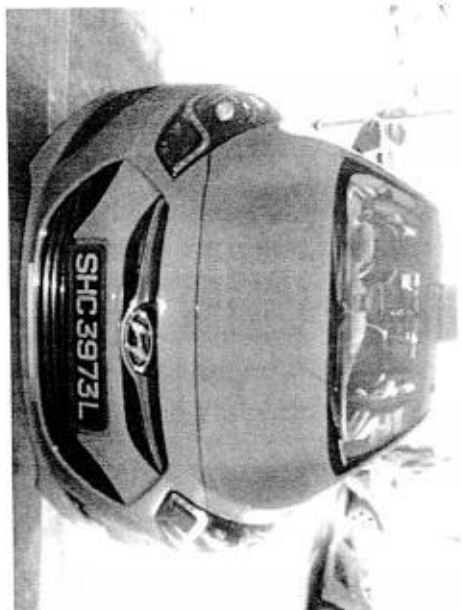
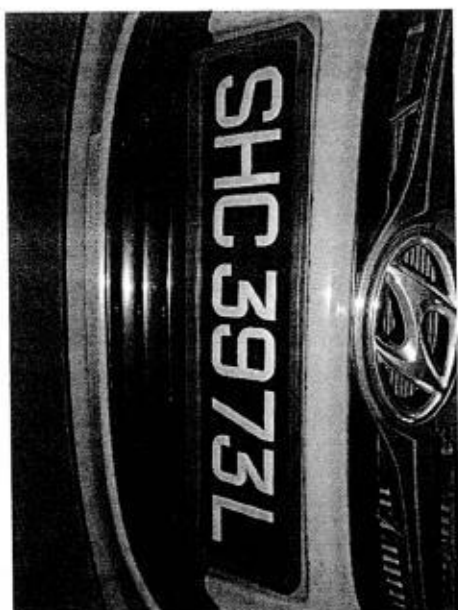
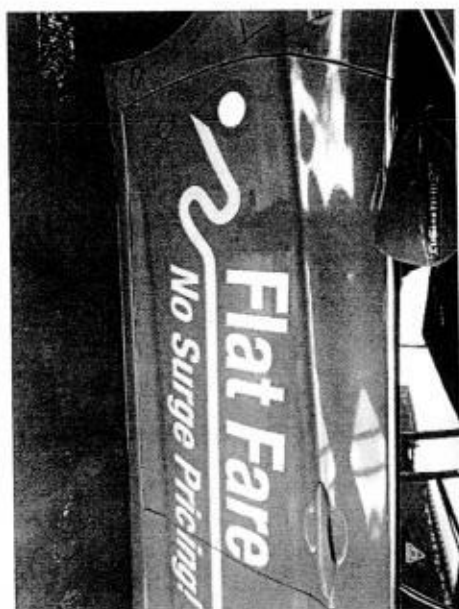
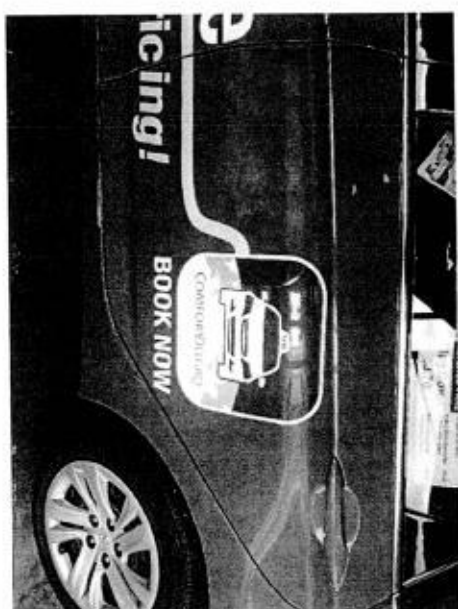
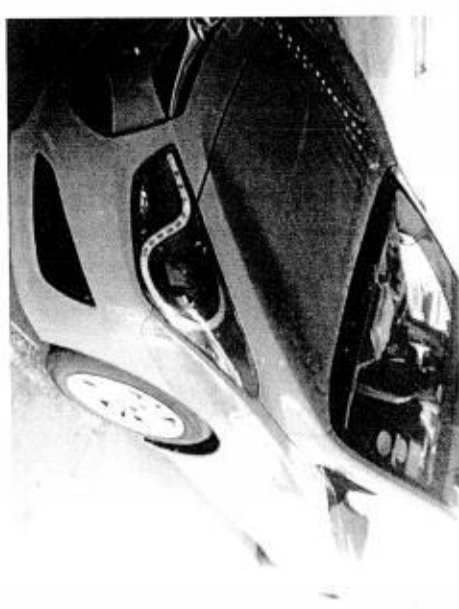
The right front to vehicle B sustained minor dents.

Qty	Description of Parts	Condition	Estimate By Workshop (\$)	Our Adjusted (\$)
REPLACEMENT OF PARTS				
1	FRONT FENDER (LH)	TO REPAIR	619.00	-
1	FRONT FENDER SHIELD (LH)	SERVICEABLE	169.80	-
1	FRONT FENDER RETAINER	SERVICEABLE	9.20	-
1	FRONT DOOR MIRROR (LH)	TO REPAIR	980.50	-
	LESS 20% DISCOUNT		-355.70	-
			1,422.80	-
SPECIAL NETT ITEMS				
1	FRONT FENDER ADVERTISEMENT LOGO (LH) (SN)	NECESSARY	100.00	100.00
1	FRONT DOOR COMFORT LOGO (LH) (SN)	NECESSARY	75.00	75.00
			175.00	175.00
LABOUR				
	THATCHAM STANDARD REPAIR TIME ON BODY WORKS.		400.00	200.00
	THATCHAM TTS STANDARD SPRAY PAINTING COST AND LABOUR.		450.00	360.00
			850.00	560.00
GRAND TOTAL			2,447.80	735.00
RECOMMENDED COST OF REPAIRS (CONFIRMED)				735.00
