NTUC INCOME INSURANCE CO-OPERATIVE LTD Ref: NS/INC17024074/K1qb

1. Policy Particulars :- THIRD PARTY CLAIM

Insured Veh.	PC 5891G	Veh. Inspected	SH 8013T
Policy No.	5090990583	Coverage (\$)	0.00
Claim No.		Excess (\$)	0.00
Assign From		Assign Date	19/12/2017

ADJUSTMENT ON REPAIR COST FOR VEHICLE NO. SH 8013T

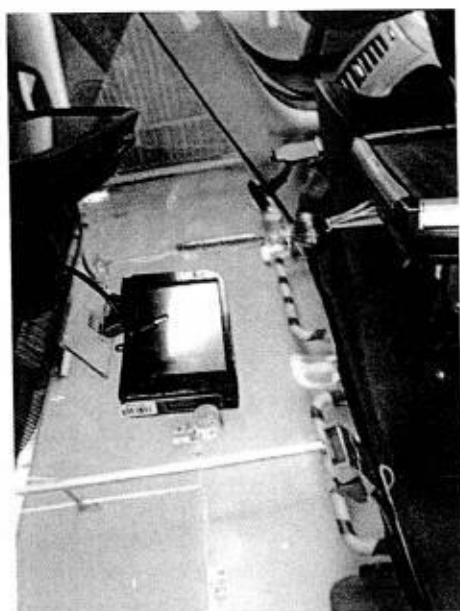
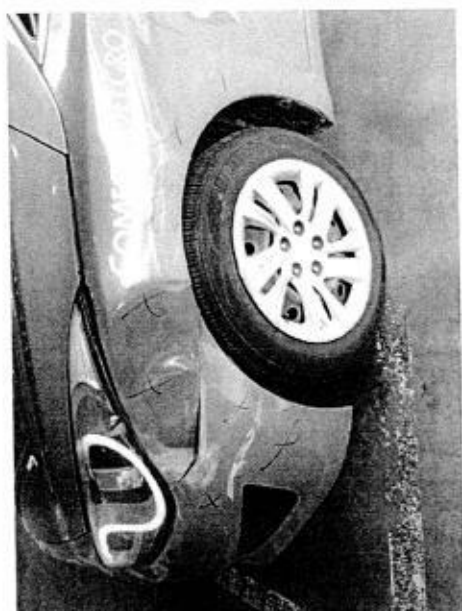
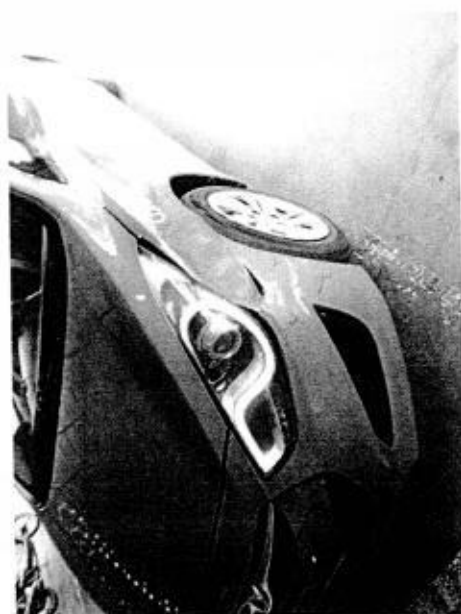
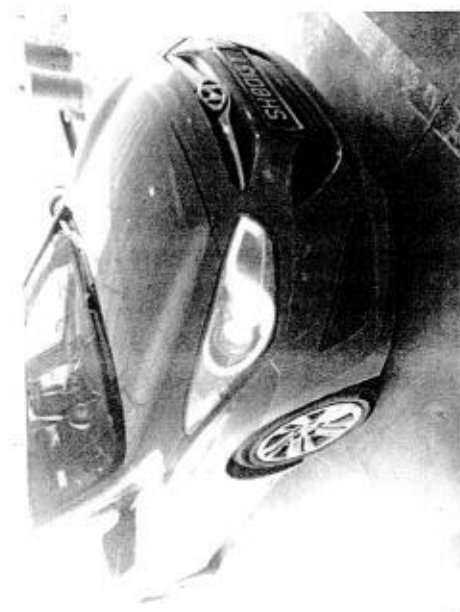
THE VEHICLE SUSTAINED DAMAGES AT THE N/S FRONT PORTION. DAMAGES SEE DETAILS.

Qty	Description of Parts	Condition	Estimate By Workshop (\$)	Our Adjusted (\$)
<u>REPLACEMENT OF PARTS</u>				
1	FRONT BUMPER COVER	DEFORMED	562.30	562.30
1	FRONT BUMPER BRACKET TOP (LH)	SERVICEABLE	22.40	-
1	FRONT BUMPER RETAINER MOUNTING	SERVICEABLE	9.20	-
1	HEADLAMP SUPPORT TOP COVER	SERVICEABLE	398.00	-
1	HEADLAMP SUPPORT PANEL ASSY	SERVICEABLE	1,067.50	-
1	HEADLAMP (LH)	GRAZED	1,388.00	1,388.00
1	FRONT FENDER (LH)	DENTED	619.00	619.00
1	FRONT FENDER SHIELD (LH)	SERVICEABLE	169.80	-
1	FRONT FENDER RETAINER	SERVICEABLE	9.20	-
1	FRONT WHEEL HUB CAP	GRAZED	150.70	150.70
1	LH WING MIRROR	BROKEN	980.50	980.50
	LESS 20% DISCOUNT		-1,075.32	-740.10
			4,301.28	2,960.40
<u>SPECIAL NETT ITEMS</u>				
1	FRONT FENDER ADVERTISEMENT LOGO (LH)(SN)	NECESSARY	100.00	100.00

100.00	100.00
<u>LABOUR</u>				
	THATCHAM STANDARD REPAIR TIME ON BODY WORKS.		1,130.00	420.00
	THATCHAM TTS STANDARD SPRAY PAINTING COST AND LABOUR.		450.00	430.00
			1,580.00	850.00
GRAND TOTAL			5,981.28	3,910.40
RECOMMENDED COST OF LUMP SUM REPAIRS (TO ITS PRE-ACCIDENT CONDITION) (CONFIRMED)				3,100.00
