## SINGAPORE ACCIDENT STATEMENT

VEHICLE NO : SH 6740R

Code: INC4	
<b>1. Policy Particulars : THIRD PARTY CLAIM</b>			
Insured Veh.	SHD 1580U	Veh. Inspected	SH 6740R
Policy No.	5095103893	Coverage (\$)	0.00
Claim No.	MT/0974232-002	Excess (\$)	0.00
Assign From		Assign Date	19/12/2017
<b>2. Vehicle Particulars &amp; Condition</b>			
Make & Model	TOYOTA PRIUS	c.c	1798
Engine No.	HIDDEN	Year of Reg.	2017
Chassis No.	JTDKB3FU703564063	Colour	BLUE
Odometer	55915	Steering	IN ORDER
Brakes	IN ORDER	Modification	STANDARD ALLOY RIM
General	FAIR		
<b>3. Conditions of Tyres</b>			
	Size	Make	Balance
R/H Front Tyre	195/65 R15	YOKOHAMA	7 mm
L/H Front Tyre	195/65 R15	YOKOHAMA	7 mm
R/H Rear Tyre	195/65 R15	YOKOHAMA	7 mm
L/H Rear Tyre	195/65 R15	YOKOHAMA	7 mm
<b>4. Description of Damages</b>			
THE VEHICLE SUSTAINED DAMAGES AT THE N/S REAR PORTION. DAMAGES SEE DETAILS.

**ADJUSTMENT ON REPAIR COST FOR VEHICLE NO. SH 6740R**

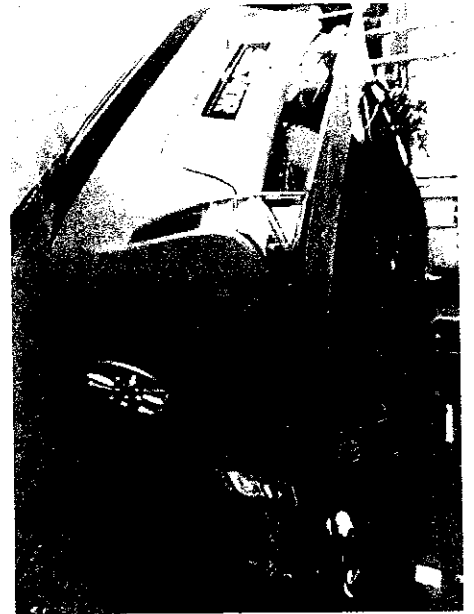
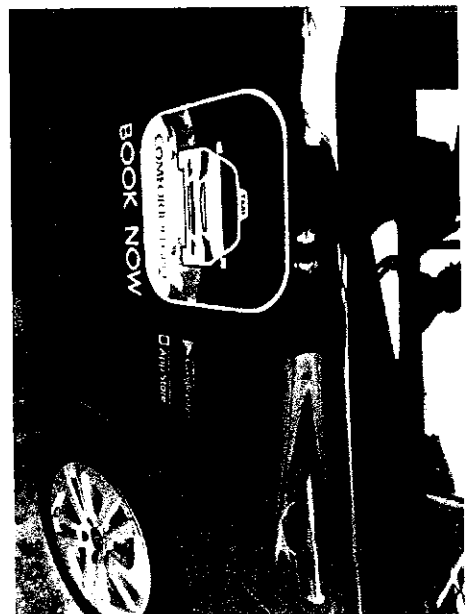
Qty	Description of Parts	Condition	Estimate By Workshop (\$)	Our Adjusted (\$)
	<b><u>REPLACEMENT OF PARTS</u></b>			
1	REAR BUMPER	DEFORMED	458.60	458.60
1	REAR BUMPER SIDE RETAINER	SERVICEABLE	112.70	-
1	REAR BUMPER UNDER SIDE COVER (LH)	TO REPAIR	232.00	-
1	REAR BUMPER CLIPS	NECESSARY	22.00	22.00
1	RETAINER, REAR BUMPER, SIDE, LH	SERVICEABLE	94.80	-
1	SEAL, REAR BUMPER SIDE, LH	SERVICEABLE	148.40	-
1	REAR LH WHEEL COVER	GRAZED	175.80	175.80
	LESS 20% DISCOUNT		-248.86	-
	LESS 25% DISCOUNT		-	-164.10

<b>RECOMMENDED COST OF REPAIRS (CONFIRMED)</b>			<b>872.30</b>
--	--	--	---------------
