TP Claims against NTUC Income: Follow-Through Survey

Code: INC4			
<b>1. Policy Particulars :- THIRD PARTY CLAIM</b>			
Insured Veh.	SJU 3979C	Veh. Inspected	SH 8328K
Policy No.	5068556164-03	Coverage (\$)	0.00
Claim No.	MT/0975149-001	Excess (\$)	0.00
Assign From		Assign Date	21/12/2017
<b>2. Vehicle Particulars &amp; Condition</b>			
Make & Model	TOYOTA PRIUS	c.c	1798
Engine No.	HIDDEN	Year of Reg.	2017
Chassis No.	JTDKB3FU103560784	Colour	BLUE
Odometer	65321	Steering	IN ORDER
Brakes	IN ORDER	Modification	STANDARD ALLOY RIM
General	FAIR		
<b>3. Conditions of Tyres</b>			
	Size	Make	Balance
R/H Front Tyre	195/65 R15	YOKOHAMA	7 mm
L/H Front Tyre	195/65 R15	YOKOHAMA	7 mm
R/H Rear Tyre	195/65 R15	YOKOHAMA	7 mm
L/H Rear Tyre	195/65 R15	YOKOHAMA	7 mm
<b>4. Description of Damages</b>			
THE VEHICLE SUSTAINED DAMAGES AT THE REAR PORTION. DAMAGES SEE DETAILS.

## ADJUSTMENT ON REPAIR COST FOR VEHICLE NO. SH 8328K

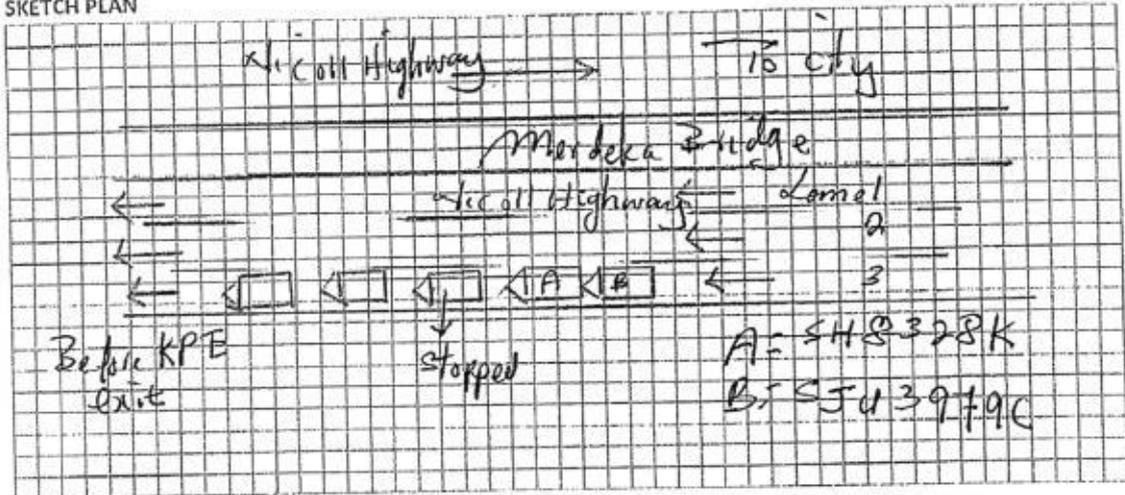
SKETCH PLAN

As seen in the video footage, when a private car stopped abruptly in front on Merdeka Bridge, I followed suit but I had barely halted my car behind when I felt a jerk and impact after car B( SJU 3979C) hit into the bumper of taxi.

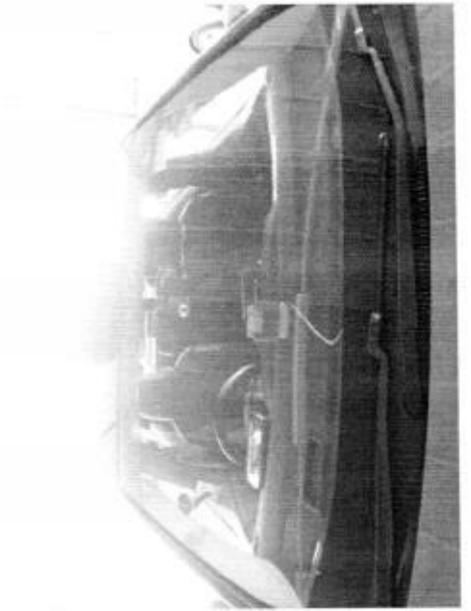
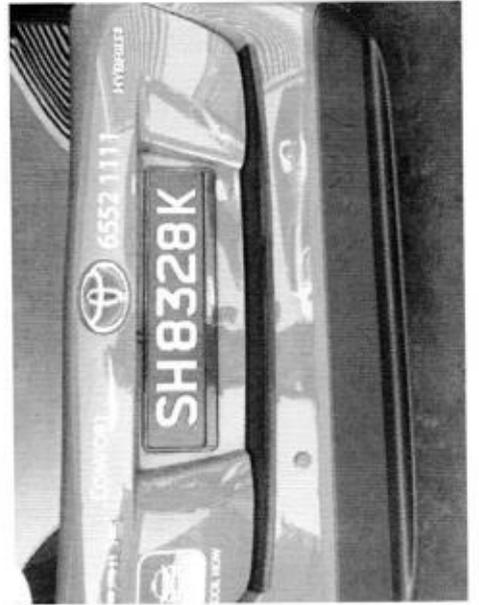
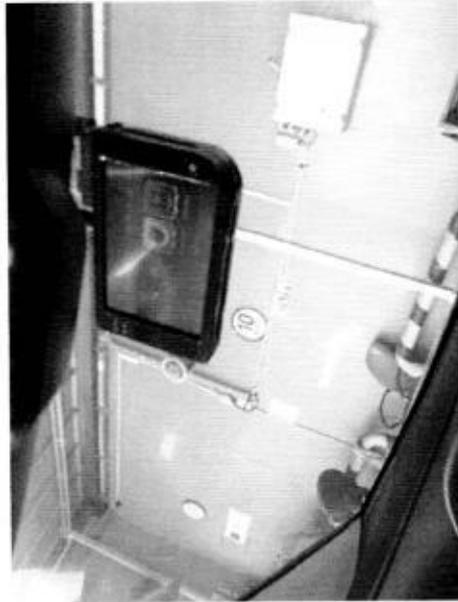
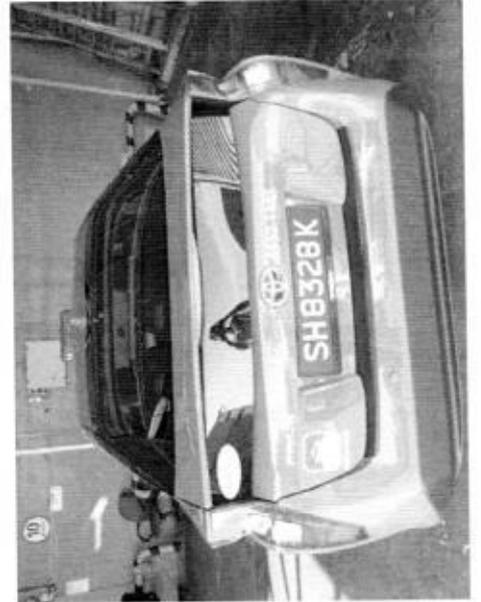
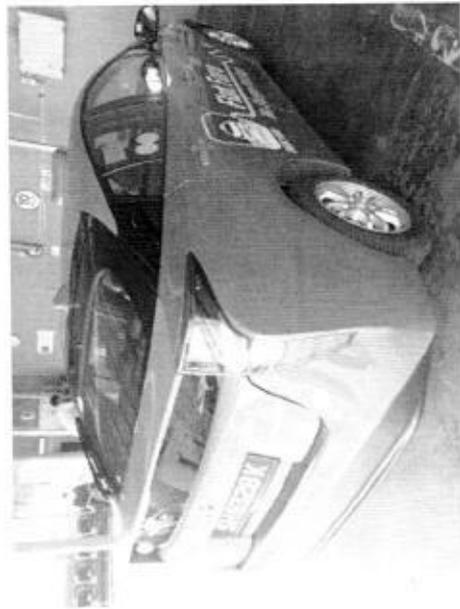
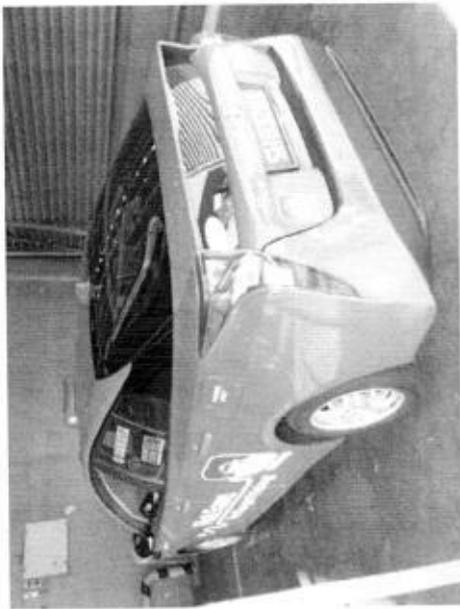
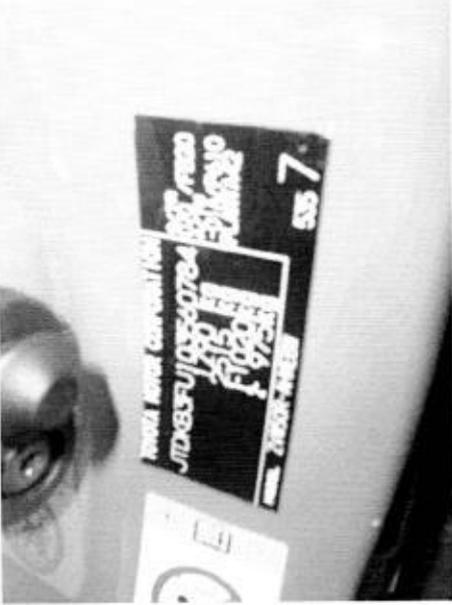
I found damage on the rear bumper of my taxi.

Qty	Description of Parts	Condition	Estimate By Workshop (\$)	Our Adjusted (\$)
<b>REPLACEMENT OF PARTS</b>				
1	REAR BUMPER	TO REPAIR	458.60	-
1	REAR BUMPER RE-INFORCEMENT	SERVICEABLE	318.80	-
1	REAR BUMPER UNDER COVER	CUT	552.60	552.60
1	REAR BUMPER SPONGE	NOT NECESSARY	143.40	-
10	REAR BUMPER CLIPS	NECESSARY	22.00	22.00
	LESS 25% DISCOUNT		-373.85	-143.65
			1,121.55	430.95
<b>SPECIAL NETT ITEMS</b>				
1	REAR BUMPER REVERSE SENSOR (SN)	SERVICEABLE	135.70	-
1	REAR BUMPER RUBBER MAT (SN)	NOT NECESSARY	50.00	-
			185.70	-
<b>LABOUR</b>				
	THATCHAM STANDARD REPAIR TIME ON BODY WORKS.		570.00	200.00
	THATCHAM TTS STANDARD SPRAY PAINTING COST AND LABOUR.		200.00	180.00
			770.00	380.00
<b>GRAND TOTAL</b>			<b>2,077.25</b>	<b>810.95</b>
<b>RECOMMENDED COST OF REPAIRS (CONFIRMED)</b>				<b>810.95</b>
