REF NS/INC17024239/Klgbn2

National Assessment Centre Services

TP Claims against NTUC Income: Follow-Through Survey

ADJUSTMENT ON REPAIR COST FOR VEHICLE NO. SHA 4023H

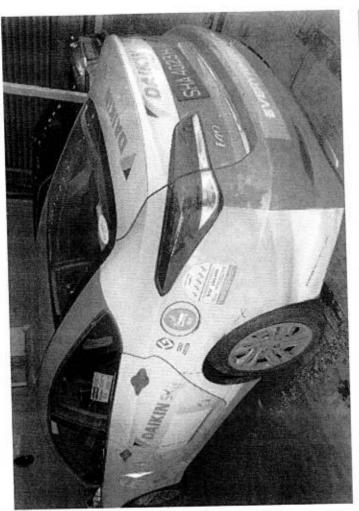
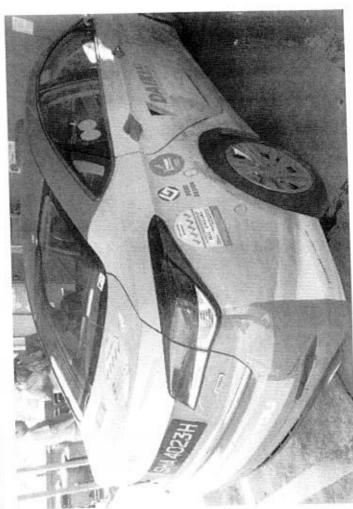
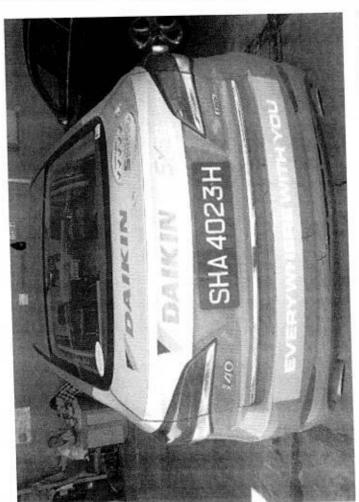
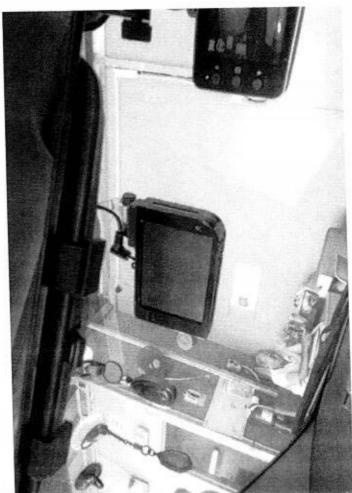
4.				Damages		
	CORRECT MARKETON	STAINED DAMAGES AT THE R	EAR PO	RTION.		
	DAMAGES SEE D		al Infor			
5.	I		-	ection Date	21/12/2017	
	Accident Date 20/12/2017 Survey held at COMFORTDELGRO ENGINE				1170 mingrap (616	
	Survey held at	59 LOYANG DRIVE SINGAPORE 508969				
5a.	Remarks					
Jul 1	A)THE INSPECTI B)IN ACCORDAN	ON WAS CONDUCTED ON A"W CE TO YOUR INSTRUCTIONS,	ITHOUT	PREJUDICE" BAS E NOT AUTHORIS	IS. ED REPAIRS.	
5b.				of Repair		
	ESTIMATED NOR	MAL PERIOD FOR REPAIR:		2 Working Day	S

Qty	Description of Parts	Condition	Estimate By Workshop (\$)	Our Adjusted (\$)
	REPLACEMENT OF PARTS			
1	REAR BUMPER	DEFORMED	603.60	603.60
1	REAR BUMPER REINFORCEMENT	SERVICEABLE	504.35	-
2	REAR BUMPER REINFORCEMENT BRACKET (LH/RH) @\$180.00	SERVICEABLE	360.00	2
1	REAR BUMPER SIDE BRACKET	SERVICEABLE	49.00	10
10	REAR BUMPER CLIPS	NECESSARY	22.00	22.00
1	REAR BUMPER SPONGE	SERVICEABLE	143.40	-
1	REAR BUMPER UNDER COVER	CUT	225.00	225.00
1	REAR BUMPER REFLECTOR LAMP (RH)(CRACKED)	NOT CONSISTENT WITH THE IMPACT	32.00	-
	LESS 20% DISCOUNT		-387.87	-170.12
			1,551.48	680.48
	SPECIAL NETT ITEMS			
া	REAR BUMPER REVERSE SENSOR (SN)	NOT FITTED	135.70	The second secon
1	REAR BUMPER ADVERTISEMENT LOGO (SN)	NECESSARY	50.00	50.00
2	REAR FENDER ADVERTISEMENT LOGO (LH/RH) @\$100.00 (SN)	NECESSARY	200.00	200.00

750.00	380.00
	GRAND TOTAL		2,687.18	1,310.48
	RECOMMENDED COST OF LUMP SUM REPAIRS (TO ITS PRE-ACCIDENT CONDITION)			1,050.00
