NTUC INCOME INSURANCE CO-OPERATIVE LTD Ref: NS/INC17024514/K1tb

1. Policy Particulars :- THIRD PARTY CLAIM

Insured Veh.	SLM 8253Z	Veh. Inspected	SHA 2671A
Policy No.	5088313745-01	Coverage (\$)	0.00
Claim No.		Excess (\$)	0.00
Assign From		Assign Date	22/12/2017

ADJUSTMENT ON REPAIR COST FOR VEHICLE NO. SHA 2671A

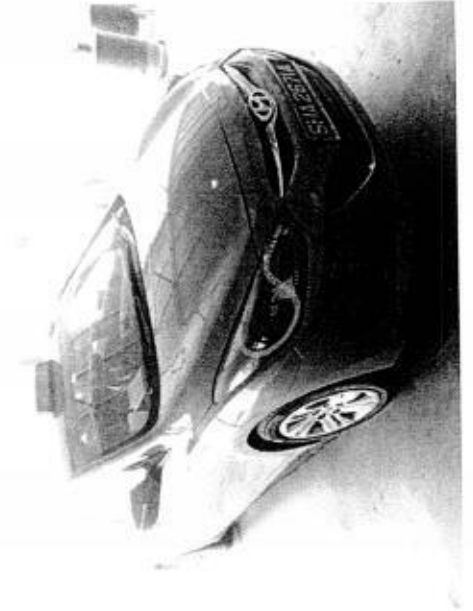
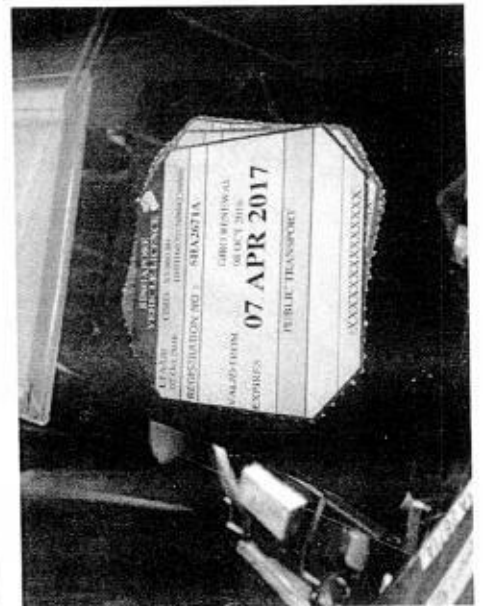
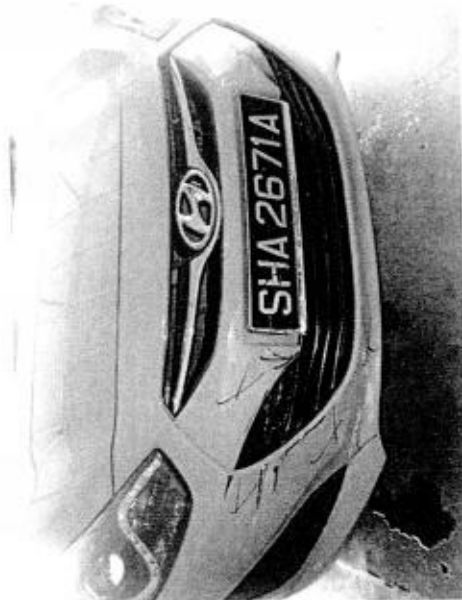
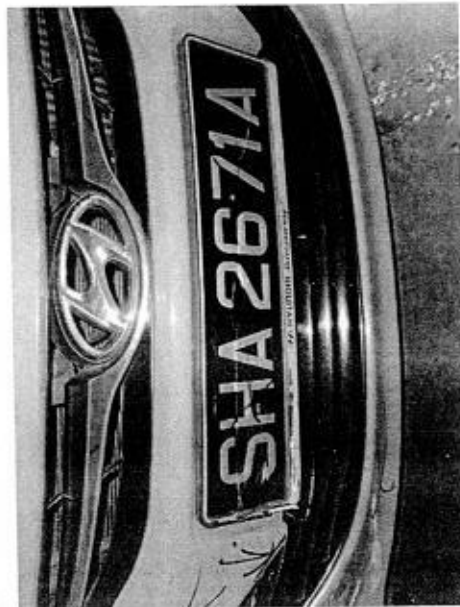
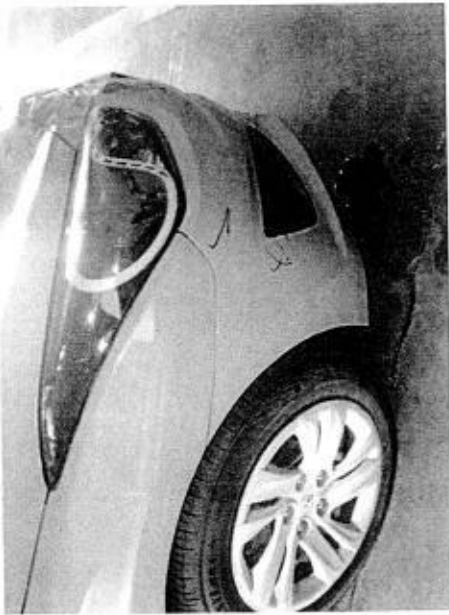
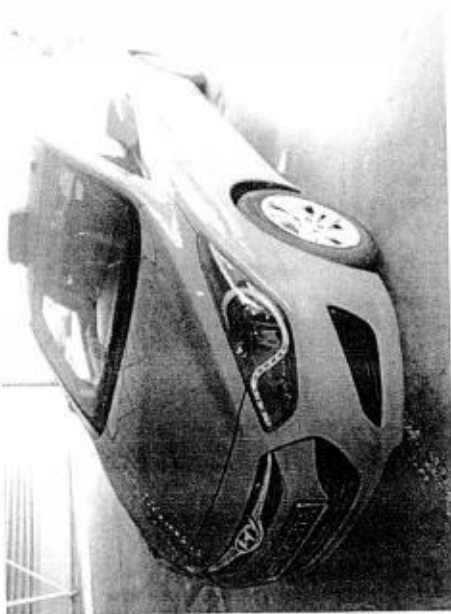
While the impact inflicted damage on the front of my taxi, vehicle B's whole right side sustained scratching dents

THE VEHICLE SUSTAINED DAMAGES AT THE FRONT PORTION. DAMAGES SEE DETAILS.

Qty	Description of Parts	Condition	Estimate By Workshop (\$)	Our Adjusted (\$)
REPLACEMENT OF PARTS				
1	RADIATOR GRILLE	CRACKED	294.35	294.35
1	RADIATOR GRILLE H EMBLEM	CRACKED	113.65	113.65
1	FRONT BUMPER COVER	DEFORMED	562.30	562.30
1	FRONT BUMPER SPONGE	SERVICEABLE	142.20	-
1	FRONT BUMPER REINFORCEMENT	SERVICEABLE	526.10	-
1	FRONT BUMPER GRILLE (RH)	SERVICEABLE	285.50	-
1	FRONT BUMPER GRILLE AIRDUCT (RH)	SERVICEABLE	155.00	-
1	FRONT BUMPER CENTRE GRILLE	CRACKED	176.90	176.90
1	FRONT BUMPER BRACKET TOP (RH)	SERVICEABLE	22.40	-
1	FRONT BUMPER RETAINER MOUNTING	SERVICEABLE	9.20	-
	LESS 20% DISCOUNT		-457.52	-229.44
			1,830.08	917.76
SPECIAL NETT ITEMS				
1	FRONT NUMBER PLATE (SN)	CRACKED	25.00	25.00
1	FRONT NO PLATE TRIM COVER (SN)	CRACKED	30.00	30.00

550.00	380.00
GRAND TOTAL			2,435.08	1,352.76
RECOMMENDED COST OF LUMP SUM REPAIRS (TO ITS PRE-ACCIDENT CONDITION) (CONFIRMED)				1,100.00
