1. Policy Particulars :- THIRD PARTY CLAIM			
Insured Veh.	GBB 1942R	Veh. Inspected	SHD 7056C
Policy No.	5090425321-01	Coverage (\$)	0.00
Claim No.	MT/0975626-001	Excess (\$)	0.00
Assign From		Assign Date	22/12/2017

4. Description of Damages			
THE VEHICLE SUSTAINED DAMAGES AT THE REAR N/S PORTION. DAMAGES SEE DETAILS.			
5. General Information			
Accident Date	21/12/2017	Inspection Date	22/12/2017
Survey held at	COMFORTDELGRO ENGINEERING PTE LTD 59 LOYANG DRIVE SINGAPORE 508969		
5a. Remarks			
A)THE INSPECTION WAS CONDUCTED ON A"WITHOUT PREJUDICE" BASIS. B)IN ACCORDANCE TO YOUR INSTRUCTIONS, WE HAVE NOT AUTHORISED REPAIRS.			
5b. Estimate Days of Repair			
ESTIMATED NORMAL PERIOD FOR REPAIR:		2 Working Days

ADJUSTMENT ON REPAIR COST FOR VEHICLE NO. SHD 7056C

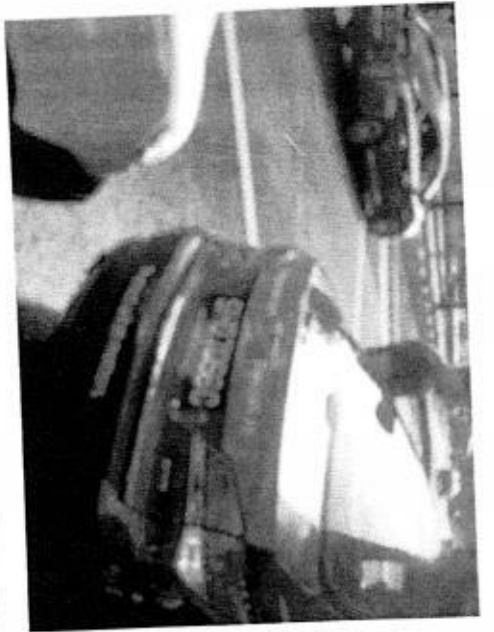
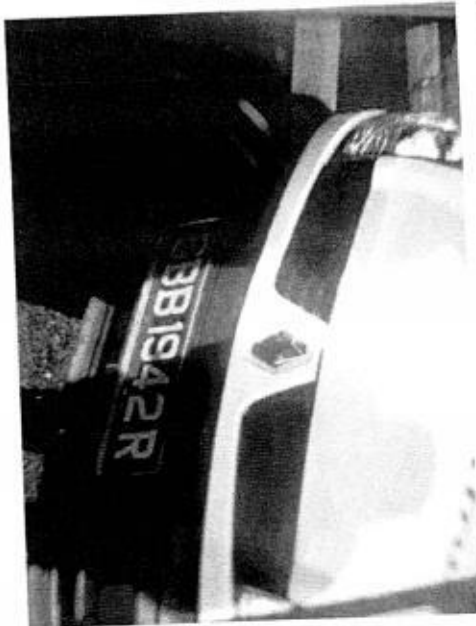
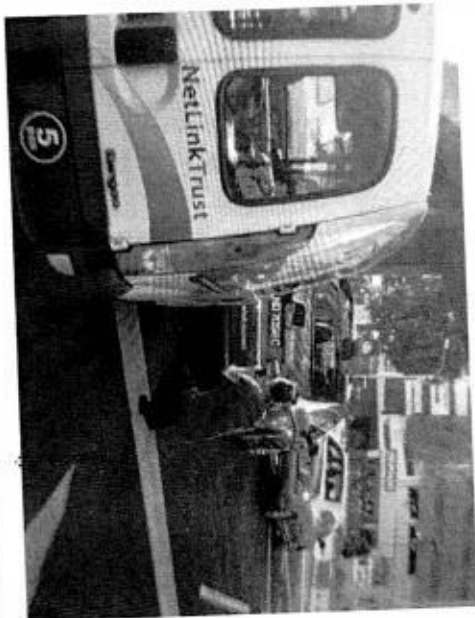
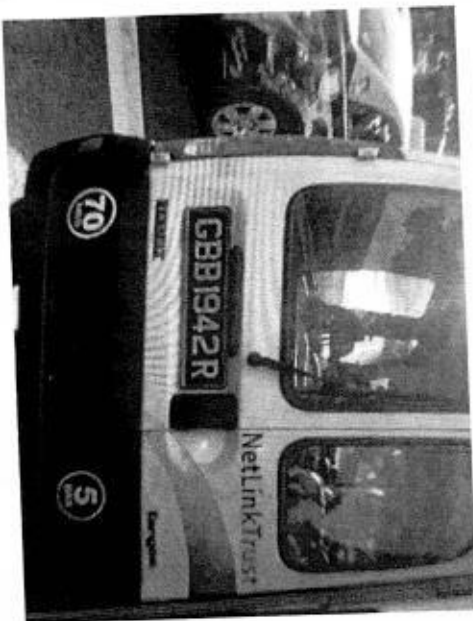
Qty	Description of Parts	Condition	Estimate By Workshop (\$)	Our Adjusted (\$)
REPLACEMENT OF PARTS				
1	REAR BUMPER	DEFORMED	603.60	603.60
1	REAR BUMPER REINFORCEMENT	SERVICEABLE	504.35	-
2	REAR BUMPER REINFORCEMENT BRACKET (LH/RH) @\$180.00	SERVICEABLE	360.00	-
1	REAR BUMPER SIDE BRACKET	SERVICEABLE	49.00	-
10	REAR BUMPER CLIPS	NECESSARY	22.00	22.00
1	REAR BUMPER SPONGE	SERVICEABLE	143.40	-
1	REAR BUMPER UNDER COVER	CUT	225.00	225.00
	LESS 20% DISCOUNT		-381.47	-170.12
			1,525.88	680.48
SPECIAL NETT ITEMS				
1	REAR BUMPER REVERSE SENSOR (SN)	NOT NECESSARY	135.70	-
1	REAR BUMPER ADVERTISEMENT LOGO (SN)	NECESSARY	50.00	50.00
2	REAR FENDER ADVERTISEMENT LOGO (LH/RH) @\$100.00 (SN)	NECESSARY	200.00	200.00
1	REAR BUMPER MAT (SN)	NECESSARY	50.00	50.00

750.00	400.00
			2,711.58	1,380.48
GRAND TOTAL				
RECOMMENDED COST OF LUMP SUM REPAIRS (TO ITS PRE-ACCIDENT CONDITION) (CONFIRMED)				1,100.00
