# National Assessment Centre Services

## 1. Policy Particulars :- THIRD PARTY CLAIM

THE VEHICLE SUSTAINED DAMAGES AT THE REAR O/S PORTION. DAMAGES SEE DETAILS.
--

**ADJUSTMENT ON REPAIR COST FOR VEHICLE NO. SHC 8031Y**

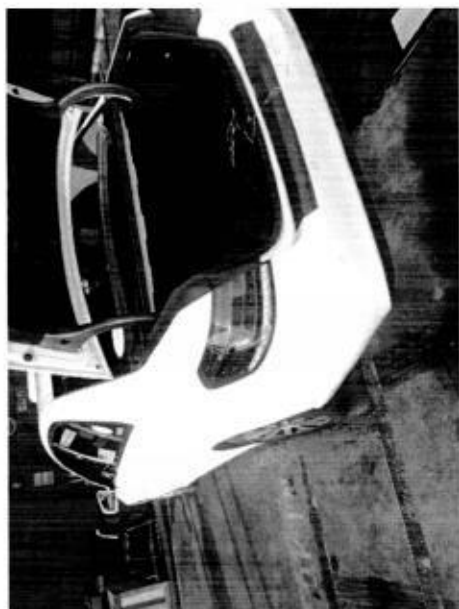
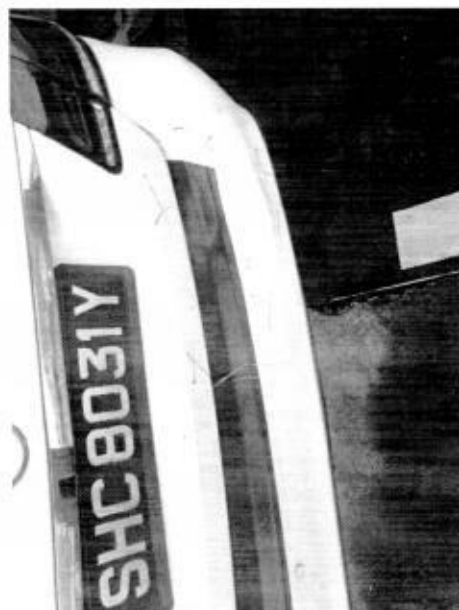
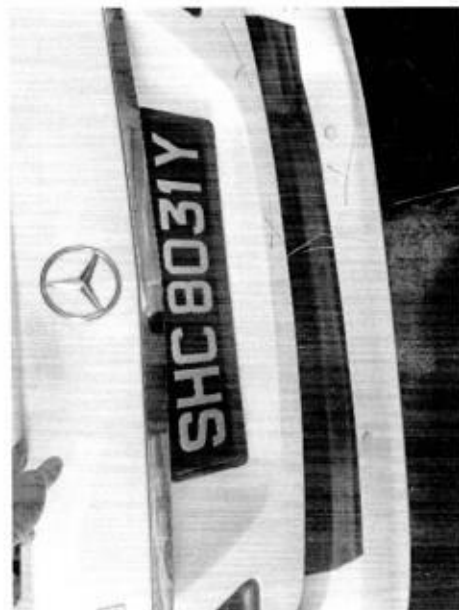
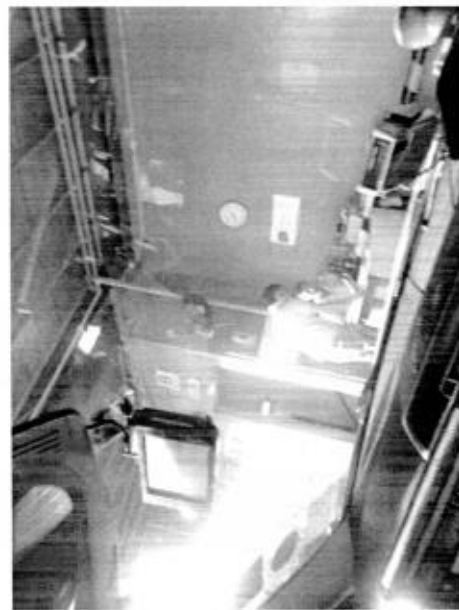
The U/C / Chassis frame / Body Structure affected due to collision.

GRAND TOTAL		9,337.04	3,135.04
RECOMMENDED COST OF LUMP SUM REPAIRS (TO ITS PRE-ACCIDENT CONDITION) (CONFIRMED)			2,500.00
