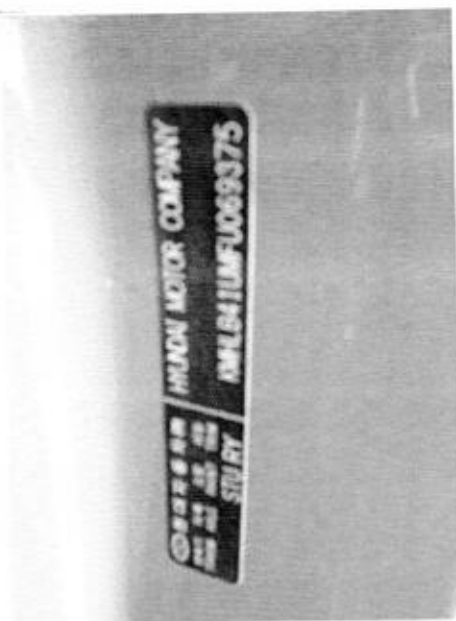
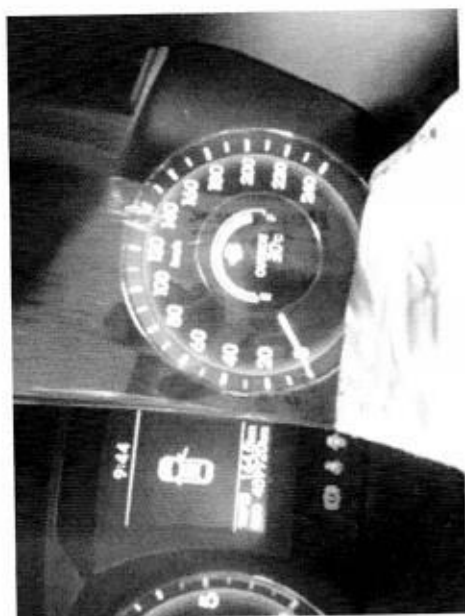
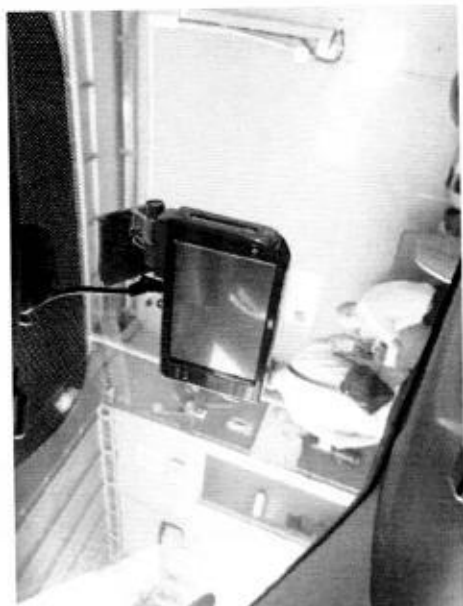
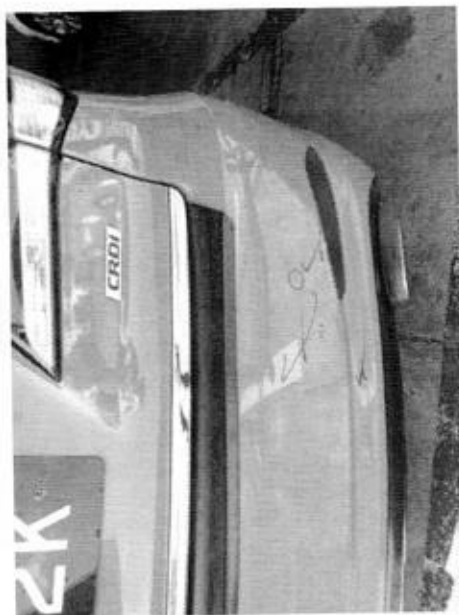
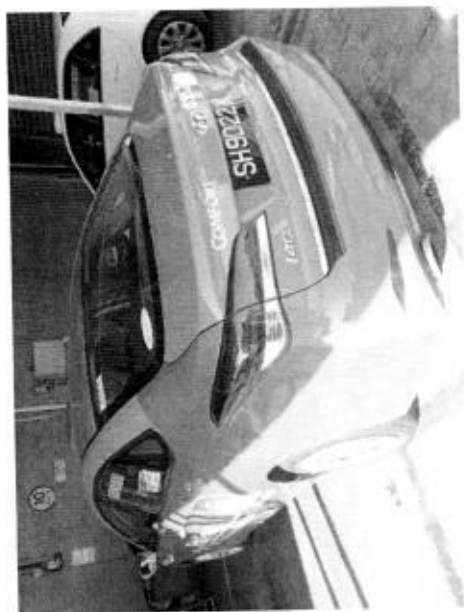
THE VEHICLE SUSTAINED DAMAGES AT THE REAR PORTION. DAMAGES SEE DETAILS.
--

Qty	Description of Parts	Condition	Estimate By Workshop (\$)	Our Adjusted (\$)
REPLACEMENT OF PARTS				
1	REAR BUMPER	DEFORMED	603.60	603.60
1	REAR BUMPER REINFORCEMENT	SERVICEABLE	504.35	-
2	REAR BUMPER REINFORCEMENT BRACKET (LH/RH) @\$180.00	SERVICEABLE	360.00	-
1	REAR BUMPER SIDE BRACKET	SERVICEABLE	49.00	-
10	REAR BUMPER CLIPS	NECESSARY	22.00	22.00
1	REAR BUMPER SPONGE	SERVICEABLE	143.40	-
1	REAR BUMPER UNDER COVER	SERVICEABLE	225.00	-
	LESS 20% DISCOUNT		-381.47	-125.12
			1,525.88	500.48
SPECIAL NETT ITEMS				
1	REAR BUMPER REVERSE SENSOR (SN)	SERVICEABLE	135.70	-
1	REAR BUMPER RUBBER MAT (SN)	NECESSARY	50.00	50.00

750.00	400.00
GRAND TOTAL			2,461.58	950.48
RECOMMENDED COST OF LUMP SUM REPAIRS (TO ITS PRE-ACCIDENT CONDITION) (CONFIRMED)				750.00
