# National Assessment Centre Services

## 1. Policy Particulars :- THIRD PARTY CLAIM

THE VEHICLE SUSTAINED DAMAGES AT THE N/S BODY. DAMAGES SEE DETAILS.
--

**ADJUSTMENT ON REPAIR COST FOR VEHICLE NO. SHC 3668T**

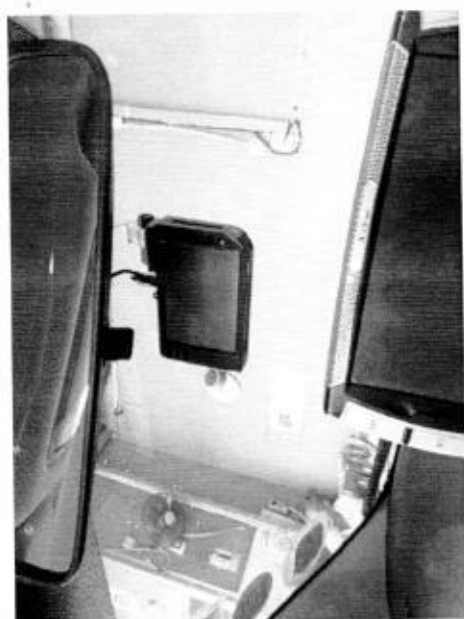
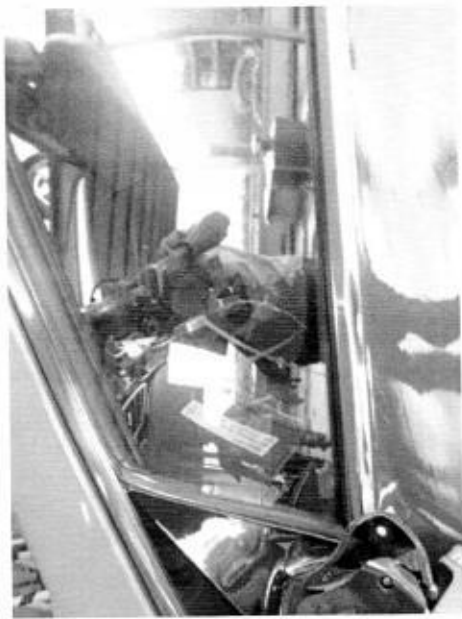
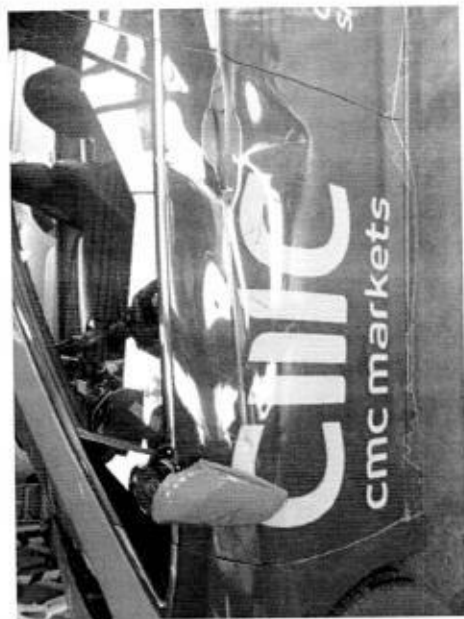
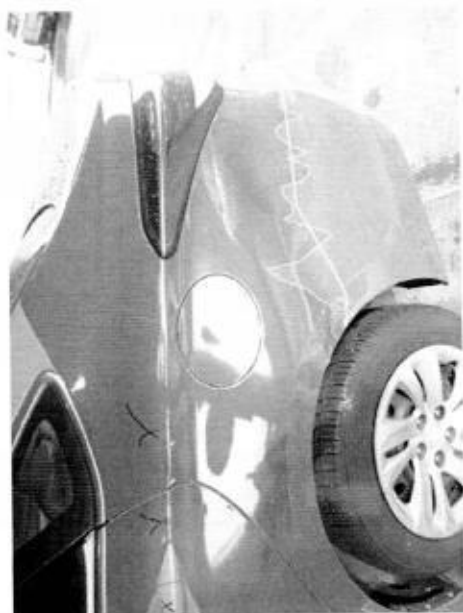
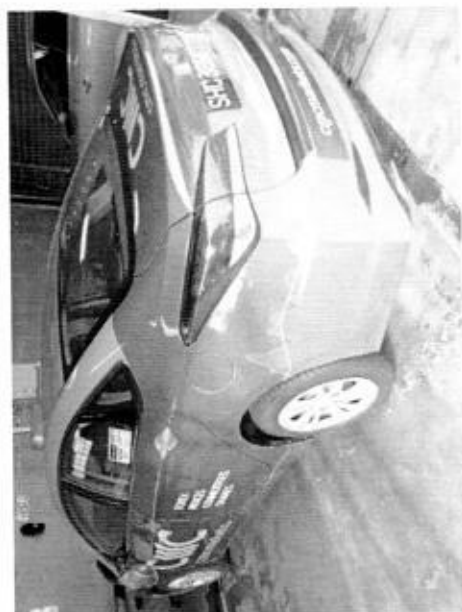
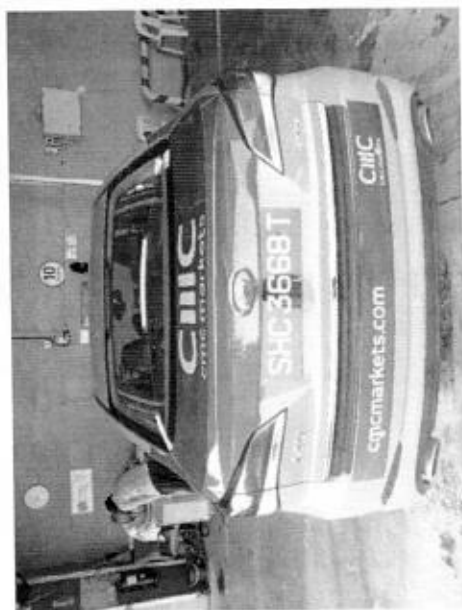
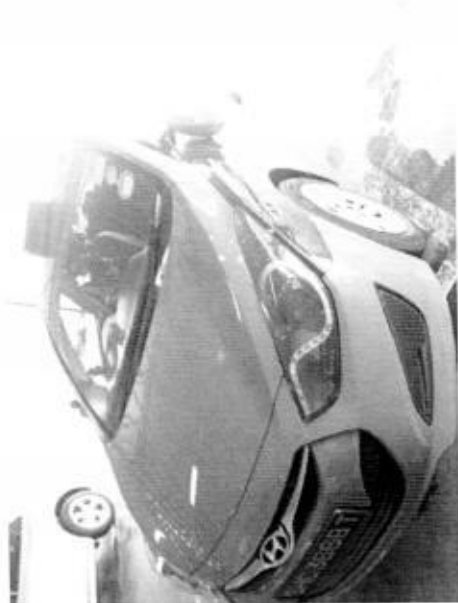
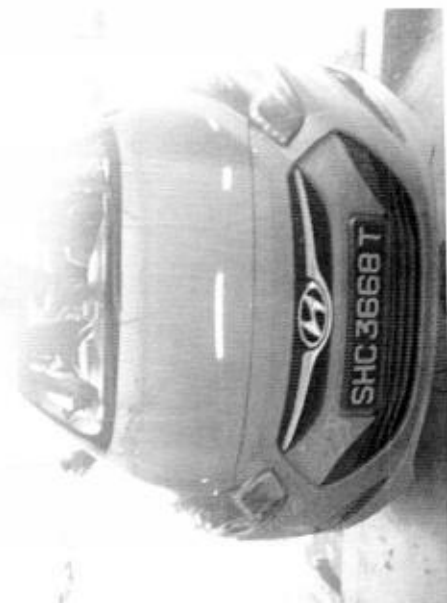
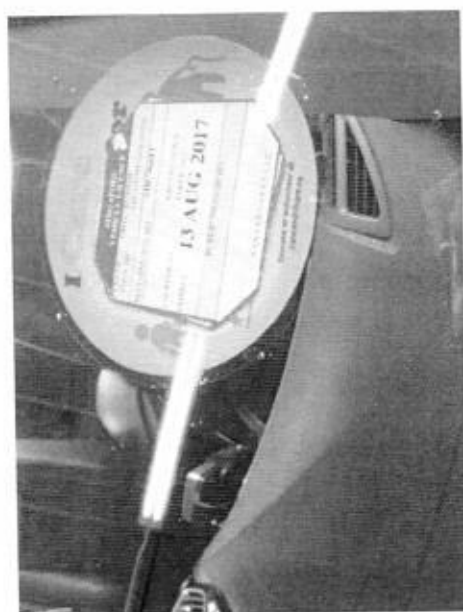
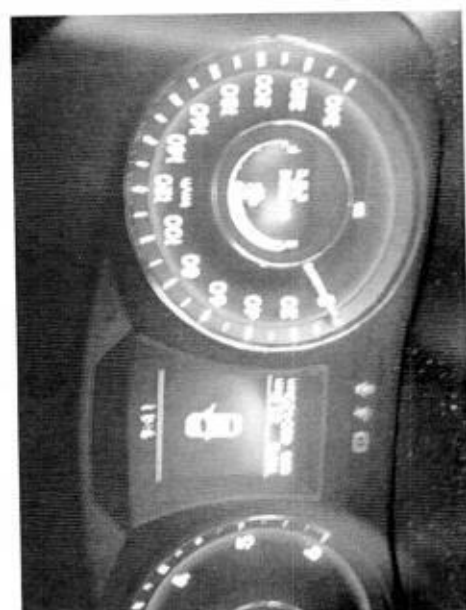
NTUC - taxi whole left side damage  
LRR/Kalini -

Qty	Parts Description/ Labour	Type	Unit Price	Amount	
	Rear Door Outer Handle (LH) <i>x repair</i>			\$ 41.40	
	Front Door (LH) <i>— part</i>			\$ 1,403.05	
	Front Door Glass (LH) <i>— cut</i>			\$ 379.55	
	Front Door Outer Handle (LH) <i>— 100</i>			\$ 38.75	
	Front Door Outer Moulding (LH) <i>— part</i>			\$ 63.70	
	Front Door Mirror (LH) <i>— Broken</i>			\$ 980.50	
	<b>SUB TOTAL</b>			<b>\$ 2,906.95</b>	
	<b>LESS 20%</b>			<b>\$ 581.39</b>	
	<b>DISCOUNTED TOTAL</b>			<b>\$ 2,325.56</b>	
	Rear Fender Advertisement Logo (LH/RH) <i>— net</i>	\$	100.00	\$ 200.00	Nett
	Rear Door Advertisement Logo (LH) <i>— net</i>			\$ 100.00	Nett
	Front Door Coloured Comfort Logo (LH) <i>— net</i>			\$ 75.00	Nett
	Front Door Advertisement Logo (LH) <i>— net</i>			\$ 100.00	Nett
				<b>\$ 475.00</b>	
	<b>Labour Charge</b>			<i>400</i>	
	Panel Beating			\$ 850.00	
	Spray Painting Charge			\$ 600.00	590
	Wiring Charge			\$ 50.00	20
