1. Policy Particulars :- THIRD PARTY CLAIM

ADJUSTMENT ON REPAIR COST FOR VEHICLE NO. SH 9321Y

Report Ref No. NS/INC17024549/K1tbn2

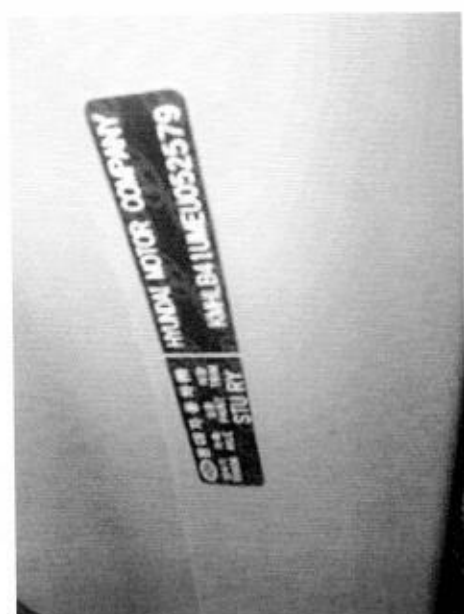
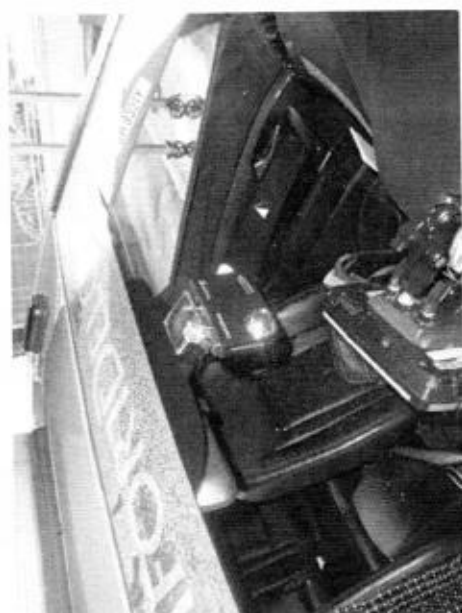
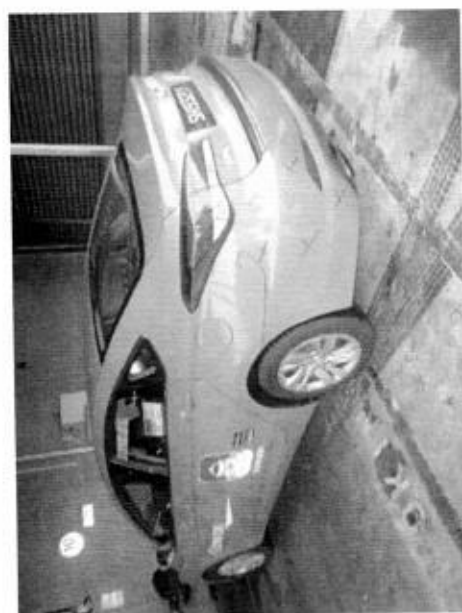
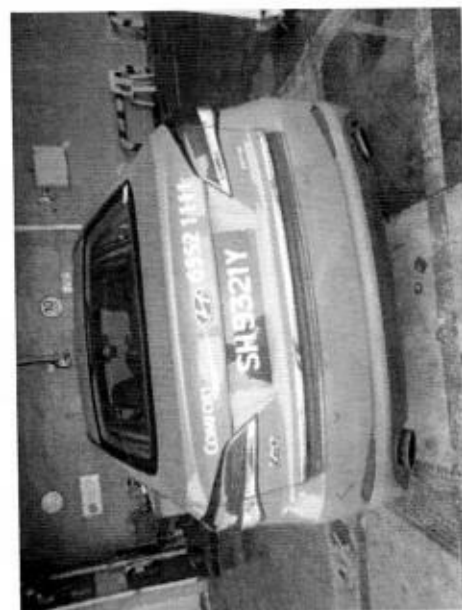
THE VEHICLE SUSTAINED DAMAGES AT THE REAR N/S PORTION. DAMAGES SEE DETAILS.
--

Qty	Description of Parts	Condition	Estimate By Workshop (\$)	Our Adjusted (\$)
	REPLACEMENT OF PARTS			
1	REAR BUMPER	TO REPAIR	603.60	-
10	REAR BUMPER CLIPS	NOT NECESSARY	22.00	-
1	TAIL LAMP (LH)	CRACKED	565.60	565.60
1	FENDER REAR (LH)(NPA)	TO REPAIR	-	-
	LESS 20% DISCOUNT		-238.24	-113.12
			952.96	452.48
	SPECIAL NETT ITEMS			
1	REAR BUMPER RUBBER MAT (SN)	NOT NECESSARY	50.00	-
			50.00	-
	LABOUR			
	THATCHAM STANDARD REPAIR TIME ON BODY WORKS.		520.00	120.00
	THATCHAM TTS STANDARD SPRAY PAINTING COST AND LABOUR.		400.00	360.00
			920.00	480.00
	GRAND TOTAL		1,922.96	932.48
	RECOMMENDED COST OF LUMP SUM REPAIRS (TO ITS PRE-ACCIDENT CONDITION) (CONFIRMED)			750.00
