**ASSIGNMENT**

## REPAIR ESTIMATE\*

**1. Policy Particulars :- THIRD PARTY CLAIM**

## ADJUSTMENT ON REPAIR COST FOR VEHICLE NO. SHD 7056C

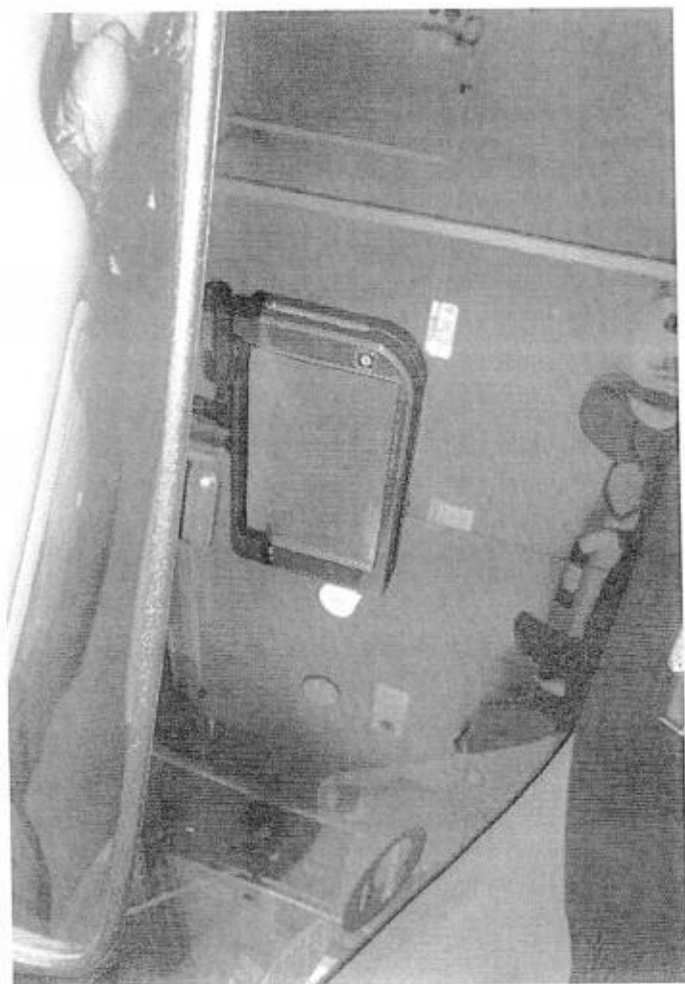
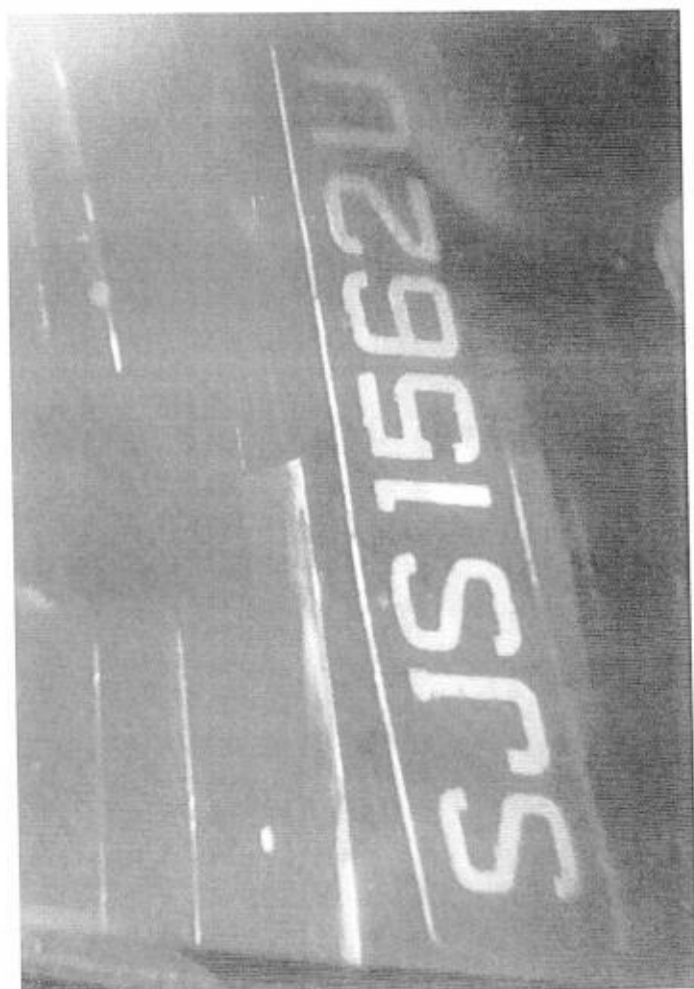
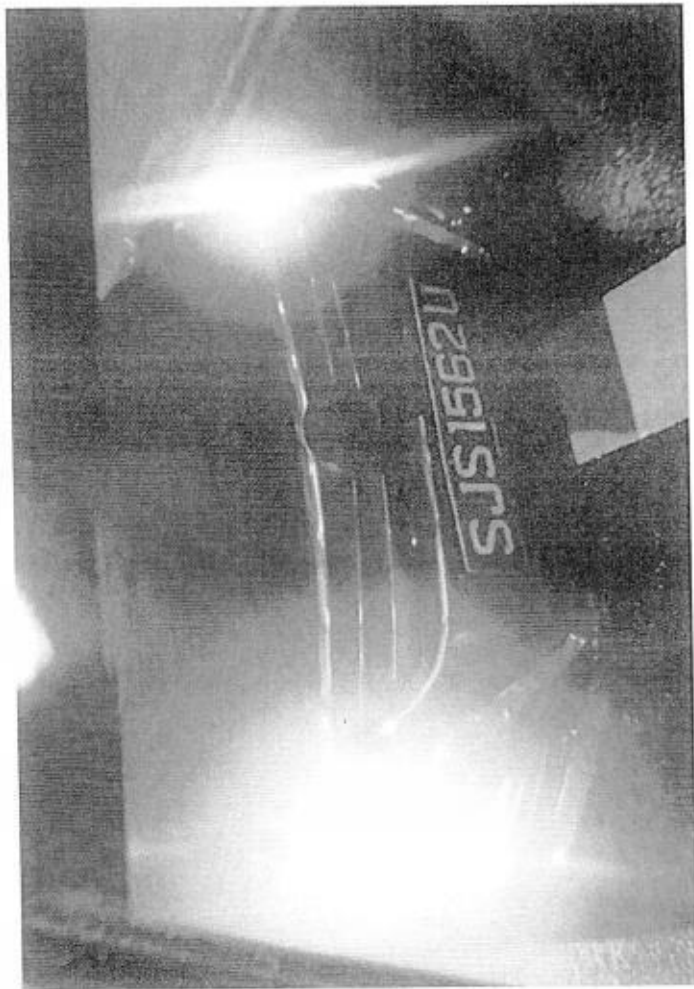
**Rear**  
 The U/C / Chassis frame / Body Structure affected due to collision.

THE VEHICLE SUSTAINED DAMAGES AT THE REAR PORTION. DAMAGES SEE DETAILS.
--

Qty	Description of Parts	Condition	Estimate By Workshop (\$)	Our Adjusted (\$)
<b>REPLACEMENT OF PARTS</b>				
1	REAR BUMPER	DEFORMED	603.60	603.60
10	REAR BUMPER CLIPS	NECESSARY	22.00	22.00
1	REAR BUMPER SPONGE	SERVICEABLE	143.40	-
1	REAR BUMPER UNDER COVER	CUT	225.00	225.00
	LESS 20% DISCOUNT		-198.80	-170.12
			795.20	680.48
<b>SPECIAL NETT ITEMS</b>				
1	REAR BUMPER RUBBER MAT (SN)	NECESSARY	50.00	50.00
			50.00	50.00
<b>LABOUR</b>				
	THATCHAM STANDARD REPAIR TIME ON BODY WORKS.		520.00	220.00
	THATCHAM TTS STANDARD SPRAY PAINTING COST AND LABOUR.		200.00	180.00
			720.00	400.00
<b>GRAND TOTAL</b>			<b>1,565.20</b>	<b>1,130.48</b>
<b>RECOMMENDED COST OF LUMP SUM REPAIRS (TO ITS PRE-ACCIDENT CONDITION) (CONFIRMED)</b>				<b>900.00</b>
