NS/ZNC17024566 / K1rbn2

NTUC INCOME INSURANCE CO-OPERATIVE LTD Ref: NS/INC17024566/K1rb

1. Policy Particulars :- THIRD PARTY CLAIM

ADJUSTMENT ON REPAIR COST FOR VEHICLE NO. SH 6097P

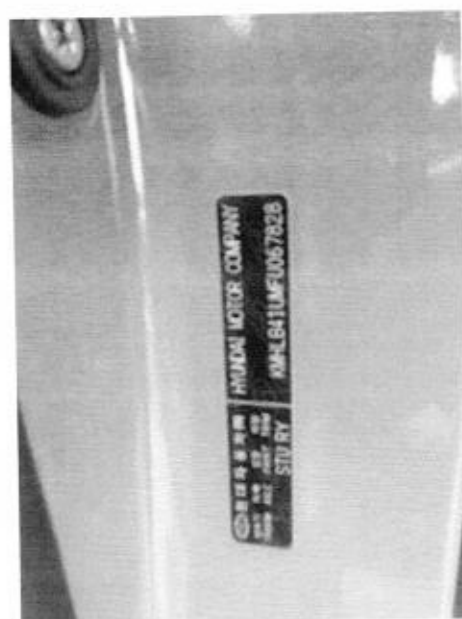
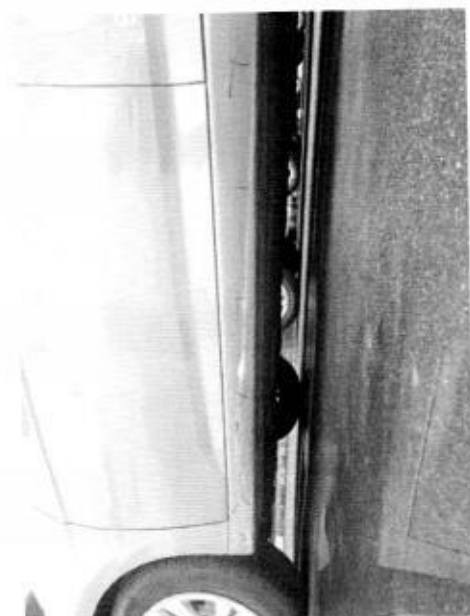
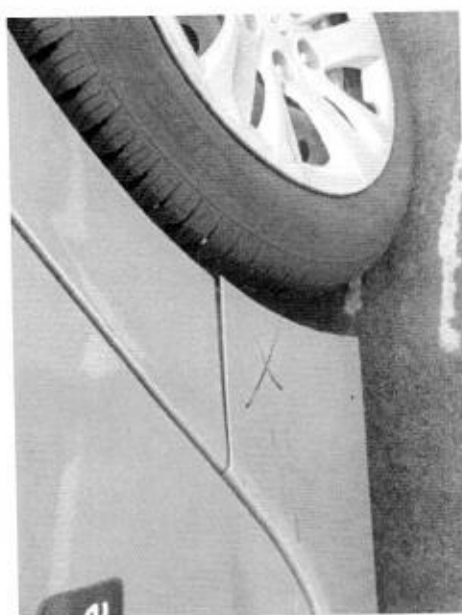
N/S Body

The U/C / Chassis frame / Body Structure affected due to collision

THE VEHICLE SUSTAINED DAMAGES AT THE N/S BODY. DAMAGES SEE DETAILS.
--

Qty	Description of Parts	Condition	Estimate By Workshop (\$)	Our Adjusted (\$)
REPLACEMENT OF PARTS				
1	ROCKER PANEL OUTER GARNISH (LH)	TO REPAIR	483.60	-
1	FRONT DOOR (LH)(NPA)	TO REPAIR	-	-
1	REAR DOOR (LH)(NPA)	TO REPAIR	-	-
	LESS 20% DISCOUNT		-96.72	-
			386.88	-
SPECIAL NETT ITEMS				
1	REAR DOOR COMFORTDELGRO & APPS STICKER (LH) (SN)	NECESSARY	80.00	80.00
1	FRONT DOOR COLOURED COMFORT LOGO (LH)(SN)	NECESSARY	75.00	75.00
			155.00	155.00
LABOUR				
	THATCHAM STANDARD REPAIR TIME ON BODY WORKS.		350.00	200.00
	THATCHAM TTS STANDARD SPRAY PAINTING COST AND LABOUR.		600.00	540.00
			950.00	740.00
GRAND TOTAL			1,491.88	895.00
RECOMMENDED COST OF LUMP SUM REPAIRS (TO ITS PRE-ACCIDENT CONDITION) (CONFIRMED)				700.00
