Ref : CS3/MSG17015198/vb-1

Insured Veh.	SCY 9108Y	Veh. Inspected	SBQ 1199R
Policy No.	28808660QMX	Coverage (\$)	0.00
Claim No.	522461	Excess (\$)	0.00
Assign From	MERIMEN (MONICA CHUNG)	Assign Date	26/12/2017

Final repair bill for BMW 325i SBQ 1199 R

VEHICLE DAMAGE INSPECTION REPORT

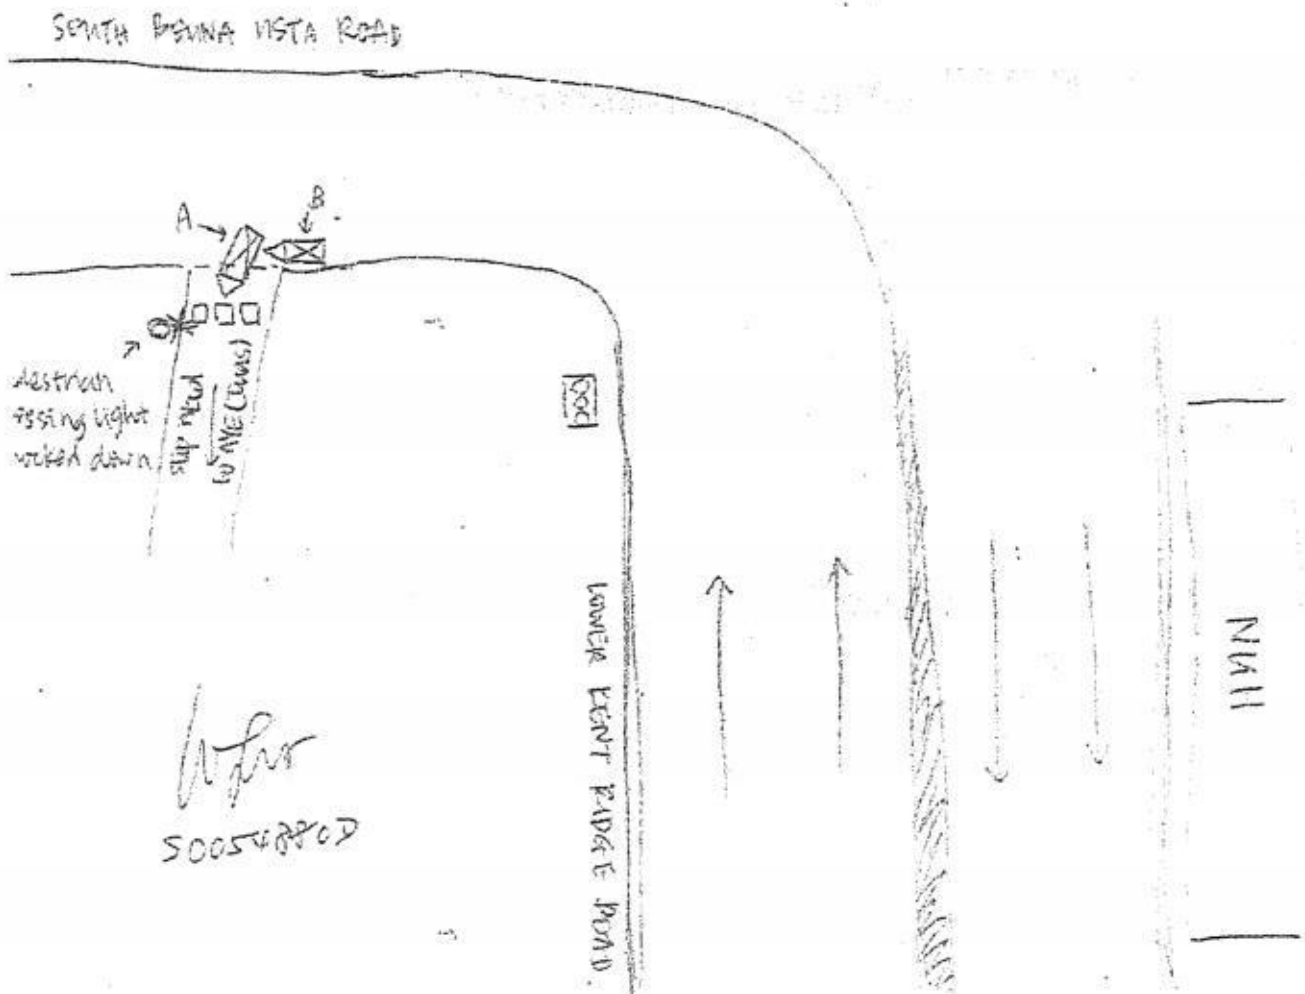
Refer to the attached sketch plan

A → SCY 9108 Y
B → SBQ 1199 R
