To inspect Vehicle No: GV1318D Insured: SFU 2233A

- FW: PRE-REPAIR INSPECTION - ACCIDENT INVOLVING OUR INSURED VEHICLE SFU2233A AND GV1318D (REVOL) ON 27/12/2017

NOTICE TO INSURER TO CONDUCT PRE-REPAIR

VEHICLE DAMAGE INSPECTION REPORT

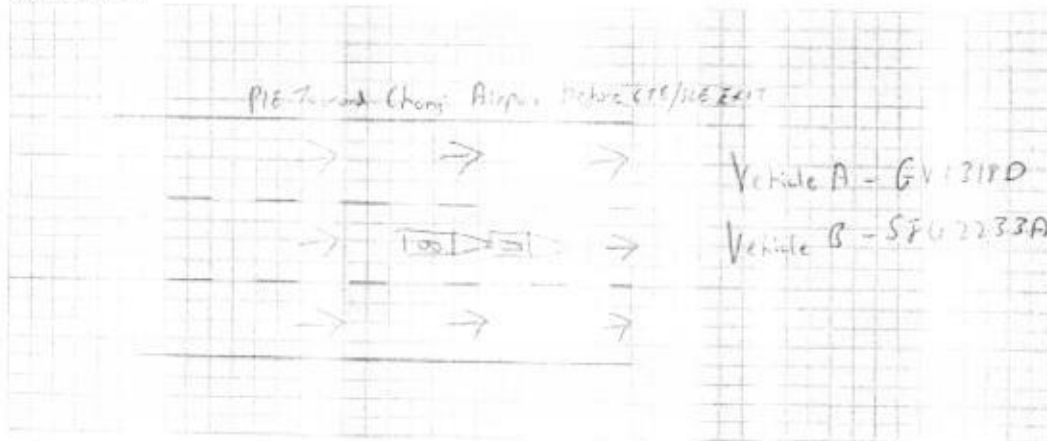
Sketch Plan #2

DESCRIBE CIRCUMSTANCES OF THE ACCIDENT

On 27/12/2017 at around 1738hrs. I am driving Vehicle A (GV1318D) travelling straight along PIE towards Chong Airport before 5:30/5:35 EXIT when suddenly Vehicle B (SFU 2233A) knocked into my rear.

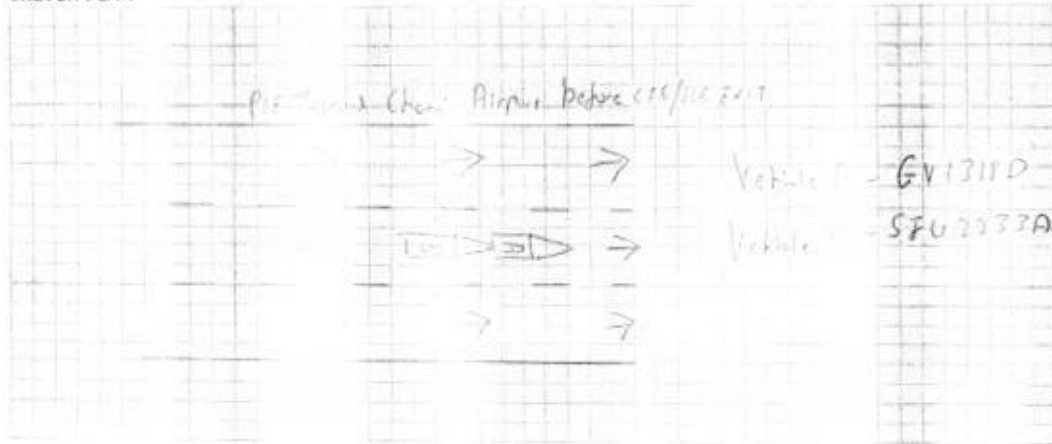
Sketch Plan #2

DESCRIBE CIRCUMSTANCES OF ACCIDENT

On 27/11/2017 at 1:28hrs, I am driving Vehicle A GY1311D towards Change Rthrup before CR/PLC EXIT when saw Vehicle B SFU 2237A entering my lane.
