1. Policy Particulars :- THIRD PARTY CLAIM

Date Of Report	29/12/2017 09:43
Date Of Accident	28/12/2017 10:35
Exact Location Of Accident	PIE TWDS CHANGI EXIT SLIP RD TO EUNOS LINK
Country/State of Loss	SINGAPORE

THE VEHICLE SUSTAINED DAMAGES AT THE O/S FRONT PORTION. DAMAGES SEE DETAILS.

ADJUSTMENT ON REPAIR COST FOR VEHICLE NO. SH 7288Z

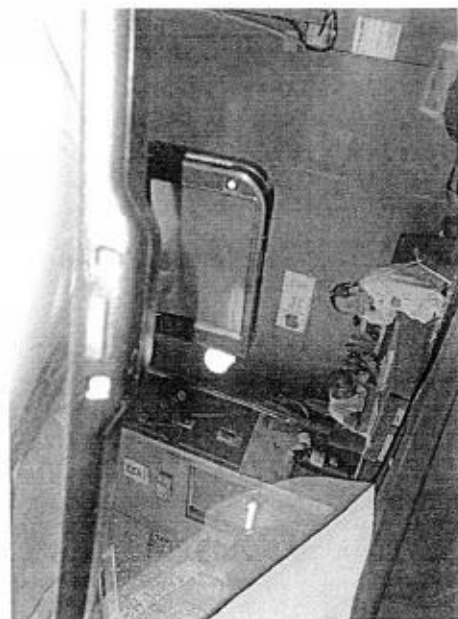
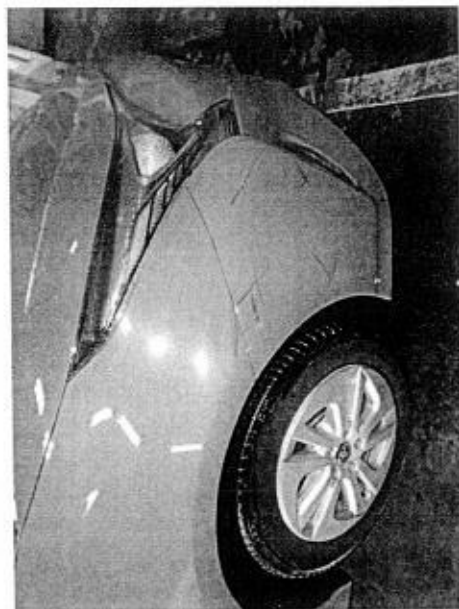
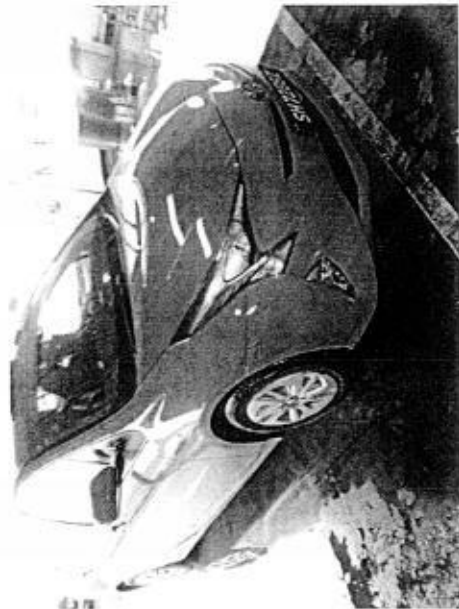
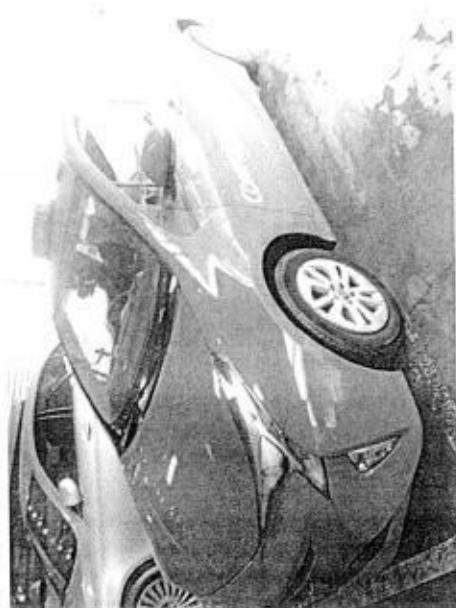
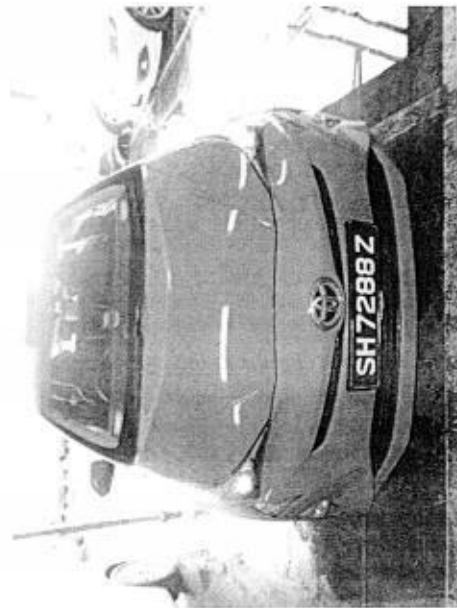
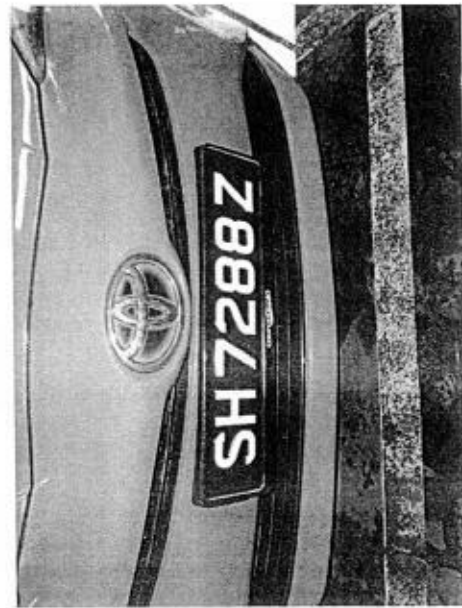
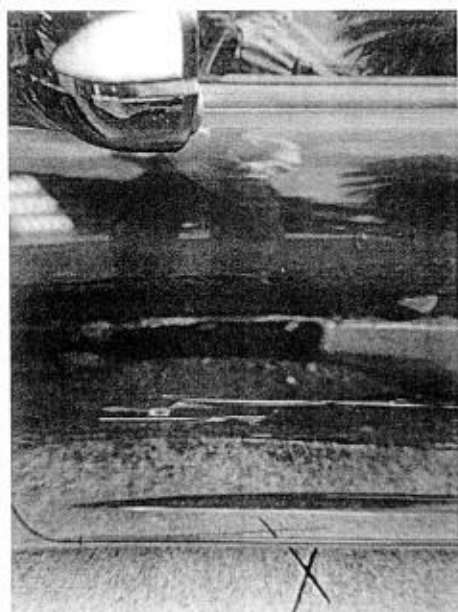
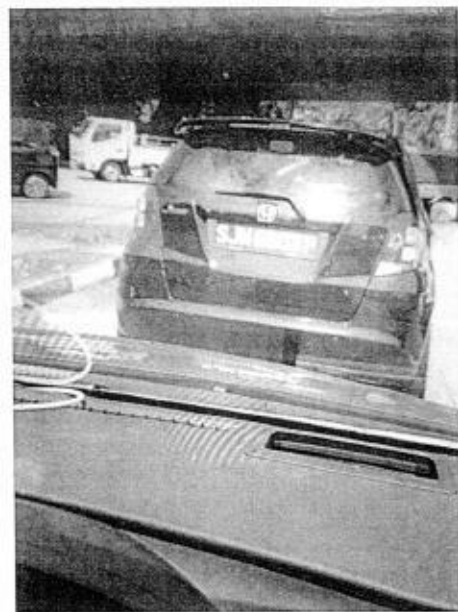
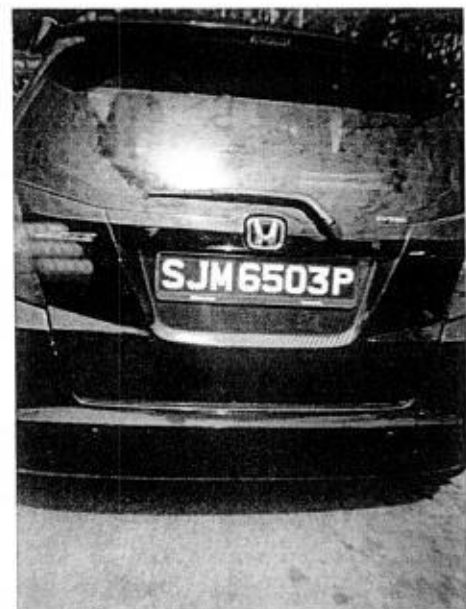
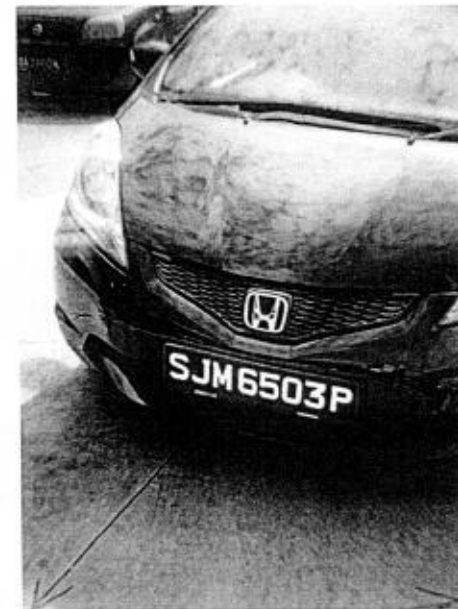
o/s Front.

Qty	Description of Parts	Condition	Estimate By Workshop (\$)	Our Adjusted (\$)
	REPLACEMENT OF PARTS			
1	FRONT BUMPER COVER	DEFORMED	490.50	490.50
1	BRACKET,FRONT BUMPER SIDE,RH	SERVICEABLE	77.00	-
1	FRONT FENDER (RH)(NPA)	TO REPAIR	-	-
	LESS 25% DISCOUNT		-141.87	-122.62
			425.63	367.88
	LABOUR			
	THATCHAM STANDARD REPAIR TIME ON BODY WORKS.		350.00	200.00
	THATCHAM TTS STANDARD SPRAY PAINTING COST AND LABOUR.		400.00	360.00
			750.00	560.00
	GRAND TOTAL		1,175.63	927.88
RECOMMENDED COST OF REPAIRS (CONFIRMED)				927.88
