1. Policy Particulars :- THIRD PARTY CLAIM

**ACCIDENT DAMAGED VEHICLE INSPECTION REPORT**

Date : 22 November 2017
Our Ref : TP/THH/SLP747C/7769

Registration No : SLP 747 C
Make : Mercedes Benz
Model : E350D AMG
Year : 2017

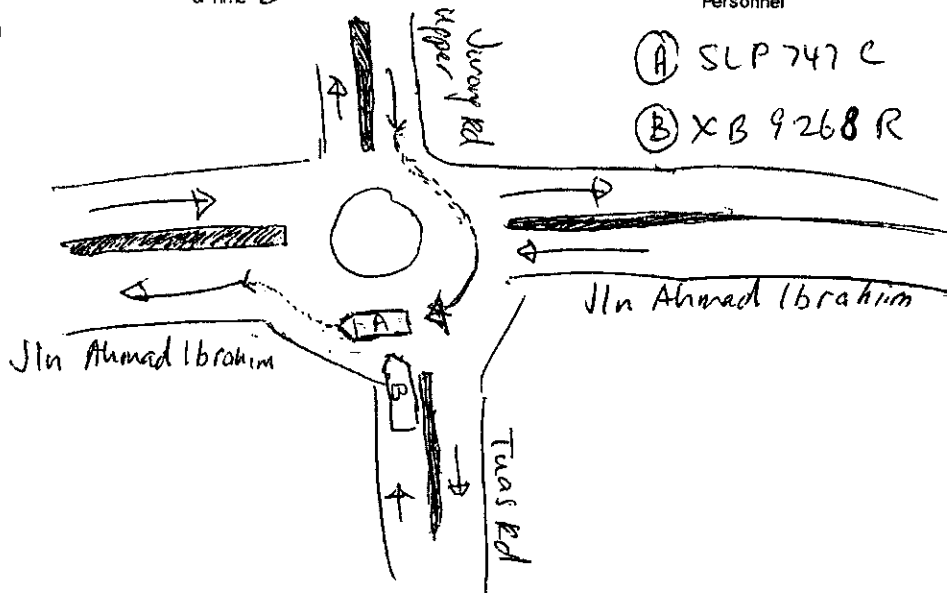
Sketch Plan

Date Of Report	07/08/2017 14:12
Date Of Accident	07/07/2017 11:05
Exact Location Of Accident	JLN AHMAD IBRAHIM/ CIRCLE-BELOW TUAS FLYOVER
Country/State of Loss	SINGAPORE

Type Of Accident	COLLISION - ROUNDABOUT
Weather Conditions	CLEAR
Road Surface	DRY
