VEHICLE DAMAGE INSPECTION REPORT**Our File No:** CS/CT118000742/GTD3E2
Date: 09/03/2018**REFERENCE**

Handling Insurer:	China Taiping Insurance (Singapore) Pte. Ltd.	Policy No:	DMCVSN3051631702		
Claimant Vehicle No :	GBD360R	Insured Vehicle No :	GBD9304U		
Date of Loss:	08/01/2018	Nature of Claim:	TP	Claim No:	SNM18D00196C02

Reg No:	GBD360R		Engine No:	ZD30337605K
Make & Model:	NISSAN CABSTAR, 3.0 5M/T ABS 2DR 2WD EURO 5 (A)		Chassis No:	JN1SC2F24Z0855693
Reg. Date:	30/04/2014 (Man. Year: 2014)		Odometer:	141564 km
Colour:	Silver			
Engine Capacity:	2953 cc			
Market Value/New Car Price:	N/A			
Sum Insured (\$\$):	Market Value/New Car Price

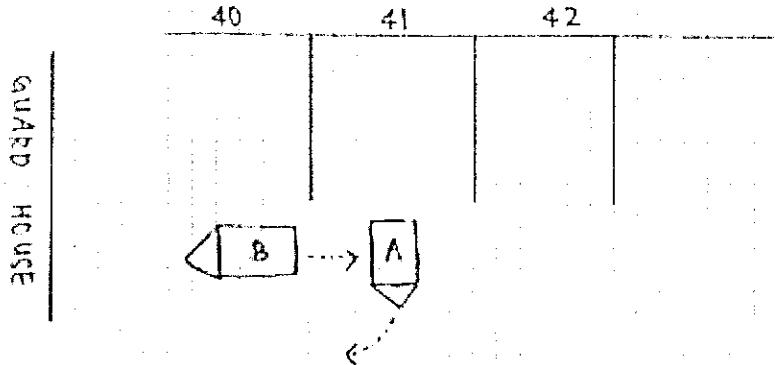
Sketch Plan #2

DESCRIBE CIRCUMSTANCES OF THE ACCIDENT

On 08.01.2018 @ 0700 HR, I came out from parking lot no. 41. vehicle "B" was parked, waiting to pick up his workers. I'm already out of the lot and was heading for the exit, suddenly vehicle "B" reversed & collided into my car. That's all.
