Your Ref: JLC/0219/2016.LLL  
Our Ref : CI1/LAW18000933/D

**Fatal Road Traffic Accident On 07 June 2016 At About  
2107Hrs, Along Jurong West Avenue 1 Towards Jurong  
Town Hall Road, Near Lamppost 55, Involving A Motor  
Car SJD 5210M And A Female Pedestrian**

**Requested By  
Jay Law Corporation  
101 Upper Cross Street #04-17A  
People's Park Centre  
Singapore 058357**

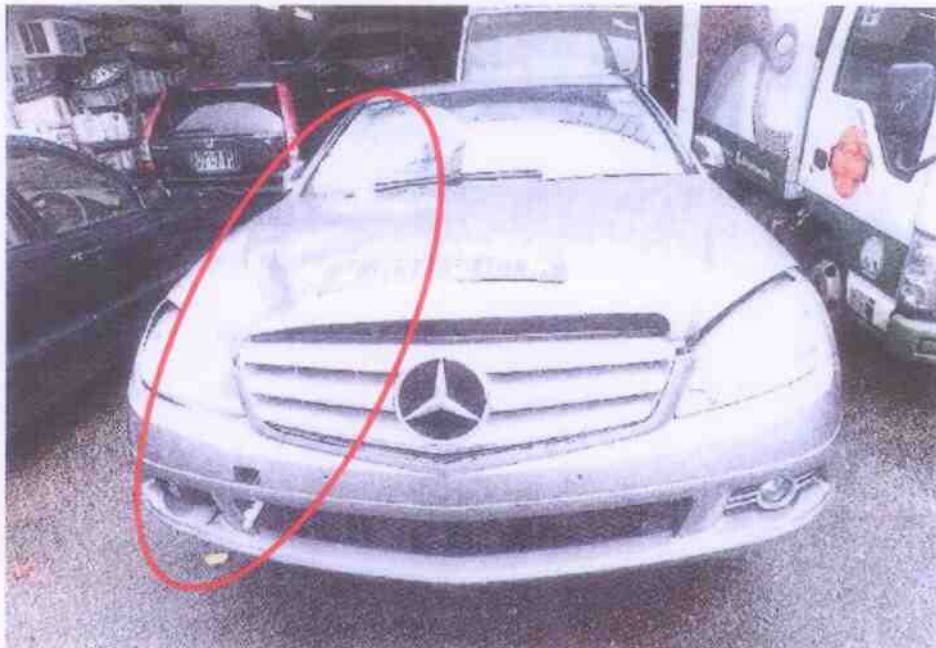
- 15. The damage to the front right portion of the Motor Car correspond to a typical motor car vs pedestrian collision where the pedestrian was struck below his/her centre of mass, resulting in the pedestrian being thrown onto the front bonnet and/or front windscreen of the Motor Car before falling/sliding onto the road surface and rolling/tumbling to his/her final rest position. See photo 1 & 2 below.

**Photo 1** shows a general view of the front body of the Motor Car. The damage to the front right body (circled) of the Motor Car was a result of its collision with the Deceased. Such damage profile is typical of a motor car vs pedestrian collision where the impact onto the pedestrian was below his/her centre of mass. In such type of collision, the pedestrian will be thrown onto the front bonnet and/or front windscreen of the motor car.

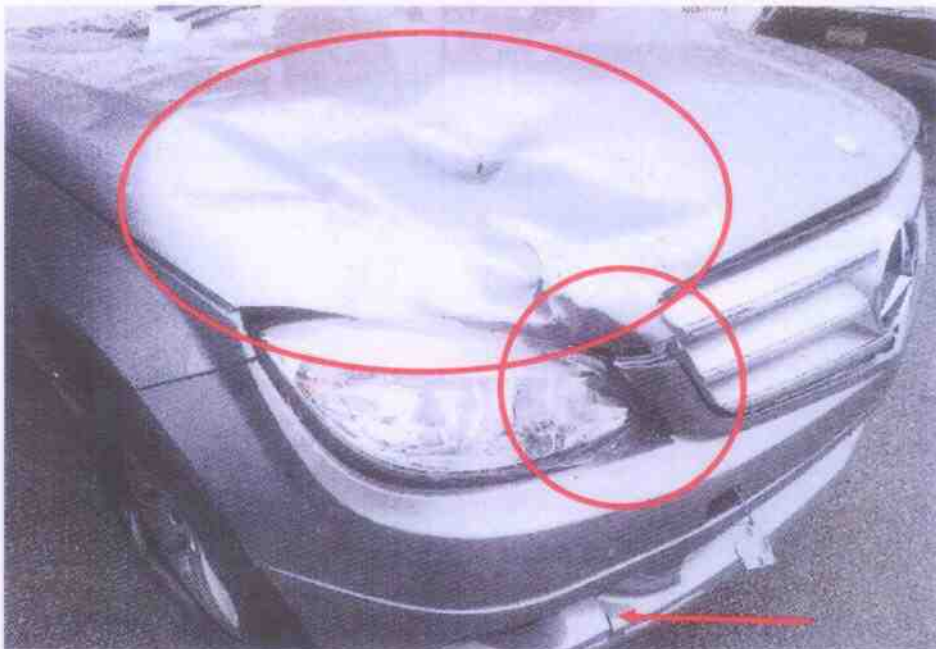
**Photo 2** shows the front body of the Motor Car. The damage to the front bumper (arrowed), front right headlamp and front bonnet (circled) were all caused by the Motor Car's collision with the Deceased.

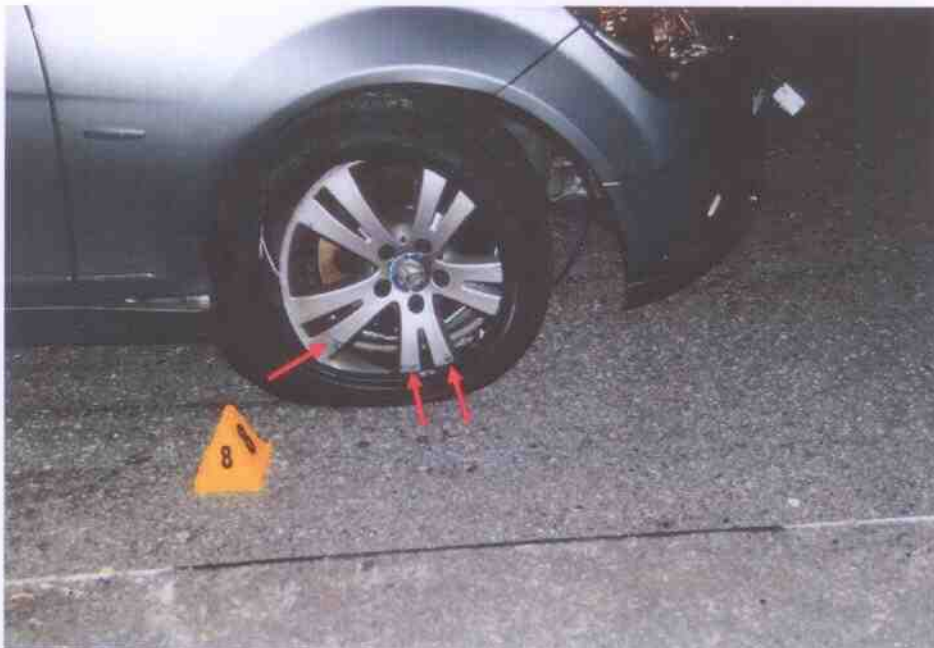
16. Apart for the damage to the front right body, the front right wheel rim of the Motor Car was also broken. The front right tyre was deflated and loosely wrapped around the broken front right wheel rim. The rear right tyre was also deflated however it was still wrapped around the rear right wheel rim.

**Photo 3** shows the Motor Car at the accident scene. The front right wheel rim was broken while the front right tyre was deflated and loosely wrapped around the front right wheel rim. The exterior surfaces of the wheel rim did not appear to have sustained any significant damage except for some blackish grazed marks (arrowed) on its outer spokes.

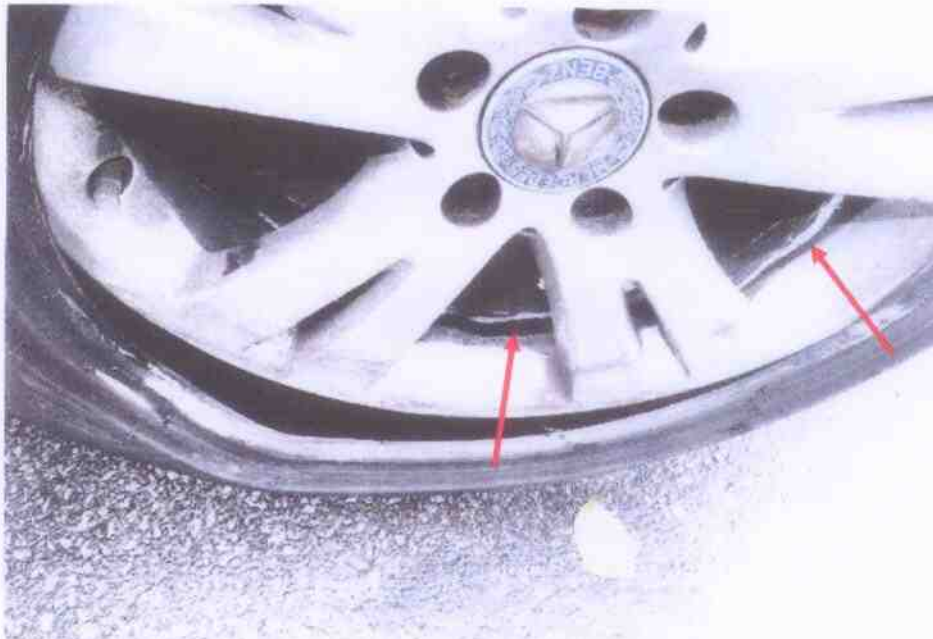
17. Further examination of the available photographs had showed the front right wheel rim was broken on the inner side width of the wheel rim. This indicates that the impact causing the wheel rim to be broken was from the underside of the Motor Car and not from the exterior side of the Motor Car.

**Photo 4** shows a closer view of the damaged front right wheel rim of the Motor Car. Upon closer examination of the photograph, it was observed that the front right wheel rim was broken on the inner side width of the wheel rim (arrowed). This indicates that the impact causing the wheel rim to be broken was from the underside of the Motor Car and not from the exterior side of the Motor Car.

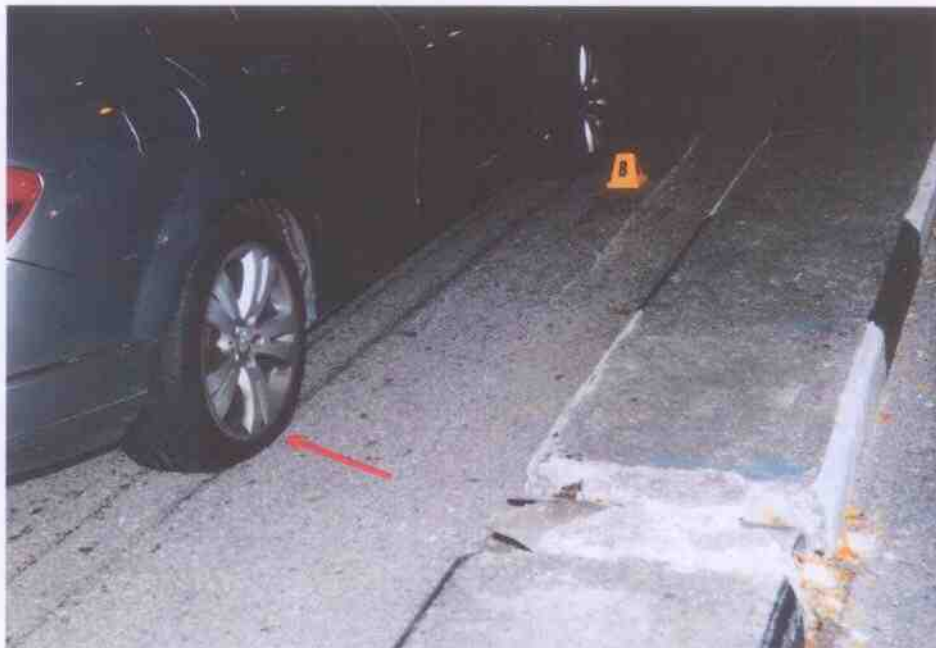
18. These damages that were found in the right side of the Motor Car did not arise from the collision with the Deceased. The information and observations that could be gathered from the police accident scene photographs and police sketch plan seem to suggest that these damages were a result of the Motor Car mounting the centre divider kerb. See photo 3 - 5 below.

**Photo 5** shows the slightly deflated rear right tyre of the Motor Car (arrowed). The damage to the front right wheel rim, deflation of the front right tyre and deflation of the rear right tyre did not arise from the collision with the Deceased.

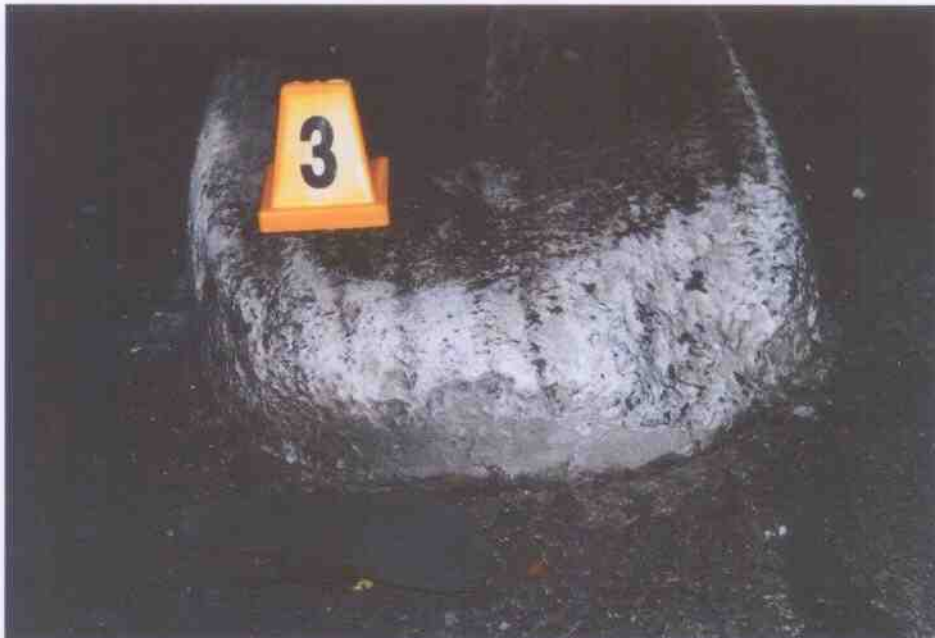
20. With regard to the chipped mark at placard 3, I was not able to conclusively ascertain whether this chipped mark was a fresh damage or old damage. The police accident scene photograph showing a close up view of this particular chip mark had showed the rounded end of the centre divider road kerb broken. The lack of powdery residue surrounding the chipped off areas and/or on the road surface suggest that the damage to this part of the road kerb may have been not related to this accident. It is therefore unlikely that the Motor Car had mounted the centre divider kerb at placard 3. See photo 6 – 10 below.

**Photo 6** shows a closer view of placard 3, identified by the police to be chipped and scratch mark. I was not able to conclusively ascertain whether the chipped mark was a fresh damage or old damage. The lack of powdery residue surrounding the chipped off areas and/or on the road surface suggest that the damage to this part of the road kerb may have been not related to this accident.

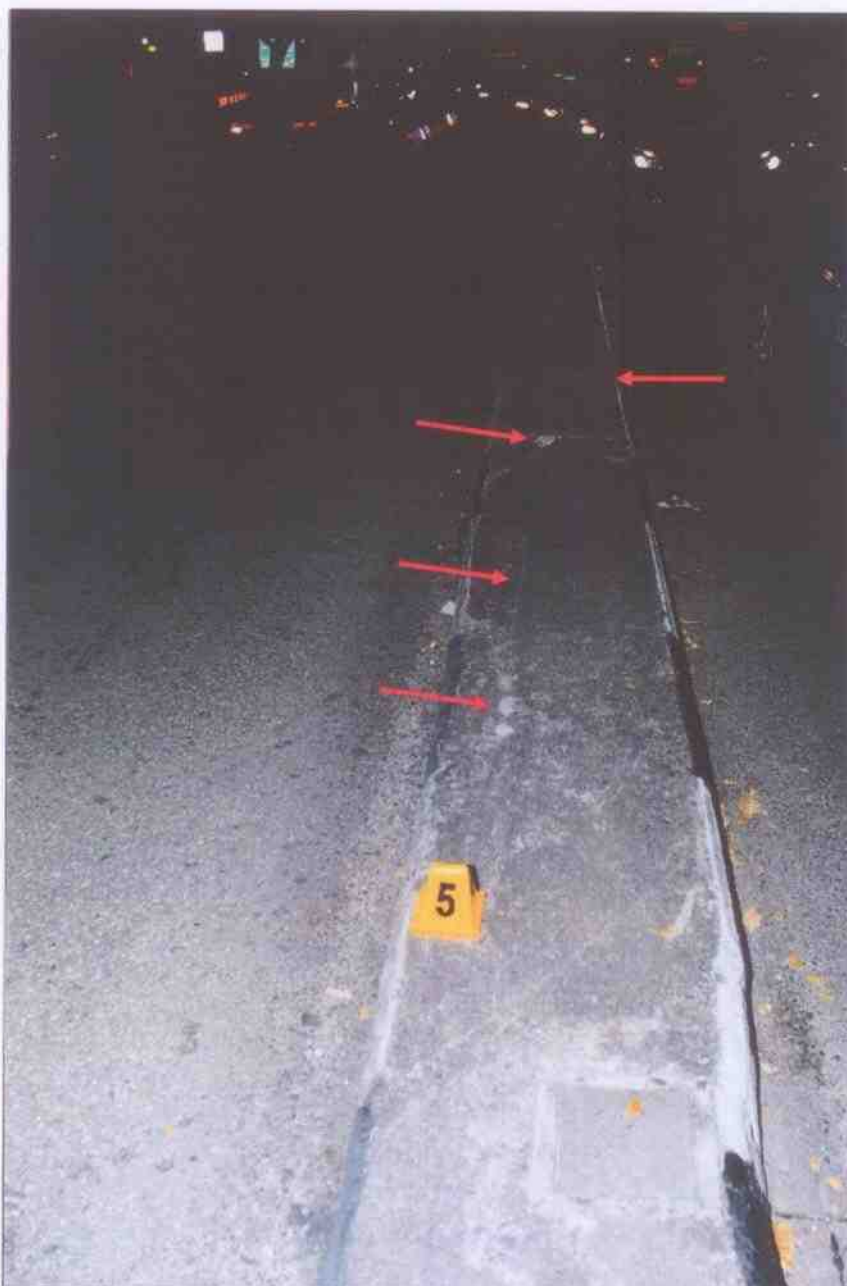
**Photo 7** shows the start of placard 5, identified by the police to be gouge mark. Although the gouge mark was not clearly depicted in the photograph, I was still able to observe marks (arrowed) that appeared to be fresh, on the top surface of the centre divider road kerb.

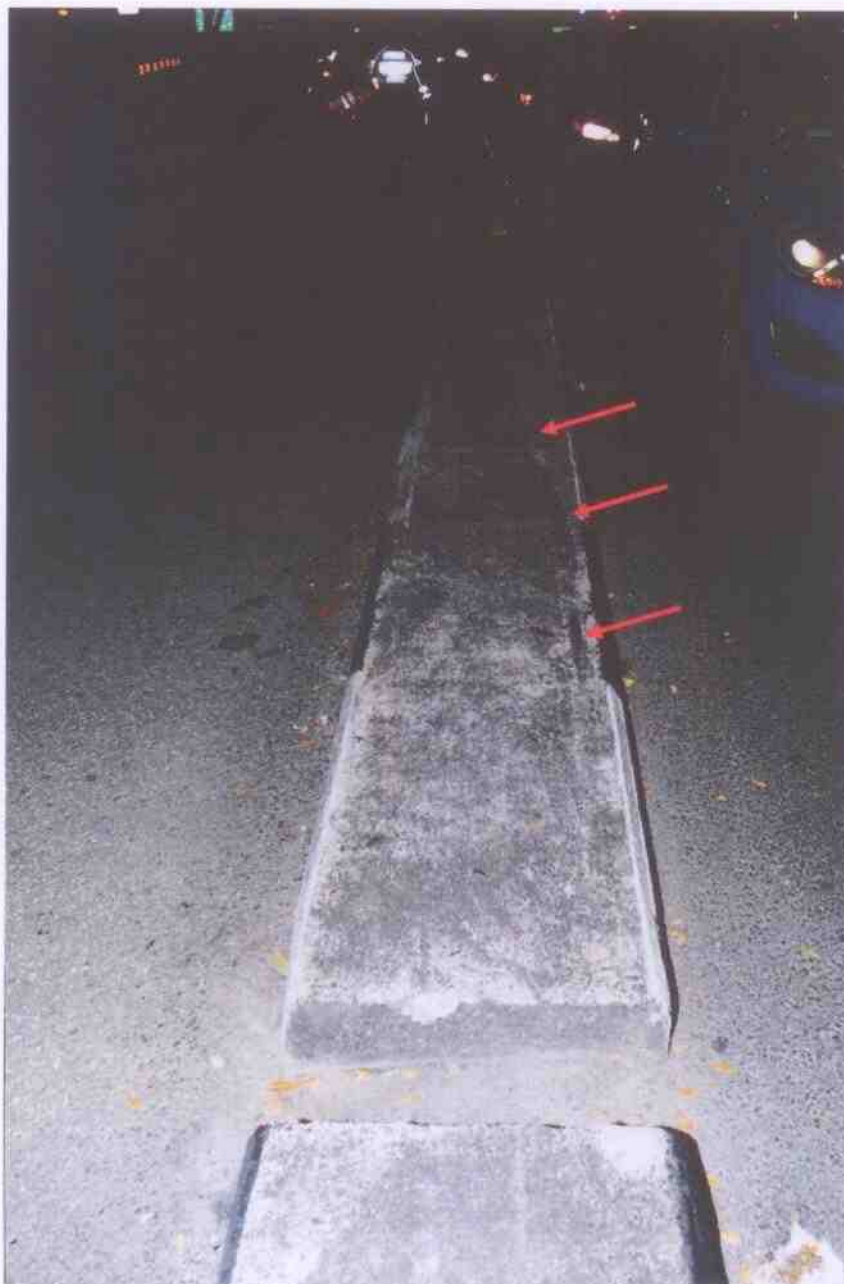
**Photo 8** shows the stretch of centre divider road kerb from placard 5 leading to placard 6. Although not recorded by the police, I had observed what appears to be tyre marks (arrowed) on the top surface area leading towards placard 6.

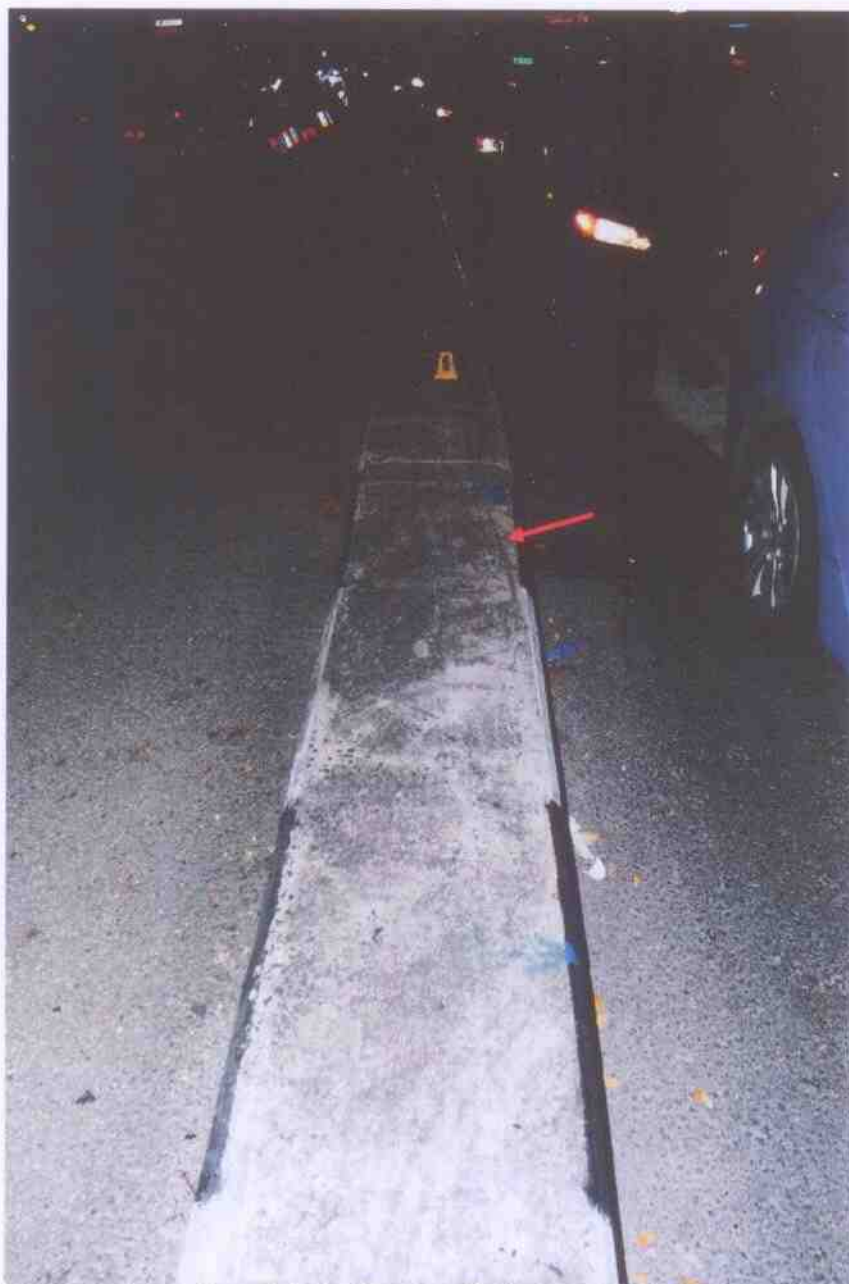
**Photo 9** shows the stretch of centre divider road kerb from placard 5 leading to placard 6. Although not recorded by the police, I had observed what appears to be tyre marks (arrowed) on the top surface area along another stretch of the centre divider road kerb leading towards placard 6.

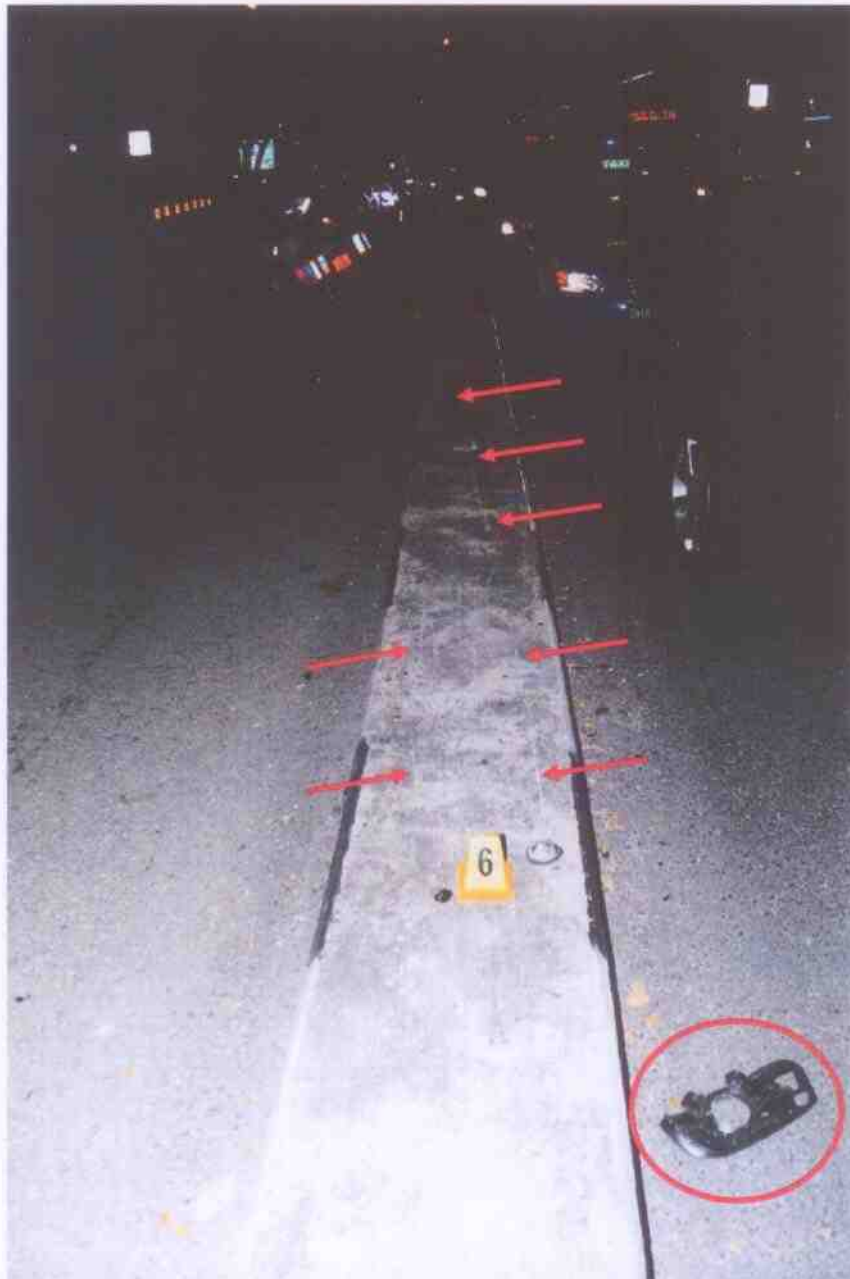
**Photo 10** shows the stretch of centre divider road kerb from placard 6. The police had identified placard 6 to be scratch marks and debris. The dislodged front right fog lamp cover (circled) of the Motor Car can be seen lying on the road surface on the opposite side of the Motor Car's travel direction. Several scratch marks (arrowed) can also be seen on the top surface of the centre divider road kerb leading towards the roadway, to placard 7, which is recorded by the police to be tyre mark.

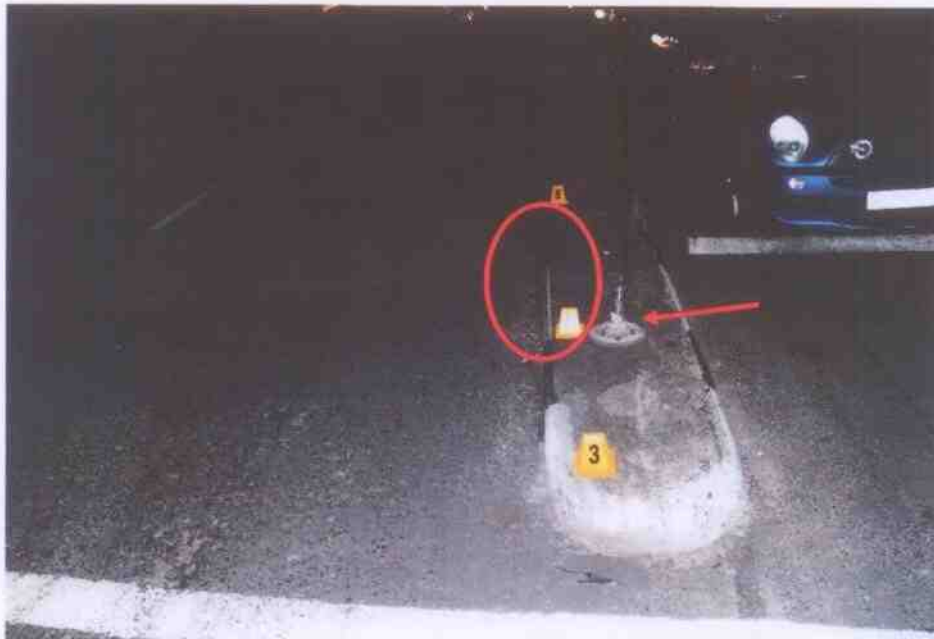
21. The damage at the front right wheel rim and deflation of the rear right tyre together with the various marks that were found on the top surface of the centre divider kerb indicates that the right side of the Motor Car had mounted the centre divider kerb. The point/location where the Motor Car had mounted the centre divider kerb does not appear to be at the rounded end of the centre divider road kerb that was marked as placard 3. It is more likely to be after placard 3, just before placard 5. The plastic bollard, marked as placard 4, could have then been possibly damaged by the Motor Car as it was mounting the centre divider kerb. See photo 11 below.

**Photo 11** shows a general view of the centre divider kerb just after the pedestrian crossing. The Motor Car was likely to have mounted the centre divider kerb after placard 3, just before placard 5 (circled). The plastic bollard (arrowed), marked with placard 4, would have been possibly damaged by the Motor Car as it was mounting the centre divider kerb.

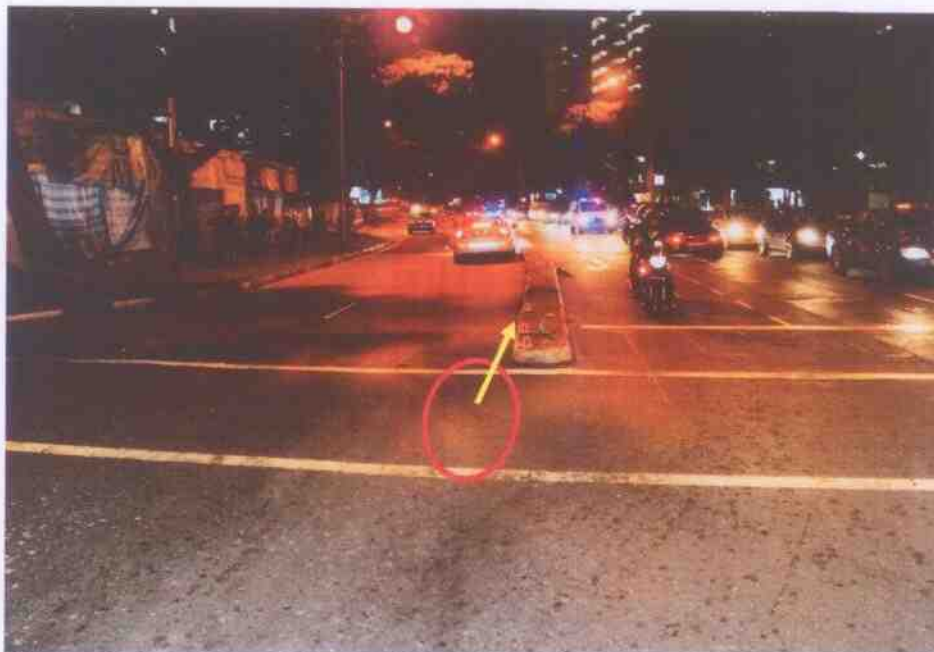
23. Since the Motor Car had likely mounted the centre divider kerb at a location that was relatively close to the pedestrian crossing, the Deceased was then more likely to be crossing the pedestrian crossing rather than standing on the centre divider kerb a distance away from the Accident Junction, as recalled by the Driver. The location of the point of impact between the Motor Car and the Deceased was likely to be within the pedestrian crossing, on the right side of the extreme right lane of Jurong West Avenue 1. The event of the Motor Car mounting the centre divider kerb was a response to a situation encountered by the Driver. This situation was the Motor Car's collision with the Deceased. See photo 12 below.

**Photo 12** shows a general view of the accident scene. The location of the point of impact between the Motor Car and the Deceased was within the pedestrian crossing, on the right side of the extreme right lane of Jurong West Avenue 1 (circled). The Motor Car subsequently mounted the centre divider road kerb, at the approximate area indicated by the yellow arrow. It eventually dismounted the centre divider road kerb, coming to a complete rest on the extreme right lane, as seen in the police accident scene photographs.
