Date Of Report	28/10/2017 13:57
Date Of Accident	28/10/2017 10:20
Exact Location Of Accident	NO : 7 SOON LEE STRRET - LEVEL 2
Country/State of Loss	SINGAPORE

## AUTOMOBILE INSPECTION REPORT

Registration No. : YN 6216 K  
Make/Model : Isuzu NNR85UH4A  
Yr of Manuf/Regn : 2014  
Carrying Capacity : -  
Chassis No. : JAANNR85HE7100021  
Engine No. : 4JJ11D0994  
Colour : Metallic White  
Class : Lorry ( Goods )

## ADJUSTMENT ON REPAIR COST FOR VEHICLE NO. YN 6216K

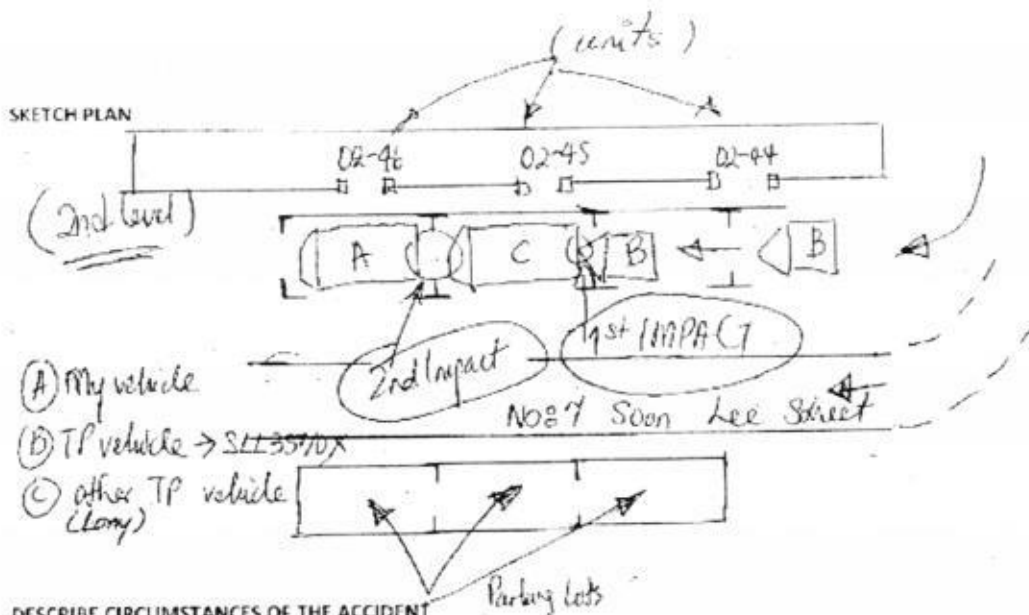
# Sketch Plan

I parked my vehicle at the stated place, date & time, at about 10:25am, my <sup>one of</sup> employee came and call me at my office, <sup>which</sup> was inside near by and told me there was 3 vehicles involved in an accident and one of this vehicle was mine. I went down to see what had happened and saw a vehicle 'B' had collided into vehicle 'C' which was parked behind my car, due to the impact vehicle 'C' had hit into my vehicle rear.

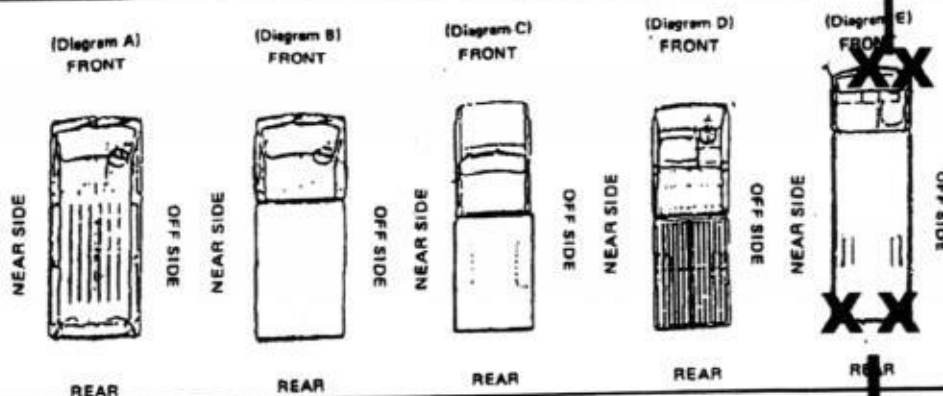
## POINT OF IMPACT

Direction of impact/damage marked (→) (X)

The vehicle sustained impact on its Front O/s portion and Rear Portion. (see Diagram E)

The front o/s corner panel and bumper, front centre panel, rear no. plate and bracket were dented.

A static inspection was carried out on 31/10/2017 & our report is here with enclosed for your perusal. The Repairs Estimate submitted by M/s Power Fook Vehicle Service as per attached Appraisalment Schedule have been revised and scrutinised thoroughly by us & in our opinion, we consider it to be fair and reasonable. The repairer has agreed to effect repairs to the owners satisfaction & to roadworthy condition on an agreed Part by Part Repair Basis of \$ 2,730.00 after deducting the Policy Excess Clause of \$ NA. As instructed, we have not authorised any of the repairs on your behalf.
