Preliminary Advice

Make : HONDA WAVE 125

The vehicle sustained impact / damages front portion, o/s and n/s body and parts claimed are consistent to the accident.

VEHICLE DAMAGE INSPECTION REPORT**Our File No:** CS/MSG18001338/GVD3E2**Date:** 01/02/2018**REFERENCE****Handling Insurer:** MSIG Insurance (Singapore) Pte. Ltd.**Policy No:** A29050805QMY**Claimant Vehicle No :** FX3338J**Insured Vehicle No :** SLT7976R**Date of Loss:** 18/01/2018**Nature of Claim:** TP**Claim No:** 546796**DESCRIPTION & IDENTIFICATION OF VEHICLE****Reg No:** FX3338J**Make & Model:** HONDA WAVE 125, 125cc**Engine No:** NF125MDE0078147**Reg. Date:** 30/10/2003 (Man. Year: 2003)**Chassis No:** NF125MD0078147**Colour:** Black**Odometer:** 0 km**Engine Capacity:** 125 cc**Market Value/New Car Price:** N/A**Sum Insured (S\$):** Market Value/New Car Price**CONDITION OF VEHICLE AT THE TIME OF SURVEY****General Condition:** Steering (Serviceable):**Yes** **Footbrake (Serviceable):** **Yes****Handbrake (Serviceable):** **Yes** **Engine Modification:****No** **Pre-accident Condition:****CONDITION OF TYRES****Front Tyre Size:** 80/90-17**Rear Tyre Size:** 90/80-17**Front Left Side:** Pirelli 4 mm**Rear Left Side:

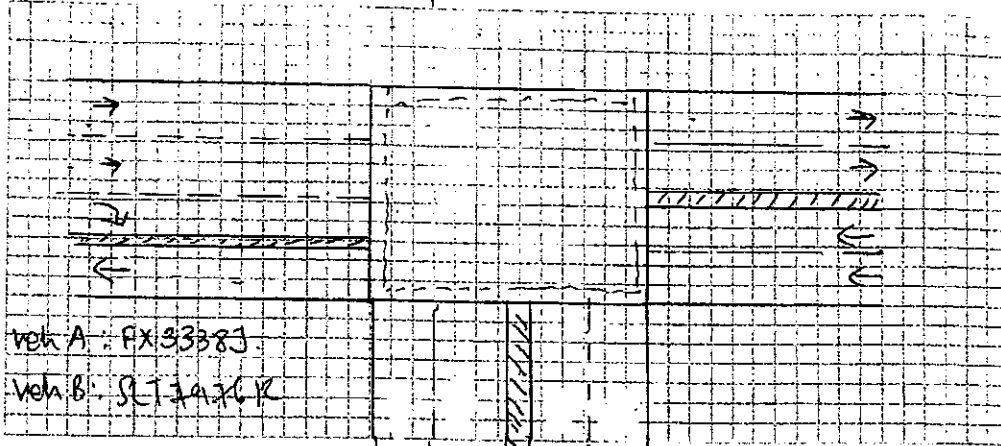
Sketch Plan #2 Pg. 1

Hand-drawn sketch of an accident scene on a grid background. It shows a vertical road and a horizontal road. A dashed line indicates a path or boundary. A car is shown in the middle of the intersection, with arrows indicating its movement. The car is labeled 'B' and 'SLT4436R'. There are also arrows pointing towards the car from the left and right. The sketch is drawn on a grid background.

Please refer to police report No: T/20180119/2082
