OD/TP Re-inspection / Evaluation

To Inspect Vehicle No: SEIN 8446M Insured: SLK 7930U
at Workshop m/s Hendon Automotive Tel: _____
of 280 Woodlands Ind Park E5 #01-19
Policy No: _____ Claim No: 964874951036
Sum Insured: _____ Excess: _____
Make of Veh: _____ D.O.A. 21.01.2018
(Client's Record)

SYNOPSIS OF DAMAGES

VEHICLE DAMAGE INSPECTION REPORT

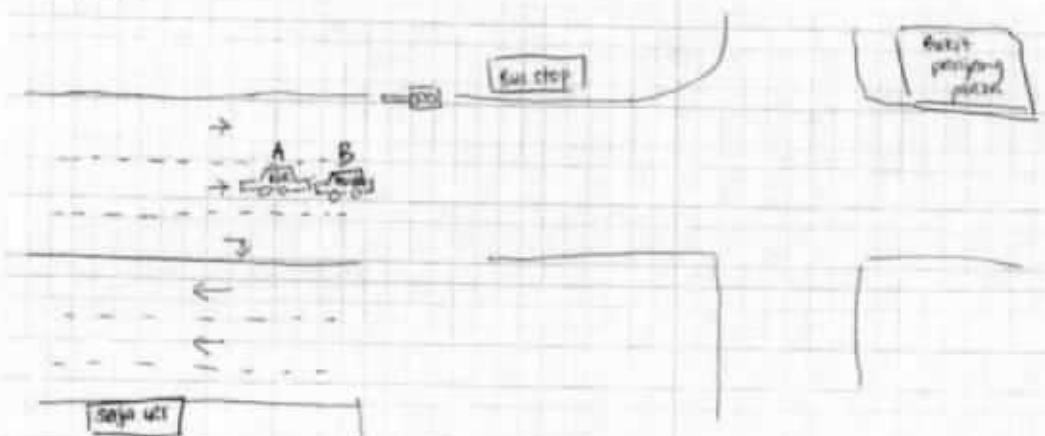
SKETCH PLAN

DESCRIBE CIRCUMSTANCES OF THE ACCIDENT

I was driving along Bukit Panyang Road, going towards Bukit Panyang Plaza. As I was approaching the traffic light which was green, a black Honda stream in front of me braked as the green light turned to amber. I applied my brake immediately but still unable to put the car to a full stop, hence knocking into the back of the Honda stream.

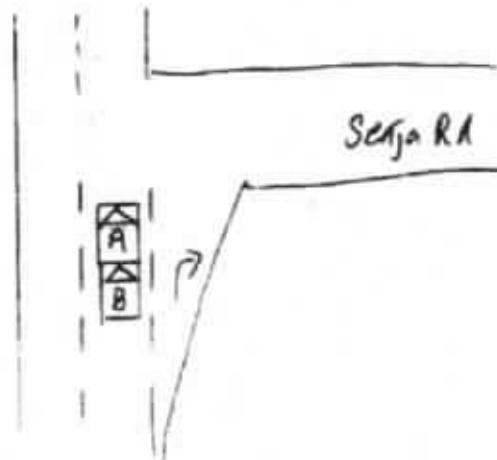
SKETCH PLAN

Veh A: SHN 8046 M
B: SLK 7930 U

DESCRIBE CIRCUMSTANCES OF THE ACCIDENT Bukit Panjang Ring Rd

I was travelling on the 2nd lane of Bukit Panjang Ring Rd towards ^{city} ~~the town~~
I stopped at the traffic light at the junction with Senja Road.
