**Preliminary Advice**

Insured Vehicle No	: SJX8662S	Accident Date	: 10/01/2018
TP Vehicle No	: SLK8840P	Assignment Date	: 23/01/2018
Make	: BMW 216D	Est. Duration of Repair	: 5.00
Date of Inspection	: 29/01/2018		
Inspection At	: PERFORMANCE MOTORS LIMITED (ALEXANDRA) 303 ALEXANDRA ROAD, SIME DARBY PERFORMANCE CENTRE SINGAPORE 159941

## VEHICLE DAMAGE INSPECTION REPORT

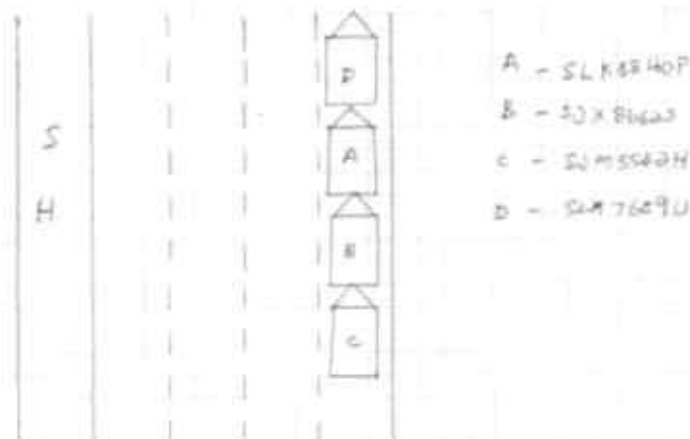
KPE (TPE) before Fort Rone Exit

However, I would like to clarify on line 4 of the report my car stopped completely and did not collide with the car in front (2M7629U). It was only after 3JX81623 collided into my car, that caused my car to move forward and lightly touch 2M7629U. The driver and passenger of 2M7629U came out to inspect their rear and there was no damage. Similarly there was no damage to the front of my car. I took down their details nonetheless so that they can provide an account of their story.
